BACTERIA IMPLEMENTATION GROUP'S TOP FIVE MOST AND TOP FIVE LEAST IMPAIRED WATER BODIES

PRELIMINARY ACTION REPORT

August 4, 2016

Prepared by
Paniz Miesen
Houston-Galveston Area Council
P.O Box 22777
Houston, Texas 77227
(832) 681-2523
paniz.miesen@h-gac.com

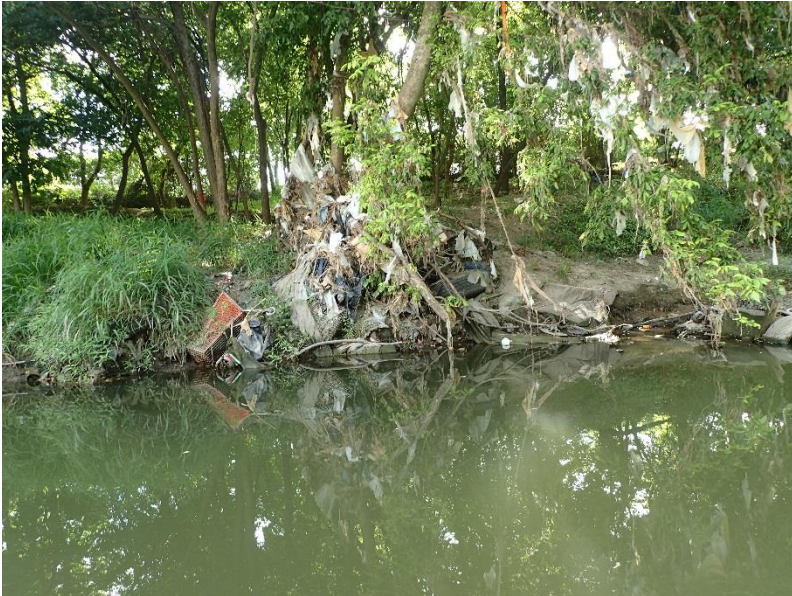
The most significant observation recorded during the Little White Oak Bayou survey was the litter and trash problem along the entire waterway. Portions of Little White Oak’s banks were completely covered in trash and debris ranging from tires, shopping carts, plastics, Styrofoam, aluminum, and clothing. Trees along the lower portion of the waterway were covered in trash, likely from high flow conditions washing significant amounts of litter downstream that become trapped in branches and wrapped around tree trunks (Figures 11-14). However, even with the accumulated trash, there were abundant amounts of wildlife and aquatic organisms observed during the field surveys. Turtles and various bird species were common, many of which have made homes in the littered trees, shopping carts and tires. Alligator gar were also observed, primarily at the mouth of storm drains and outfall locations.

Figure 11. Shopping cart and litter on water bank

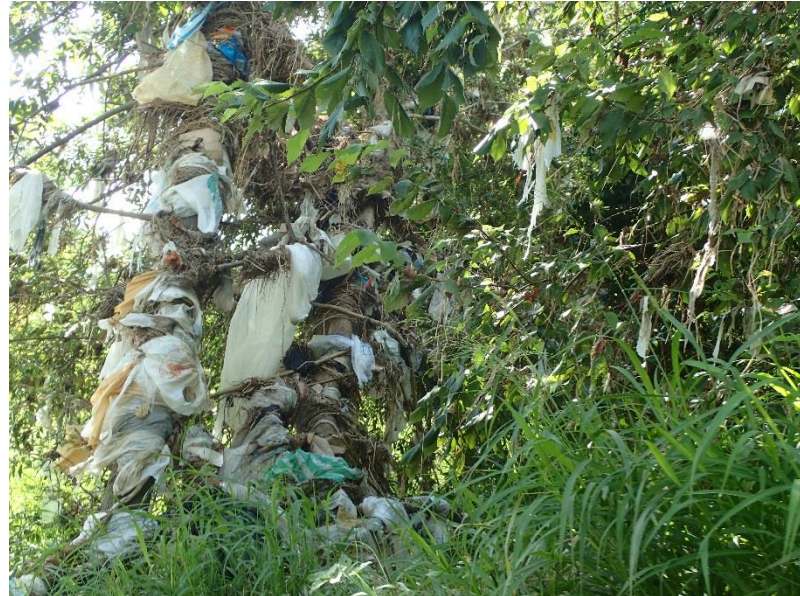
Figure 12. Trash wrapped around tree trunks in lower portion of Little White Oak

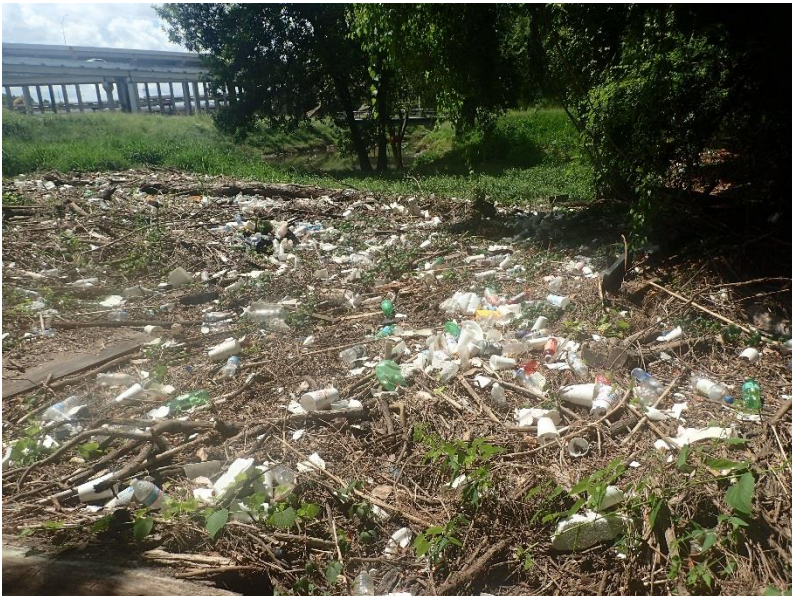
Figure 13. Trash accumulated on water banks near I-45 bridge

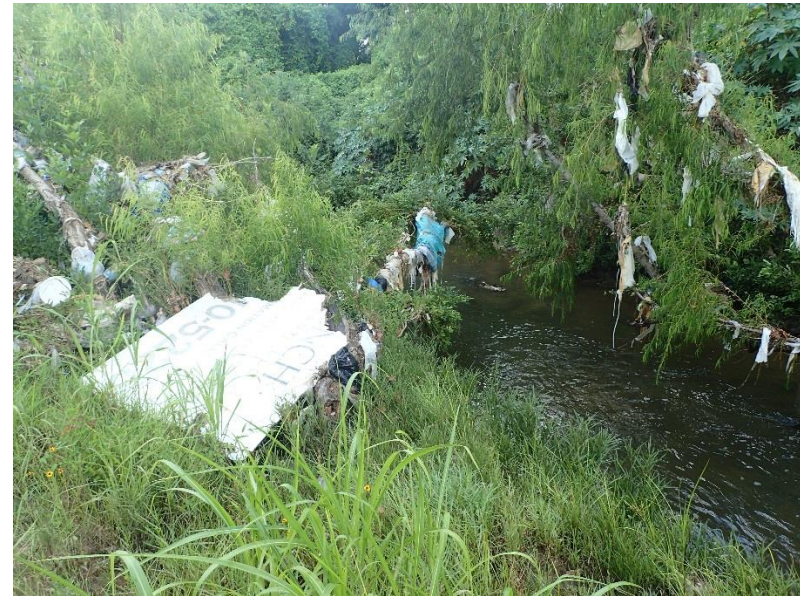
Figure 14. Washed up trash trapped by tree branches

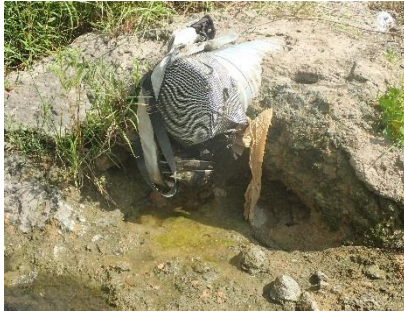
Figure 15. Outfall Tier II ID 035

- 1) Three suspicious outfall pipes adjacent to the Moody Park area had metal screened covers attached to the ends. One of the three pipes had a small amount of discharge dripping from the outfall, but not enough for sample collection and bacteria screening. Locations for the screened outfalls can be found in Table 3 (Tier II ID 033, 035, and 040). Refer to Figures 15-17 for images of the three suspicious outfall pipes.

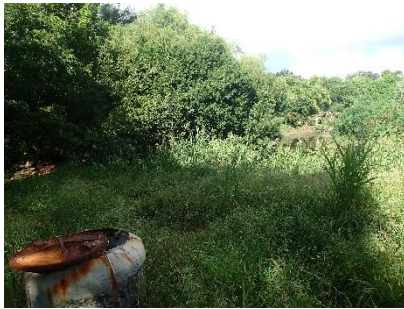
Figure 18. Outfall Tier II ID 047

- 2) Two sewer manholes require follow-up investigation. One manhole (Tier II ID 047) was found along the Bayou with an open lid likely from a recent sewer overflow. The smell of sewage inside the manhole could be detected from the bank. A second damaged manhole was found along the Bayou (Tier II ID 052). This manhole was about six feet tall with a large hole in the cement casing. Another hole was found in the ground by the sewer manhole. It was unclear if this was an active or abandoned manhole, but further investigation is recommended to ensure raw sewage does not discharge at the location. Refer to Table 3 for locations of each manhole, and to Figures 18-20 for images of each.

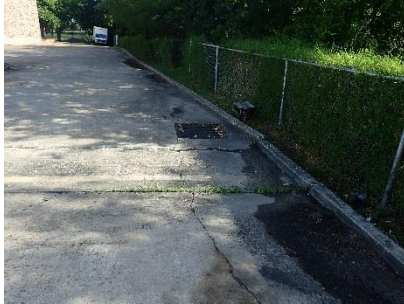
Figure 21. Astro Inn Parking lot (No. 31)

- 3) A suspicious drain line from the Astro Inn's parking lot leads directly into Little White Oak Bayou on the right bank upstream of the West Cavalcade Street bridge. There was no discharge at the outfall at the time of sampling, but a surface water sample (019) was collected directly downstream of the pipe line resulting in an *E.coli* concentration of 7,300 cfu/100mL. Additional investigation is recommended to ensure this is not an illicit discharge. Refer to Table 3 (No. 31) for GPS coordinates and to Figure 21-23 for images of the drain line and parking lot.

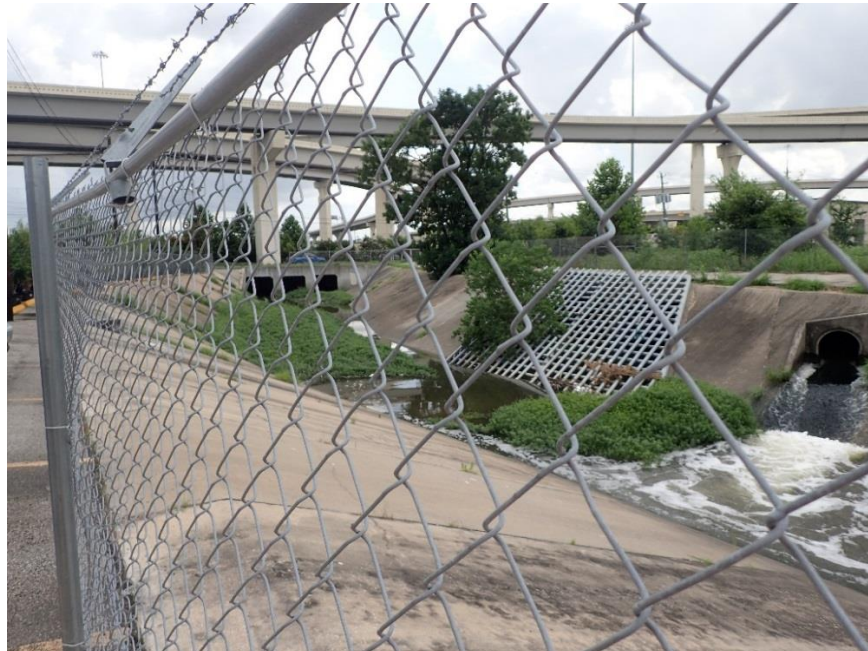
Figure 28. Stormwater detention outfall adjacent to plant nursery at southwest corner of I-10 and Beltway 8 intersection

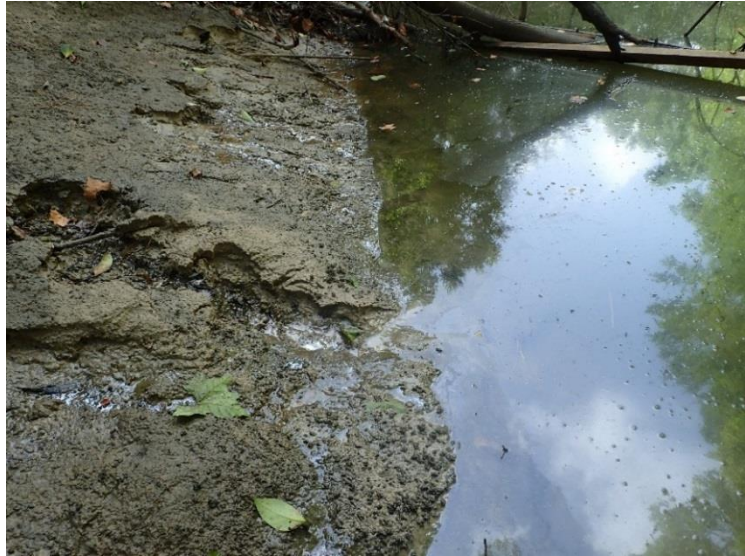
Noteworthy findings include sample 033 collected at a bend in the stream segment where trash accumulation was observed and apparent groundwater discharge was present. A slight sheen was visible on the water surface at the same location disturbed by the groundwater movement in the otherwise stagnant water (Figure 31). Two dilapidated pipes were observed at sample location 034 where high bacteria levels were detected. One pipe was bored under the waterway (Figure 32) while the other crossed above the water at street level. A concrete slab was found on the floor of Rummel Creek just downstream of the Rummel Creek Road bridge (Figure 33). The concrete was impeding water flow and creating high algae accumulation

Figure 31. Groundwater discharge and surface sheen at sample 033

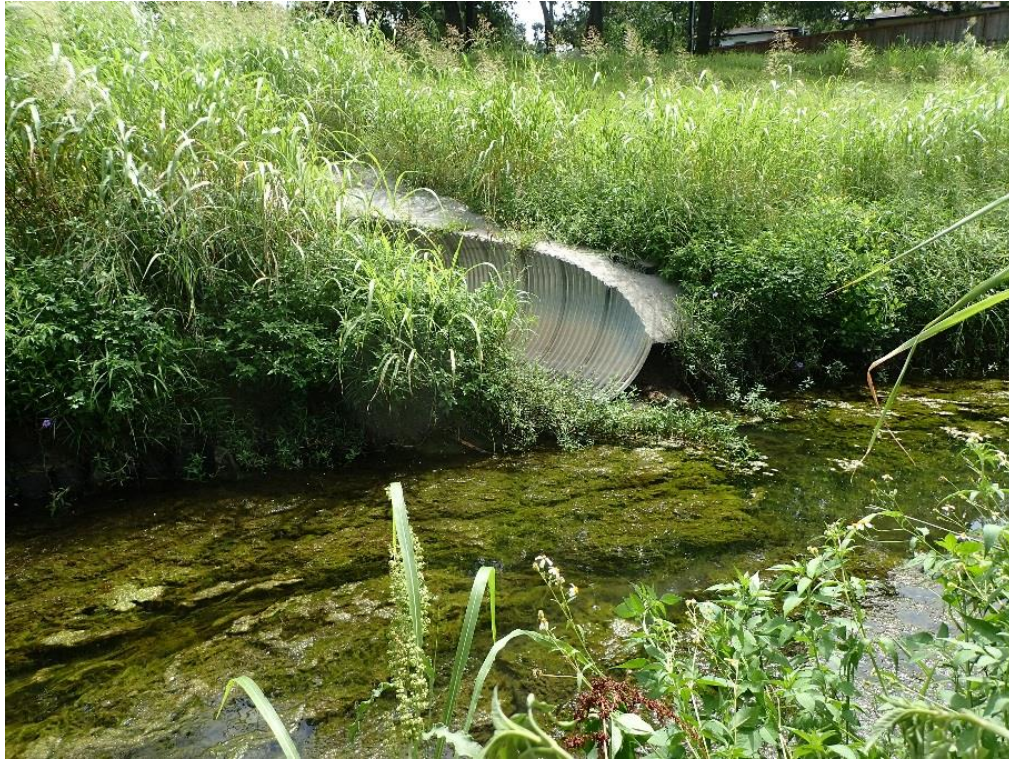
Figure 34. Dense algal blooms near Rummel Creek Elementary School (sample 036)

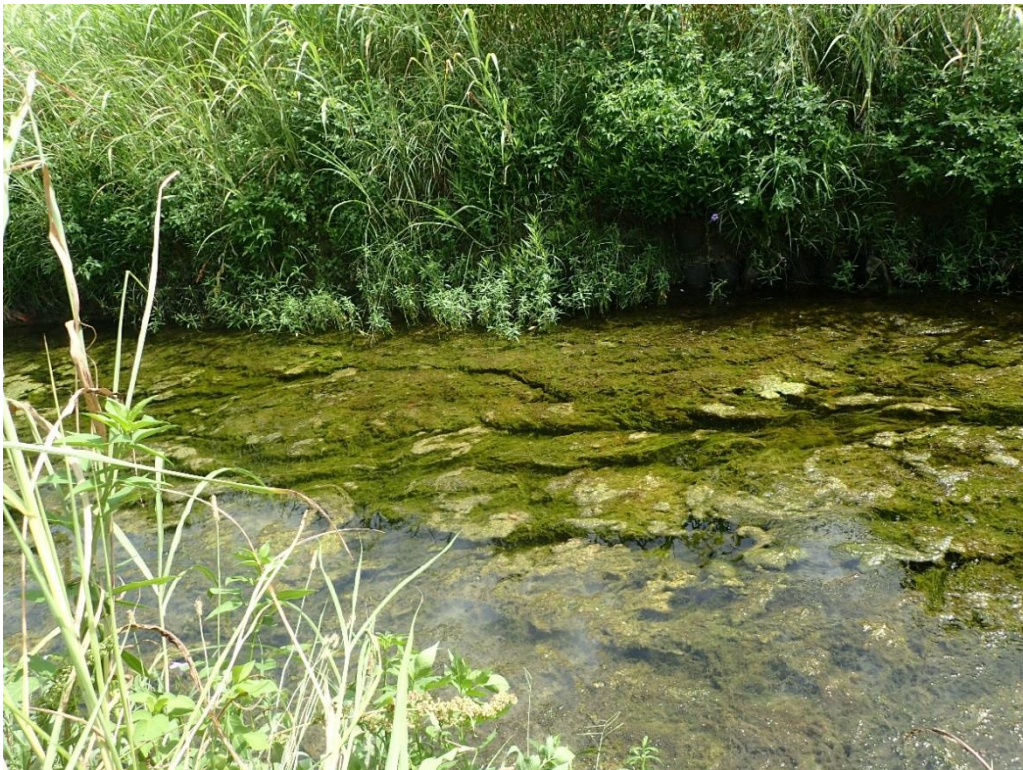
Figure 35. Dense algal blooms near Rummel Creek Elementary School (sample 036)

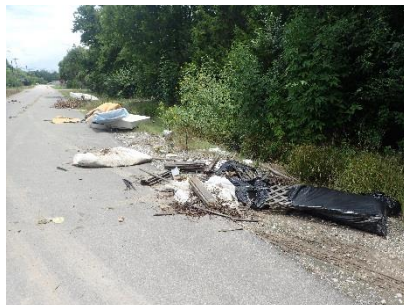
Figure 40. Illegal dumping

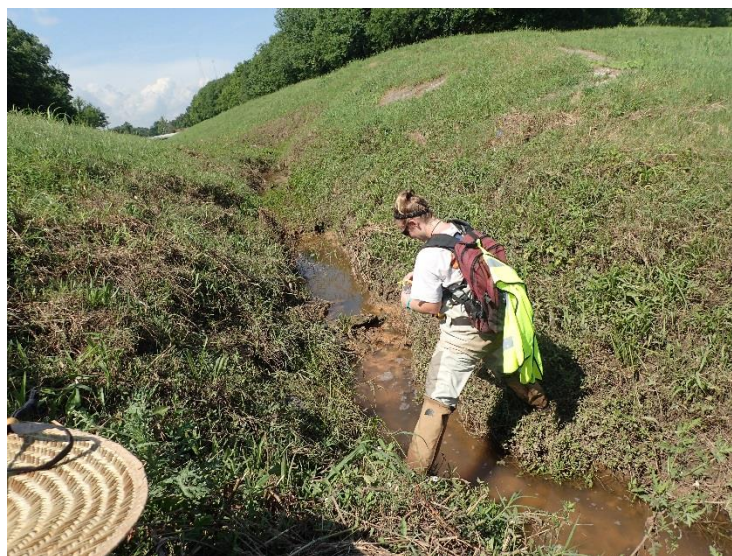
Figure 47. Tributary north of Beltway 8 with high bacteria concentration (sample 021)

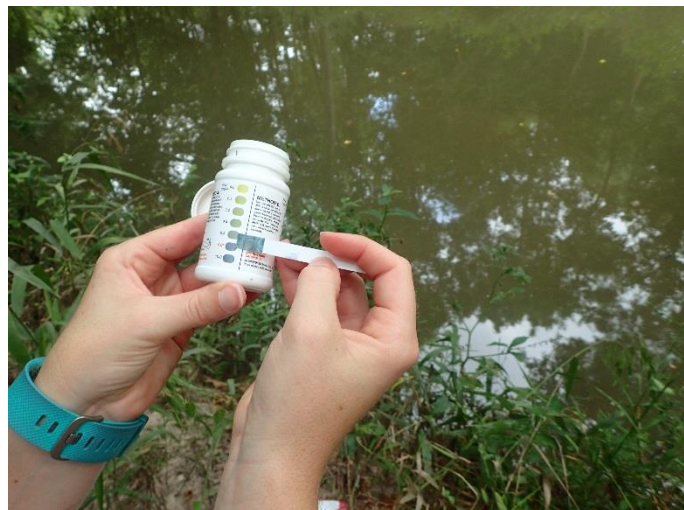
The most significant observation recorded during the Upper Panther Branch surveys was the strong odor and presence of chlorine throughout the waterway. Chlorine test strips were used at the majority of sample locations to detect estimated chlorine levels. All chlorine test strips tested positive for chlorine with *at least* 1.0 mg/L present for every sample tested (Figure 55). Many of the stormwater drainage tributaries had lower levels of chlorine and higher bacteria concentrations compared to the main stem of Upper Panther Branch. Further investigation is recommended in order to identify where the chlorine was originating.

Figure 55. Chlorine test strip result for Upper Panther Branch sample 004

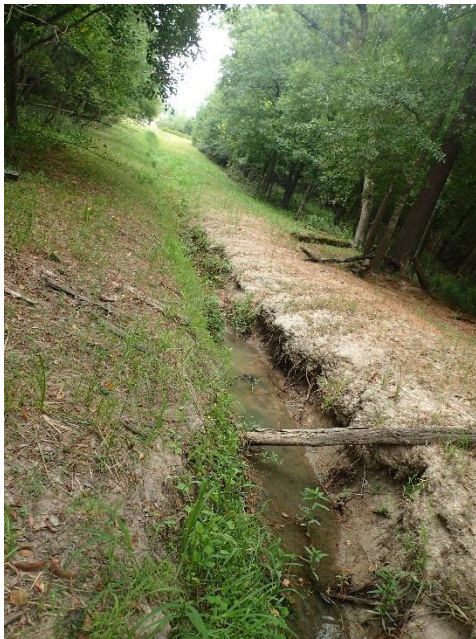
Noteworthy findings include the high bacteria loading from a stormwater drainage tributary (Tier II ID 065) originating from the subdivision off Grogans Mill Road (Figure 56). Homeowners were seen walking their dogs along the drainage tributaries in this area, making pet waste a potential contributor of bacteria at this location. Another stormwater drainage tributary (Tier II ID 072, sample 009) coming from the sporting facility on Marisco Place had high *E.coli* concentrations, 1 with the water sample having a strong petrochemical smell likely from surface runoff from the adjacent parking lot (Figure 57). Several of the tributaries feeding into Upper Panther Branch had a very distinct reddish tint (Figures 58-60). It was unclear if this was a result of impacts from different soil types or if there were other factors. However, there did not seem to be a correlation between bacteria concentration and red water at these sample locations.

Figure 56. Stormwater drainage tributary with high bacteria concentration (Tier II ID 065, sample 003)
