Bacteria Source Identification Report

BIG's Top Five Most and Top Five Least Impaired Water Bodies Project

Galveston Bay Estuary Program
Texas Commission on Environmental Quality
Local Jurisdictions

Prepared by:

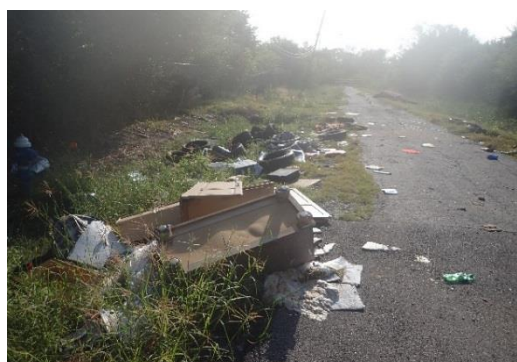
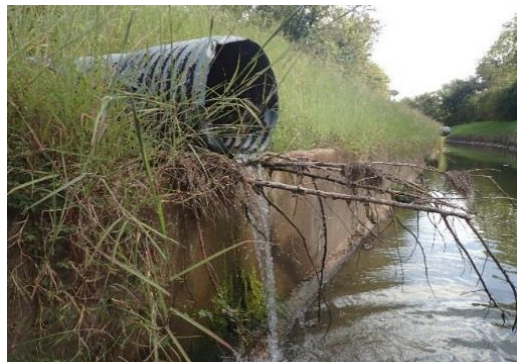
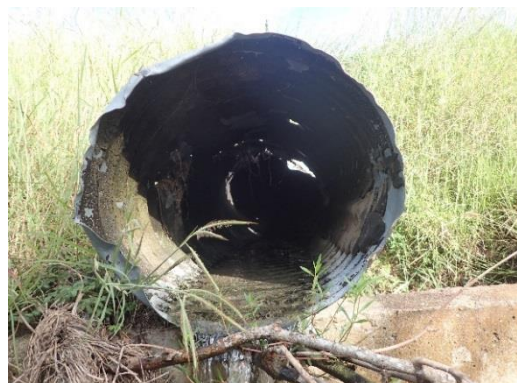
Station 8 is a metal outfall located at the downstream end of the Canal C-147 watershed boundary adjacent to a residential neighborhood and a number of auto body junk yards. Illegal dumping of trash, tires, and large debris was common in the area (Figure 5). Figures 6 and 7 are photos of the outfall taken during the dry weather sampling event. Based on these results, the City of Houston initiated an investigation at this outfall location in September 2016 and detected a potable water leak. Information about corrective actions related to the potable leak are unknown. However, Phase II investigations resulted in wet and dry weather samples with *E.coli* concentrations that are now in compliance with state standards (Table 6).

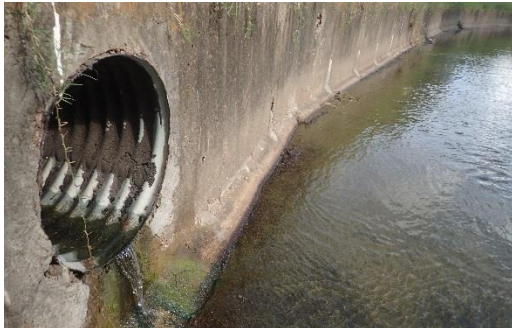
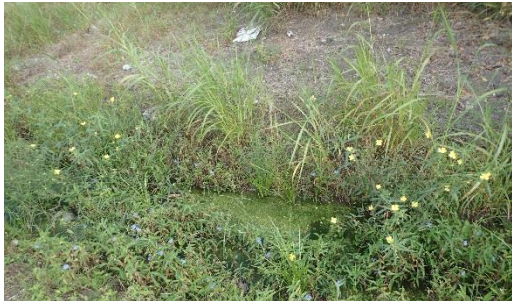
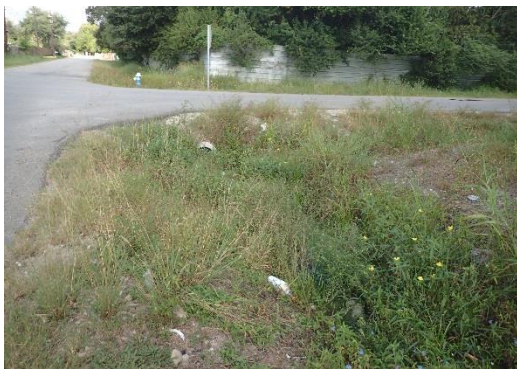
Station 8.1 is a metal outfall located approximately 85 meters upstream of the station 8 outfall (Figure 8). This outfall was not discharging during the Phase I survey so no bacteria screening samples were collected. However, during the Phase II survey, this outfall was intermittently discharging water during both wet and dry weather sampling events. The outfall is located directly underneath the Tiffany Street bridge across the street from a number of junk yards and residential homes. H-GAC field staff attempted to follow the outfall pipe to its origin and found that it is connected to the ditch running along the north side of Tiffany Street (Figures 9 and 10).

Samples were collected directly from the discharging outfall during both wet and dry weather events. Only the wet weather sample had an *E.coli* concentration that exceeded the state water quality standard of 126 MPN/100mL (Table 7).

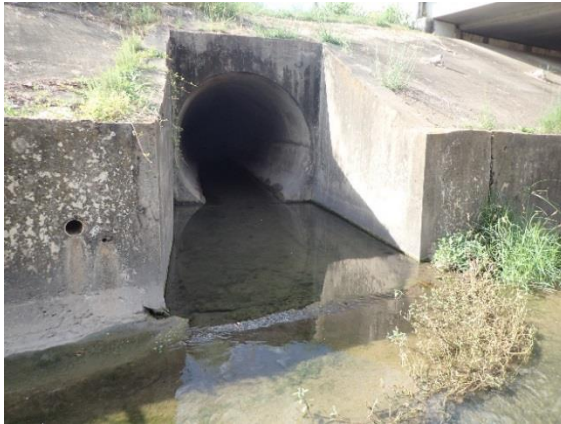
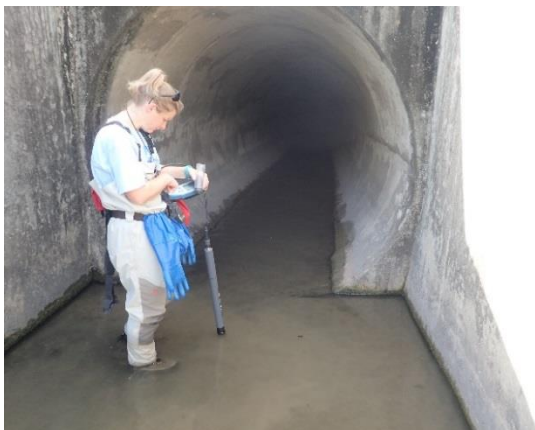
Both wet weather and dry weather samples collected at this location had *E.coli* concentrations that exceeded the state water quality standard of 126 MPN/100mL (Table 8). The high bacteria concentrations detected during both wet and dry weather events implies there is a consistent source of bacteria discharging into Canal C-147 at this location regardless of weather conditions. Schools of fish were observed swimming in the storm drain during all sampling events. Additionally, the pH level inside the storm drain during the wet weather event was significantly higher than levels outside the storm drain. Further investigation is recommended at this station.

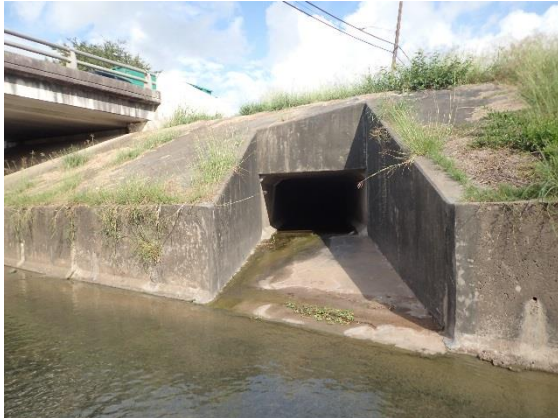
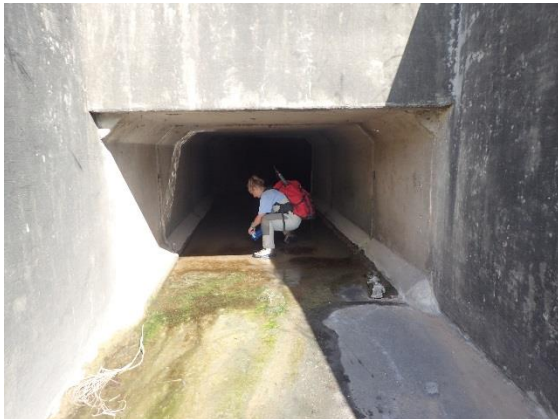
During the dry weather event, there was only a shallow trickle of water discharging from the storm drain (Figures 13 and 14). The water appeared clean and colorless with no particular odor, but was too shallow for the collection of field water quality data using the multiparameter data sonde. There was a significant difference in *E.coli* concentrations between the wet weather and dry weather sampling events (Table 9). Further investigation is recommended at this location to identify the cause for this variation during different weather conditions.

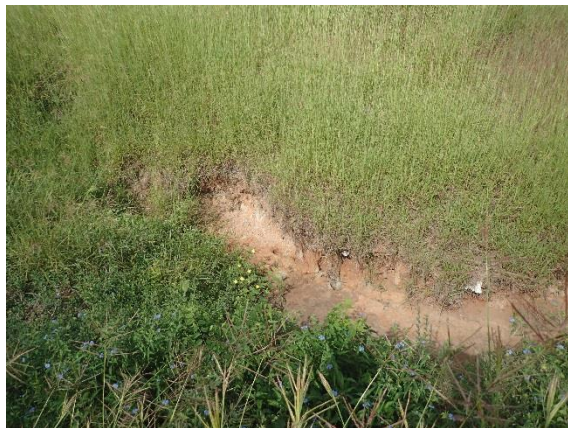
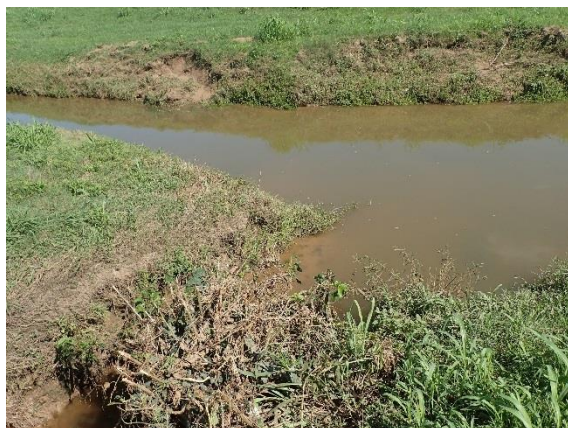
The tributary was dry during the dry weather event on October 19, 2016, so no dry weather sample was collected at this location (Figure 15). Wet weather samples were collected on November 7, 2016 following a significant rain event. The sample for station 17 was collected at the confluence of the tributary with Canal C-147 (Figure 16). A second sample was collected at station 17.1 located approximately 150 meters upstream of station 17. Both wet weather samples collected along this tributary resulted in an *E.coli* concentration of 24,200 MPN/100mL. This station was the most significant source of bacteria to Canal C-147 identified during Phase I and Phase II of the project. Further investigation is recommended.

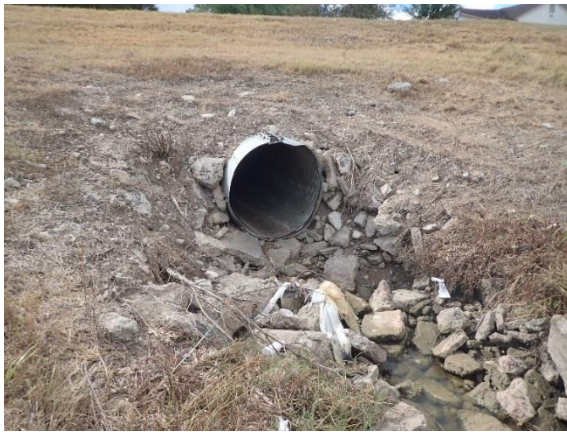
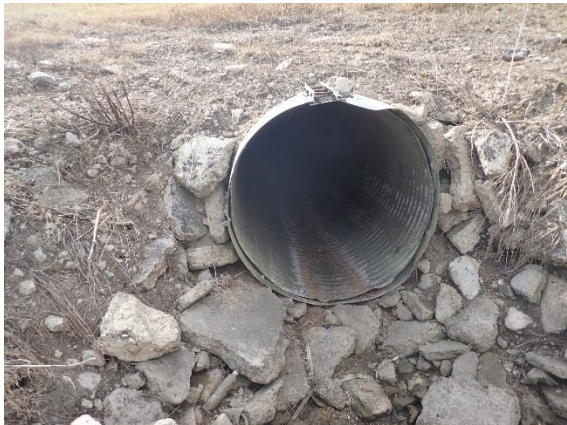
There was no discharge observed during the dry weather event conducted on October 19, 2016 (Figures 17 and 18) resulting in no dry weather samples collected at this location during Phase II investigations. A wet weather sample was collected on November 7, 2016. A sample was collected directly from the outfall and field water quality data from the data sonde were taken from the shallow pool of water accumulated in front of the outfall. The resulting bacteria concentration was 3,650 MPN/100mL which is significantly greater than the state water quality standard for *E.coli* (Table 11).

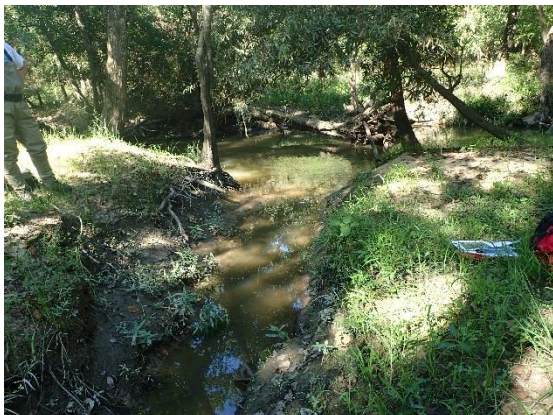
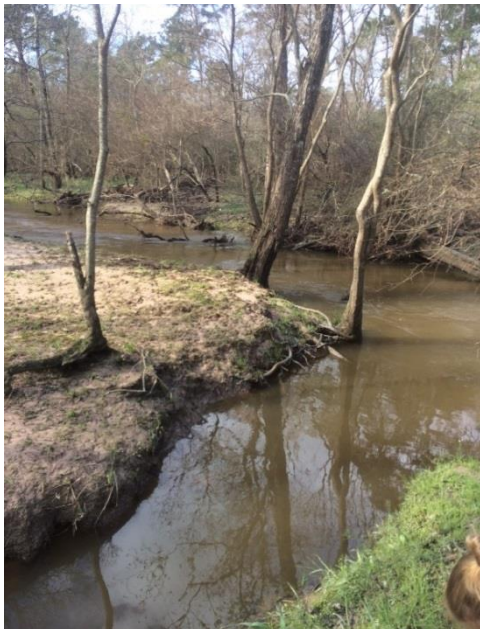
The dry weather sample collected on September 28 (Figure 23) was in compliance with state water quality standards for bacteria (Table 13). Chlorine test strips detected a chlorine level of approximately 0.65 mg/L at this location during the dry weather event. The wet weather event conducted on February 15, 2017 (Figure 24) resulted in a significantly higher bacteria concentration with levels measuring at 7,270 MPN/100mL (Table 13).

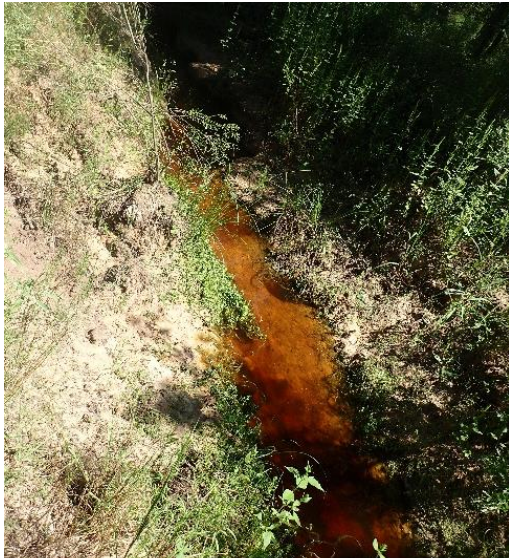
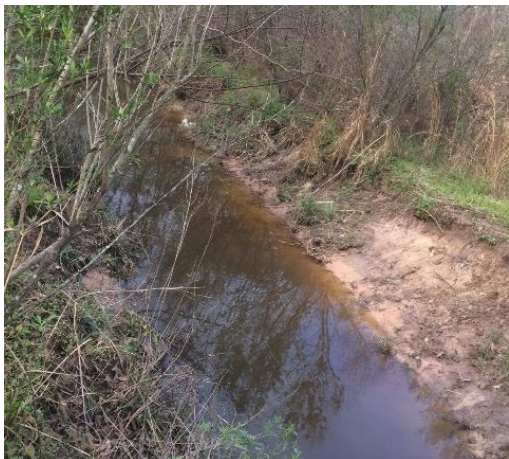
The dry weather sample collected on September 28 (Figure 25) was just above the state water quality standard for *E.coli* measuring at 185 MPN/100mL (Table 14). The water was consistently red in color at this location during all dry weather surveys conducted for this project. No chlorine was detected at this station. The wet weather event conducted on February 15, 2017 (Figure 26) resulted in the significantly higher bacteria concentration of 7,270 MPN/100mL (Table 14).

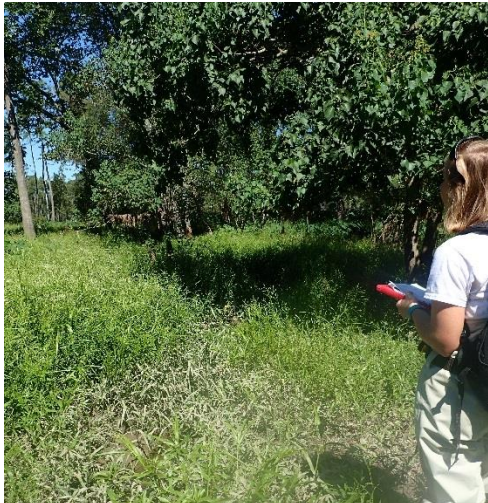
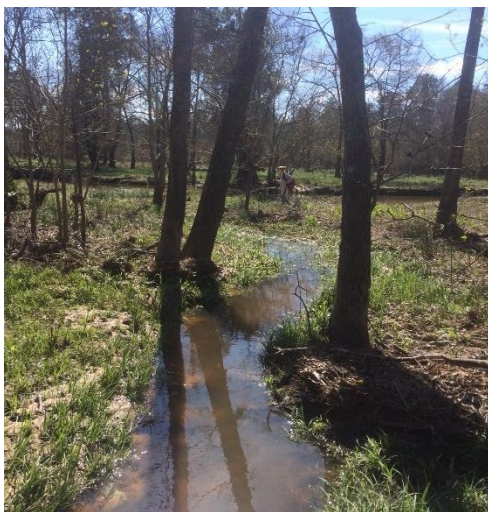
The dry weather sample collected on September 28 (Figure 27) was in compliance with state water quality standards for bacteria (Table 15). The water had a strong chemical odor during this sampling event and chlorine test strips detected a chlorine concentration of approximately 0.1 mg/L. The wet weather event conducted on February 15, 2017 (Figure 28) resulted in a bacteria concentration of 5,790 MPN/100mL (Table 15).

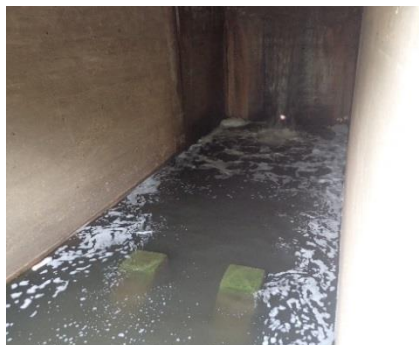
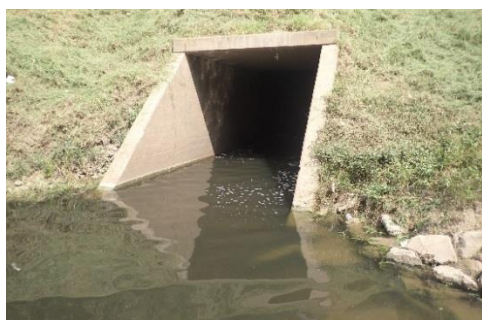
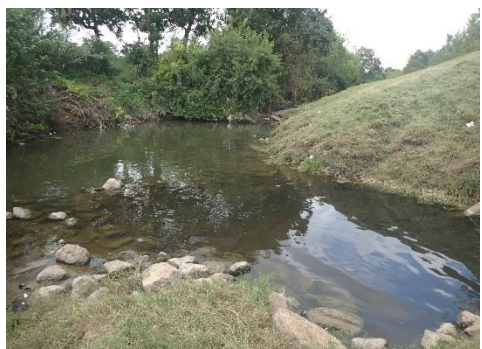
Station 8 is a large outfall located at the southern end of Moody Park adjacent to a parking lot off Fulton Street. The outfall was consistently discharging large volumes of water into Little White Oak Bayou during all Phase I and II investigations (Figures 31-32). Homeless activity was commonly observed at this location.

Samples were collected directly downstream of the outfall during Phase II investigations (Figure 33). The dry weather sample collected on October 11, 2016 was just over the state water quality standard for bacteria measuring at 199 MPN/100mL (Table 16). However, the wet weather sample collected on February 15, 2017 resulted in the much higher bacteria concentration of 24,200 MPN/100mL.

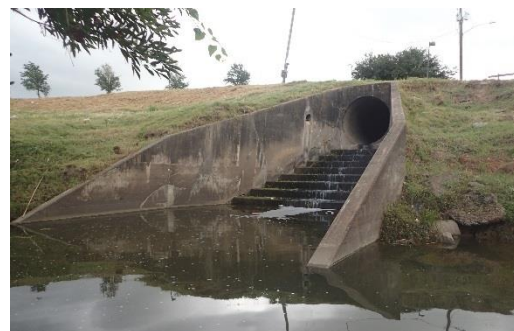
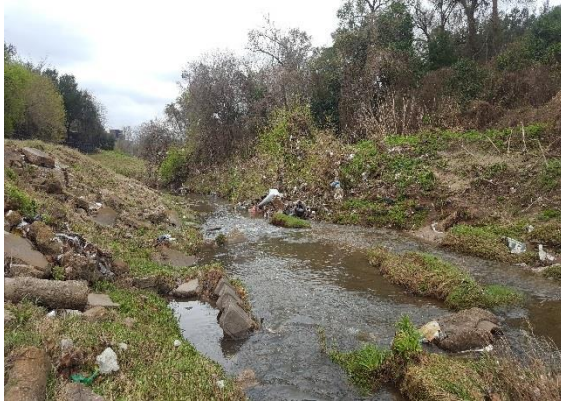
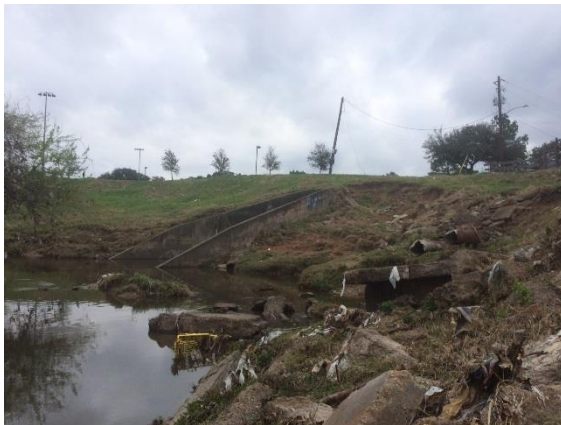
Samples were collected directly downstream of the storm drain during Phase II investigations. The dry weather sample collected on October 11, 2016 resulted in an *E.coli* concentration of 1,080 MPN/100mL, making it one of the highest bacteria sources to Little White Oak Bayou during

the dry weather event (Table 17). However, the wet weather sample collected on February 15, 2017 resulted in a much higher bacteria concentration of 24,200 MPN/100mL.

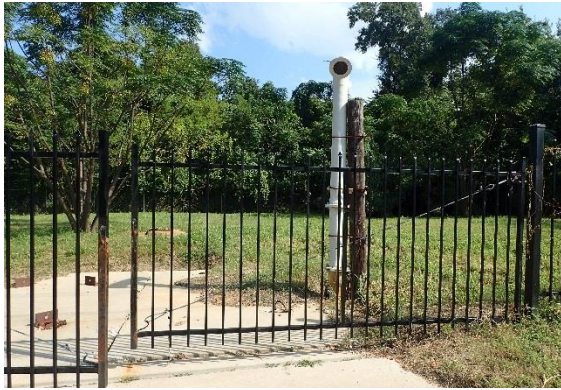
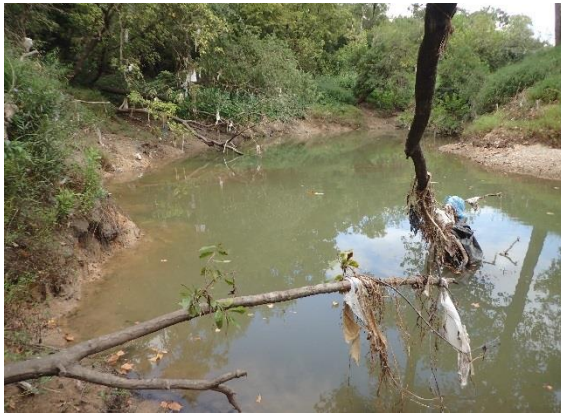
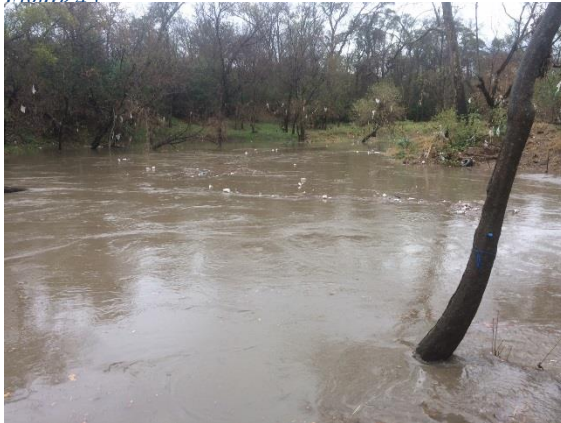
The dry weather sample collected at this location on October 11, 2016 (Figure 38) resulted in an *E.coli* concentration of 161 MPN/100mL, slightly exceeding the state water quality standard. The wet weather sample collected approximately 20 minutes after a significant rain event on February 14, 2017. The water level was high and large amounts of trash and debris were flowing with the water downstream (Figure 39). The *E.coli* concentration for the wet weather event was 24,200 MPN/100 mL, significantly higher than the dry weather concentration (Table 18).

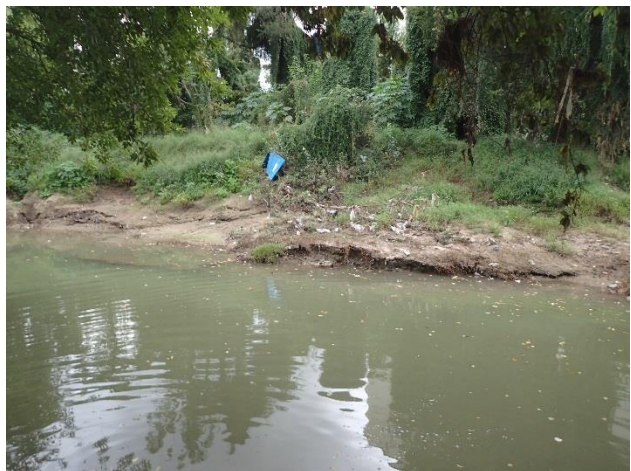
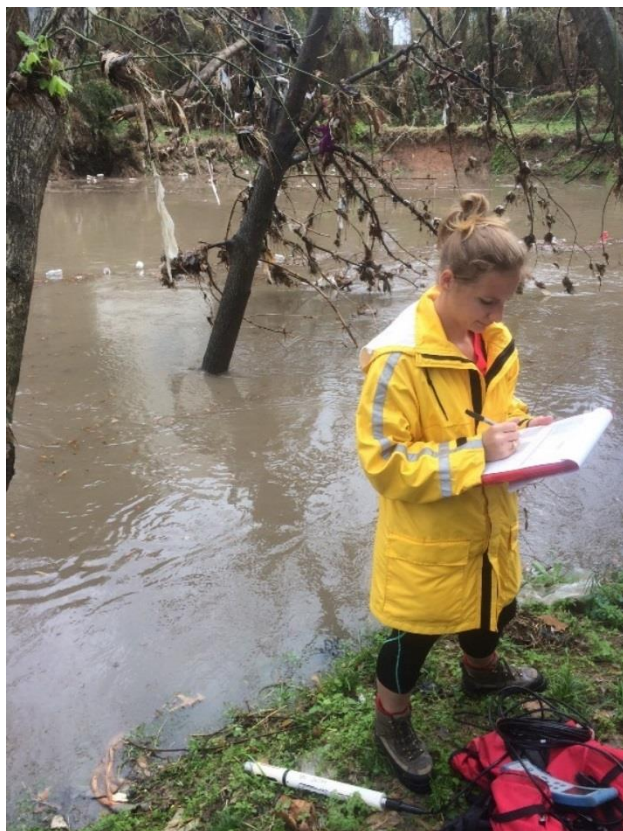
The dry weather sample collected on October 11, 2016 (Figure 40) resulted in an *E.coli* concentration of 393 MPN/100mL. This concentration is more than twice the concentration observed upstream of the junction box. However, the wet weather sample collected on February 14, 2017 (Figure 41) had the same bacteria concentration as the sample collected upstream of the junction box (Table 19).

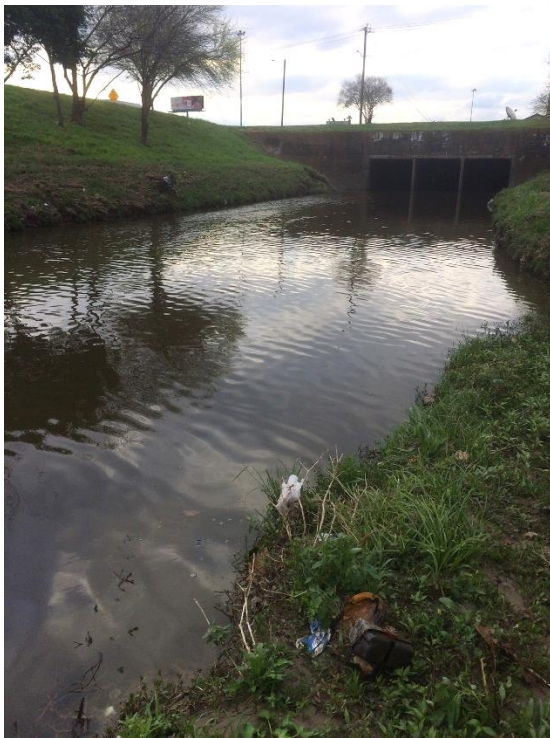
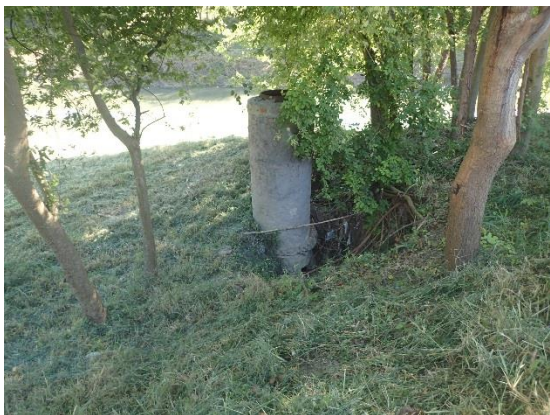
Station 17 is located at Vincent Street and Coronado Avenue directly upstream of where the waterway goes underground at I-45 (Figure 42). A faulty manhole was observed on the right bank approximately 52 meters upstream of this station. The manhole was about 6 feet above ground and the cement casing had a large hole. A hole in the ground was also observed next to the manhole with evidence of recent sewage overflows visible (Figure 43).

The dry weather sample collected on October 11, 2016 had an *E.coli* concentration of 197 MPN/100mL. The wet weather sample collected on February 15, 2017 was significantly higher at 24,200 MPN/100mL (Table 20).

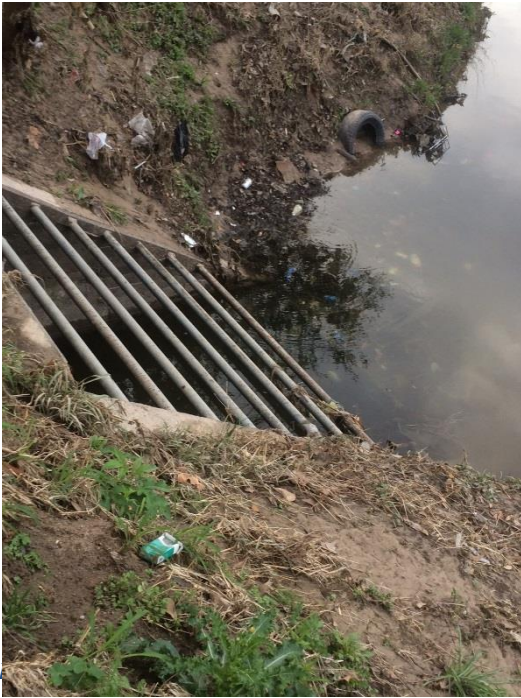
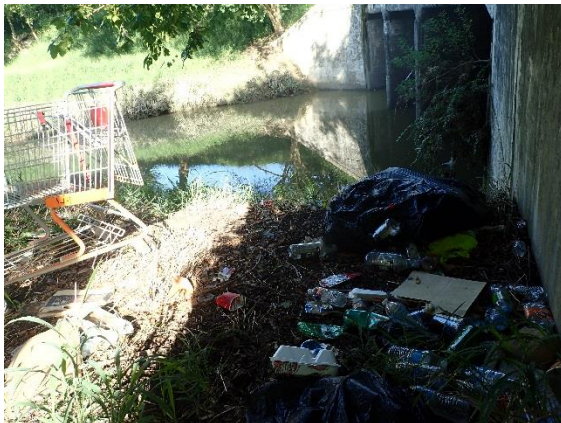
Station 18 is an outfall located on the left bank of Little White Oak Bayou to the south of the Cavalcade Street bridge (Figure 44). Homeless activity is common at this location with furniture and other debris observed on the bank (Figure 45). Alligator gar and other large fish species were observed at the mouth of this outfall during Phase I and Phase II investigations.

The dry weather sample collected on October 11, 2016 resulted in a bacteria concentration of 355 MPN/100mL. The wet weather sample collected on February 15, 2017 was significantly higher measuring at 11,200 MPN/100mL (Table 21). Although the wet weather sample concentration was slightly lower than the surface water samples collected upstream of this location, this outfall is still considered to be contributing a consistent amount of bacteria into Little White Oak Bayou regardless of weather conditions.

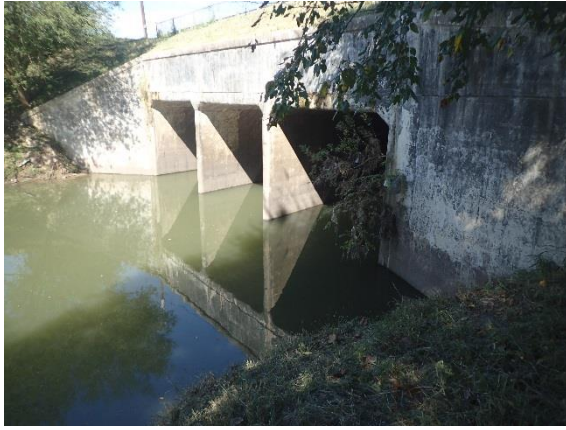
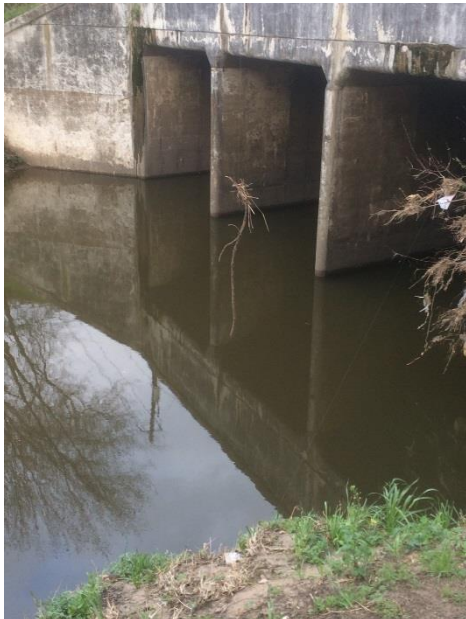
Station 18.1 is located directly upstream of outfall station 18 south of the Cavalcade Street bridge. A surface water sample was collected at this location to compare upstream bacteria levels to concentrations found at outfall 18.

Both the dry weather (Figure 46) and wet weather (Figure 47) bacteria concentrations were greater than levels found at outfall station 18.1 (Table 22) indicating that a more significant source of bacteria is located upstream of this location.

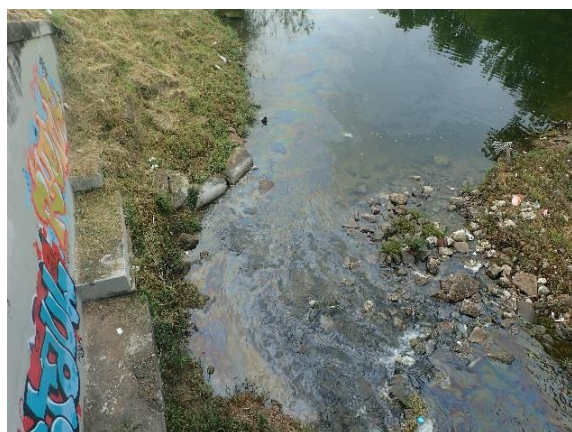
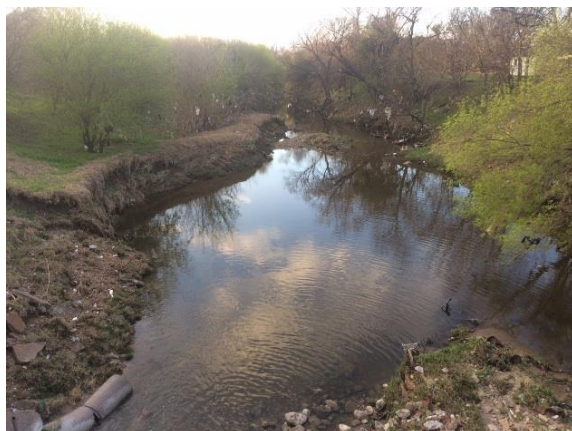
A dry weather sample was collected on October 11, 2016. At the time of sample collection, a strong odor of diesel was detected and an oily sheen was observed on the surface of the water (Figure 48). The *E.coli* concentration was 7,700 MPN/100mL which was the highest bacteria concentration collected during the dry weather event at Little White Oak Bayou. The wet weather sample collected on February 15, 2017 (Figure 49) resulted in a significantly higher bacteria concentration of 24,200 MPN/100mL. The same *E.coli* concentration was detected for all surface water samples collected on February 15, 2017 that were located downstream of this station. Further investigation upstream of this location is recommended to better evaluate specific bacteria sources impacting Little White Oak Bayou.

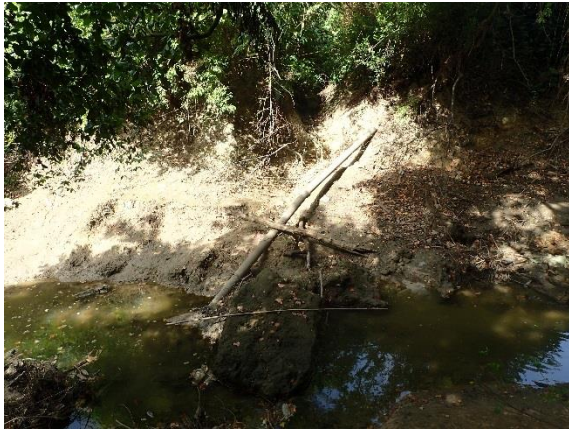
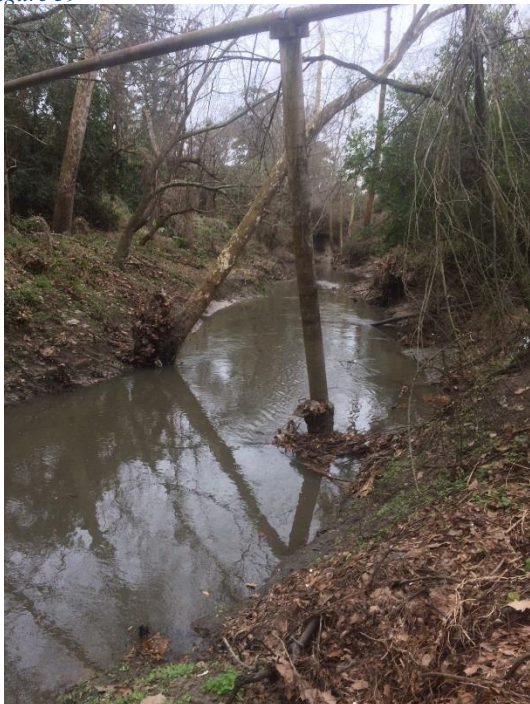
Station 34 is located at the southern end of the Rummel Creek watershed boundary downstream of the Edith L Jones Nature Conservancy. The station can be accessed through dense vegetation at the end of Hermitage Lane in a residential neighborhood. Old pipelines were observed along the stream bottom, although it was unclear if they were still operating or not (Figure 52).

A dry weather sample was collected on December 14, 2016 resulting in a bacteria concentration slightly exceeding the state water quality standard (Table 24). The wet weather sample was collected on February 14, 2017 immediately following a significant rain event (Figure 53). The bacteria concentration for the wet weather sample was 8,660 MPN/100mL which was significantly higher than the dry weather sample, but was the lowest wet weather concentration observed in Rummel Creek.

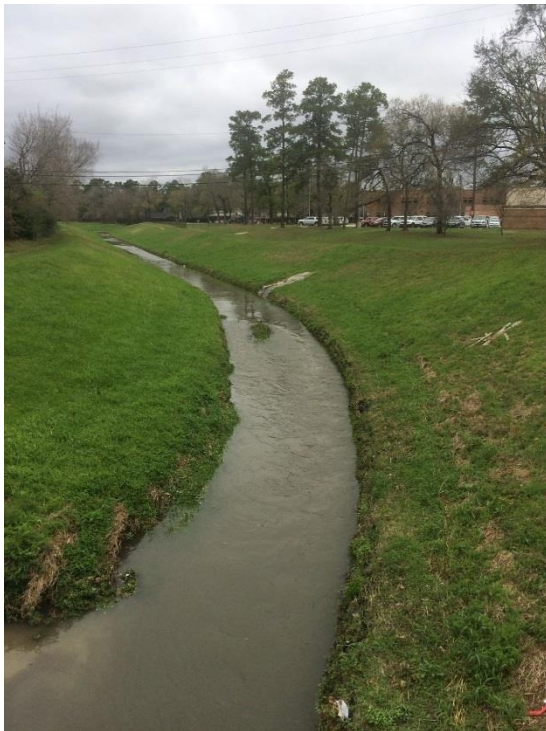
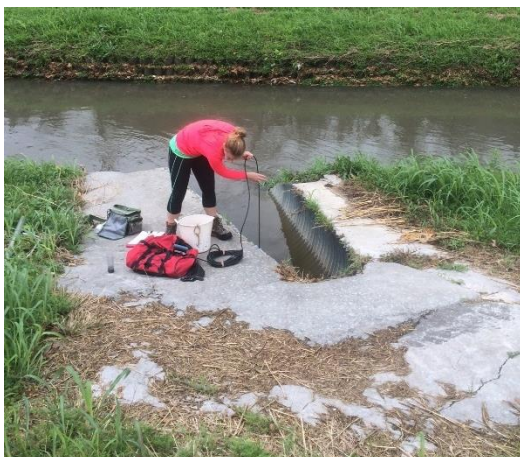
Station 36 is an outfall located downstream of Rummel Creek Elementary directly upstream of the bridge at Memorial Drive (Figure 54). This station is one of the highest contributors of bacteria into Rummel Creek during both Phase I and Phase II investigations. The outfall was discharging during all station visits, regardless of weather conditions.

The dry weather sample collected on December 14, 2016 resulted in an *E.coli* concentration of 1,860 MPN/100mL. The wet weather sample collected immediately following a significant rain event on February 14, 2017 (Figure 55) was significantly higher measuring at 24,200 MPN/100mL.

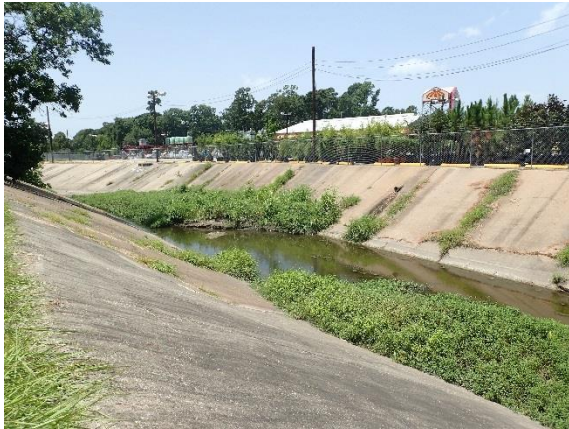
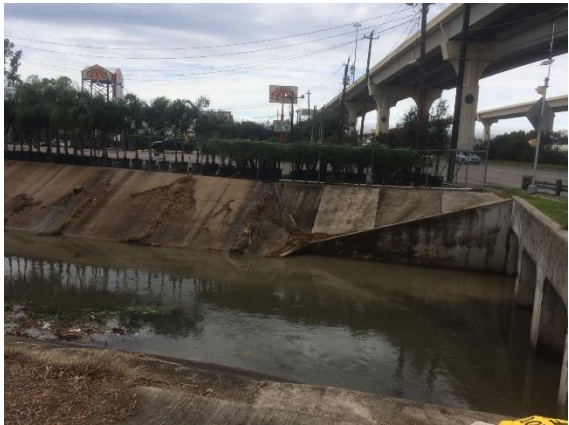
The dry weather sample collected on December 14, 2016 resulted in a bacteria concentration of 933 MPN/100mL, making this station one of the highest contributors of bacteria to Rummel Creek during dry weather conditions. At the time of the wet weather survey on February 14, 2017, the water discharging from the left bank was darker in color whereas water discharging on the right bank looked brown and cloudy, likely from heavy sediment loads from the recent rains (Figure 57). The wet weather *E.coli* concentration was significantly greater than the dry weather sample measuring at 12,000 MPN/100mL (Table 26).

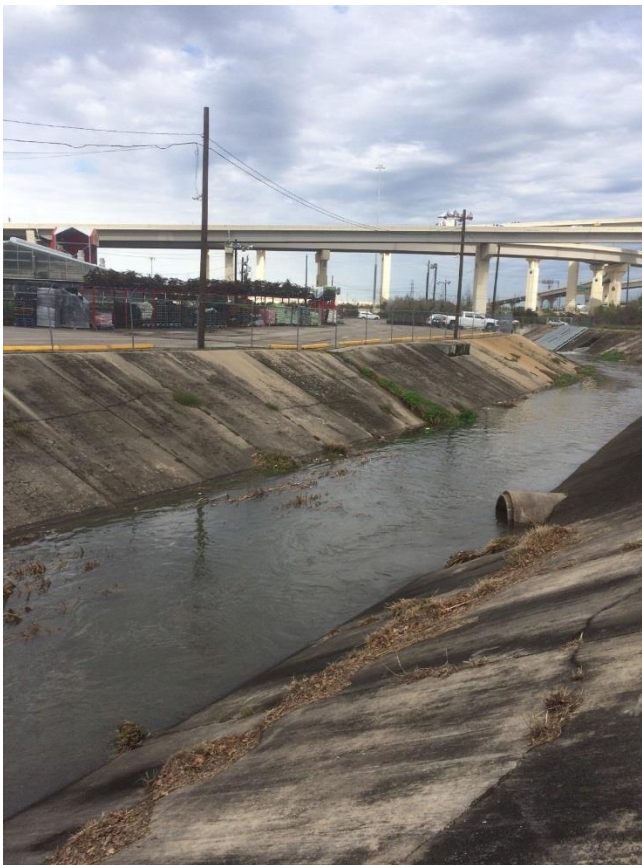
During the dry weather event conducted on December 14, 2016, a strong odor of sewage was detected at one of the large outfalls directly upstream of station 41. Toilet paper was also observed at the outfall, although no water was discharging at that time. The dry weather sample resulted in a bacteria concentration of 369 MPN/100mL. The wet weather sample collected on February 14, 2017 was 24,200 MPN/100mL making station 41 one of the highest contributors of bacteria during wet weather conditions.

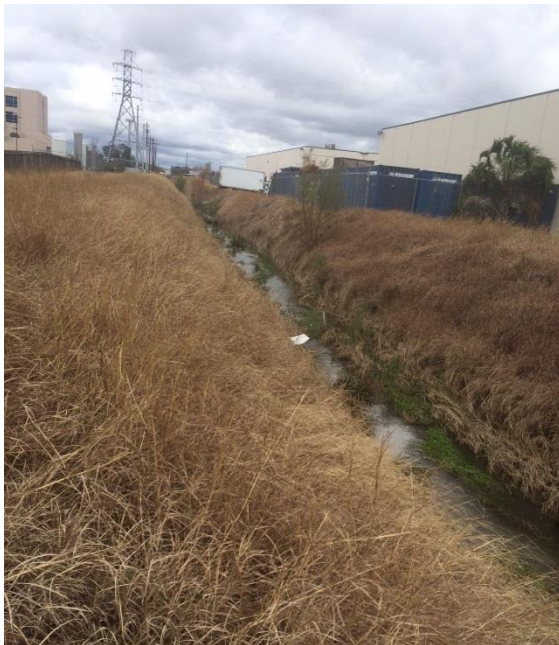
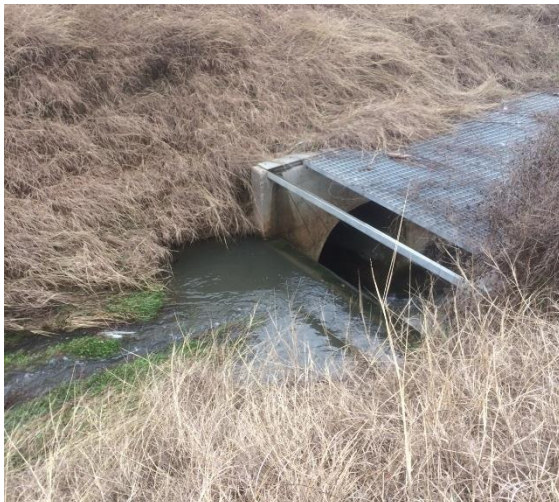
No sample was collected during the dry weather event on December 14, 2016 due to no flowing water at this station. The wet weather sample collected on February 14, 2017 resulted in an *E.coli* concentration of 19,900 MPN/100mL (Figure 60).
