North Trinity Bay

Well Plugging, Pipeline Abandonment & Structure Removal Project

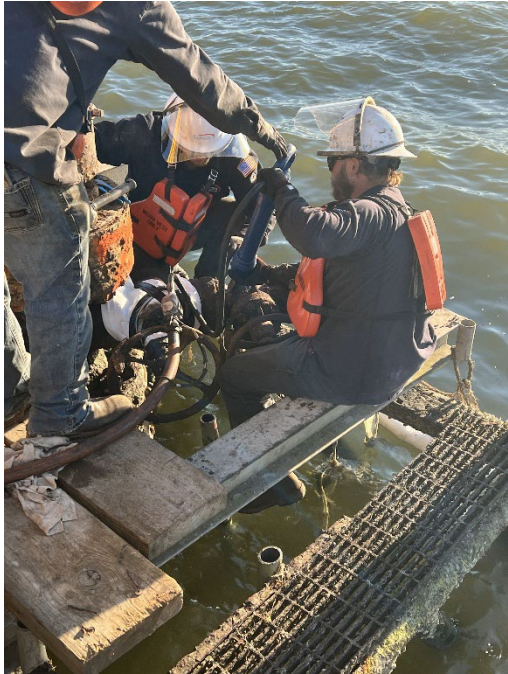
Heavy Corrosion

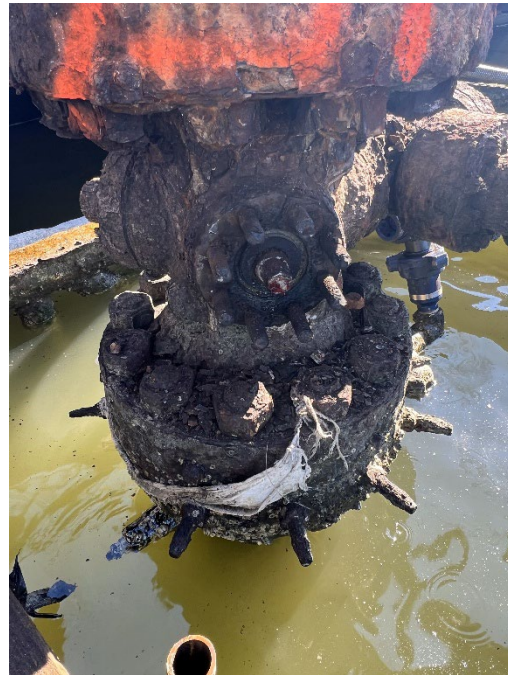
VR Plug in Flange

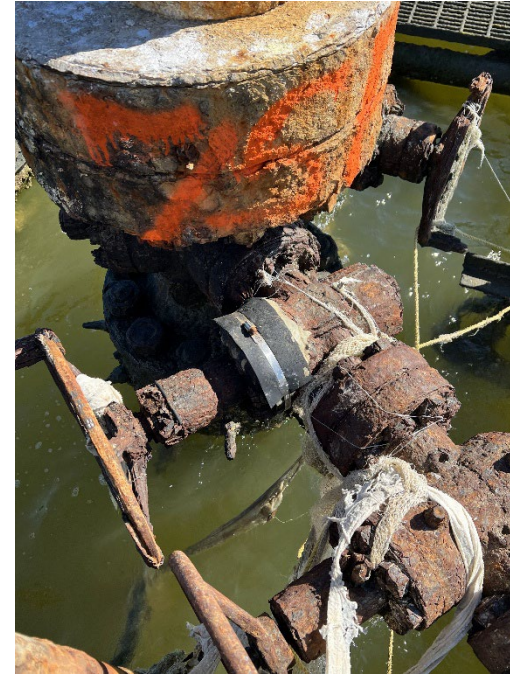
Casing Flange Patch

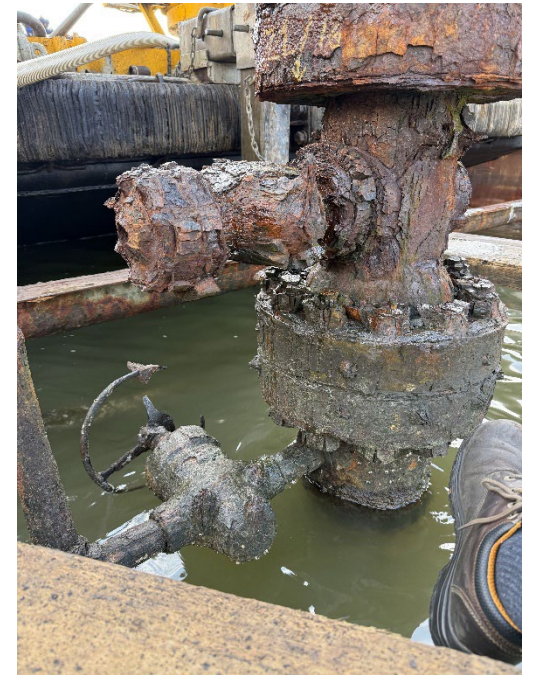
Heavy Corrosion

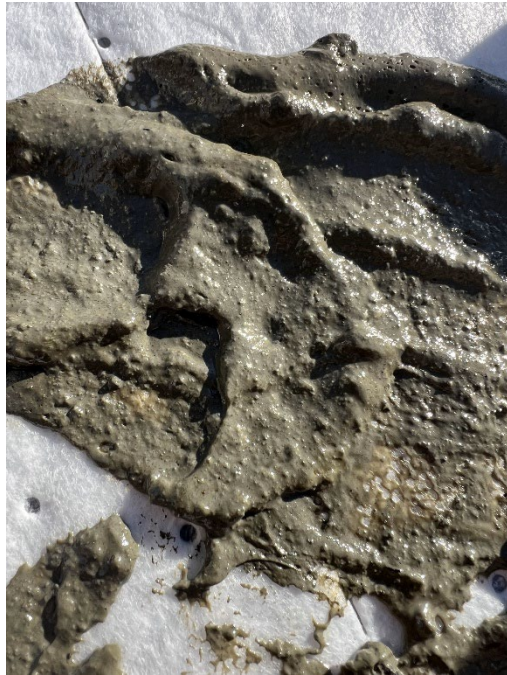
Formation
Fluid/Mud/Sand

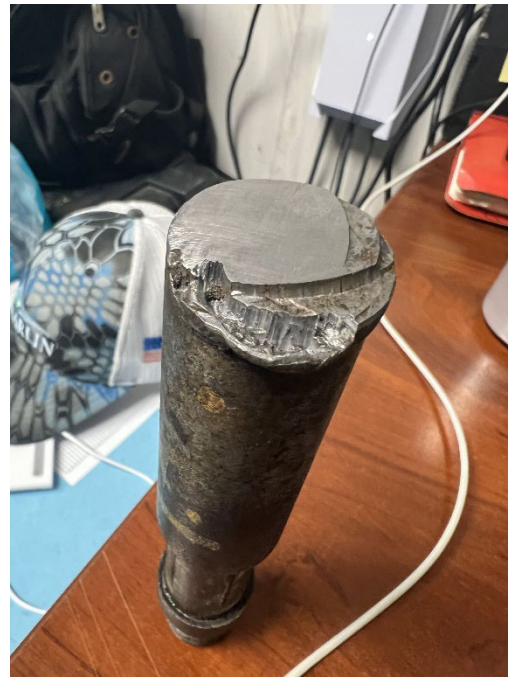
Parted Tubing

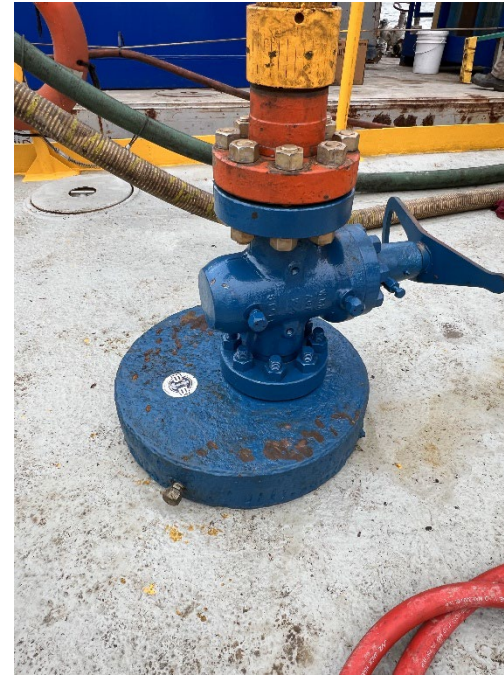
Obsolete Wellhead Design
(limited replacement options if non-
functional)

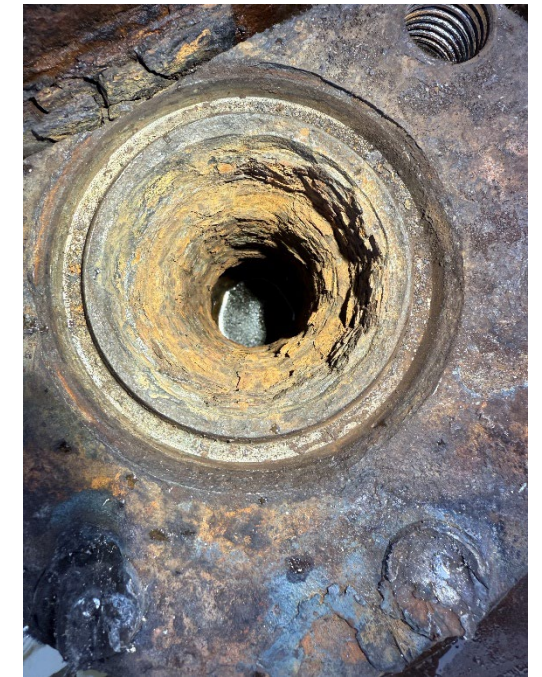
Internal Scale Buildup

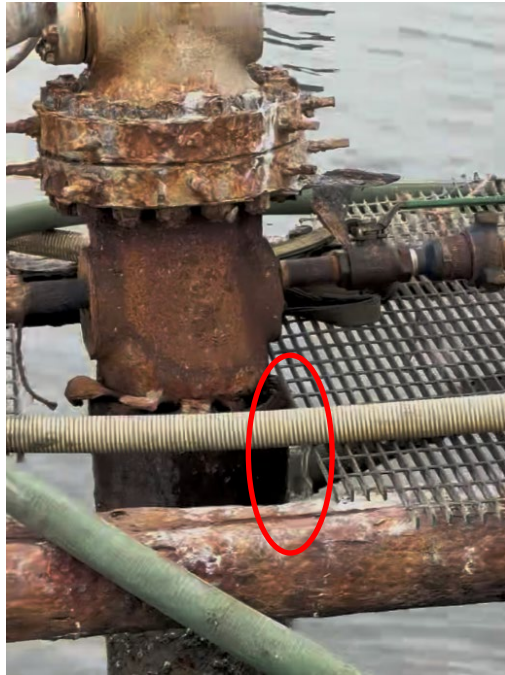
Leaking Drive Pipe

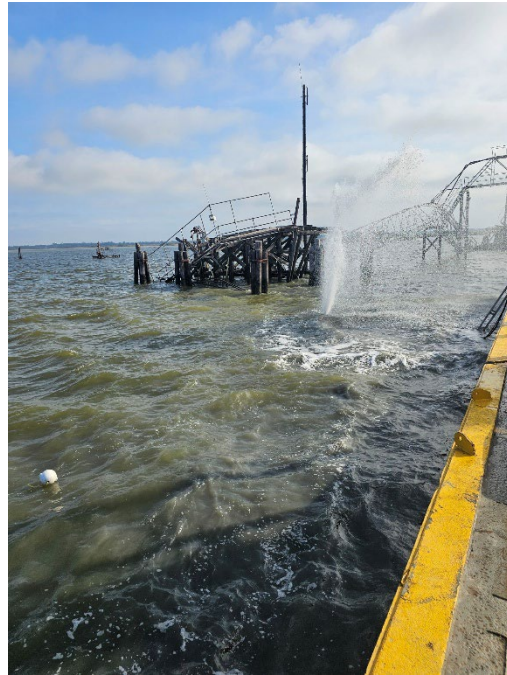
Broken Flow Lines

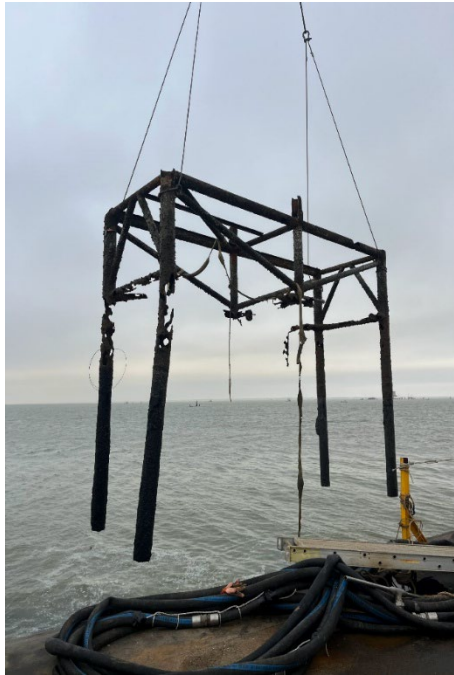
Degraded Platform Structures

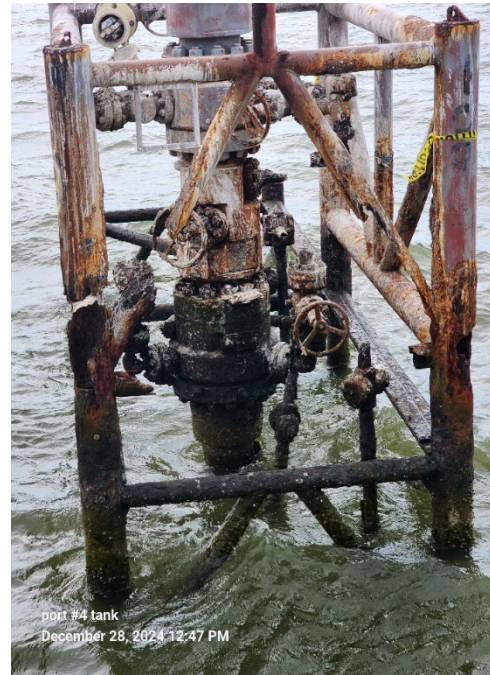
Degraded Platform Structures

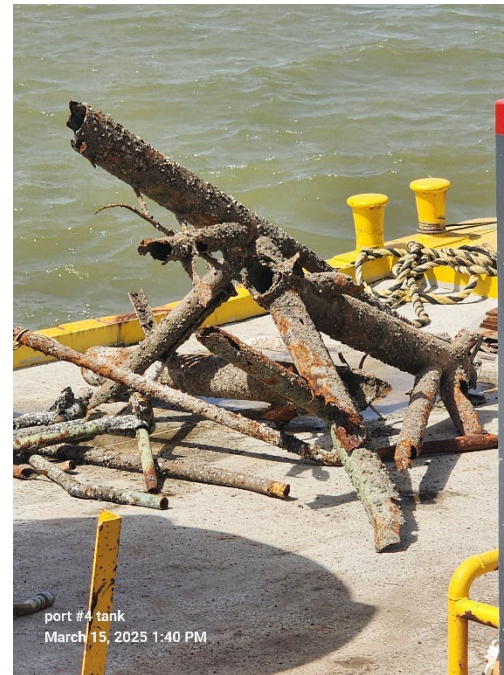
Crumbling Platform Structures

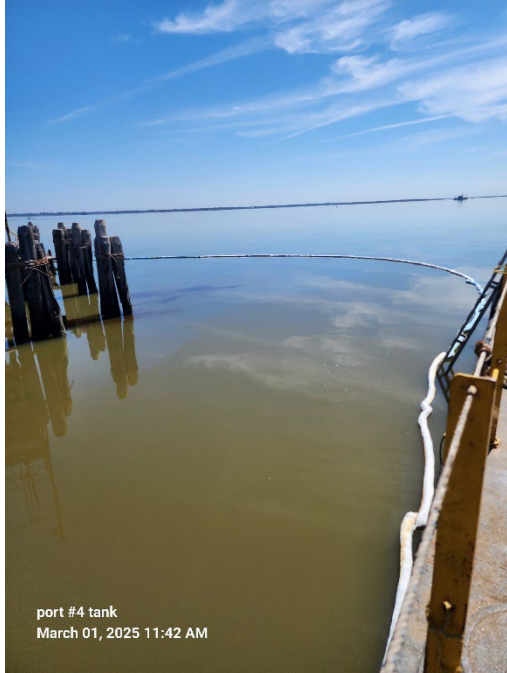
Evidence of
Hydrocarbons

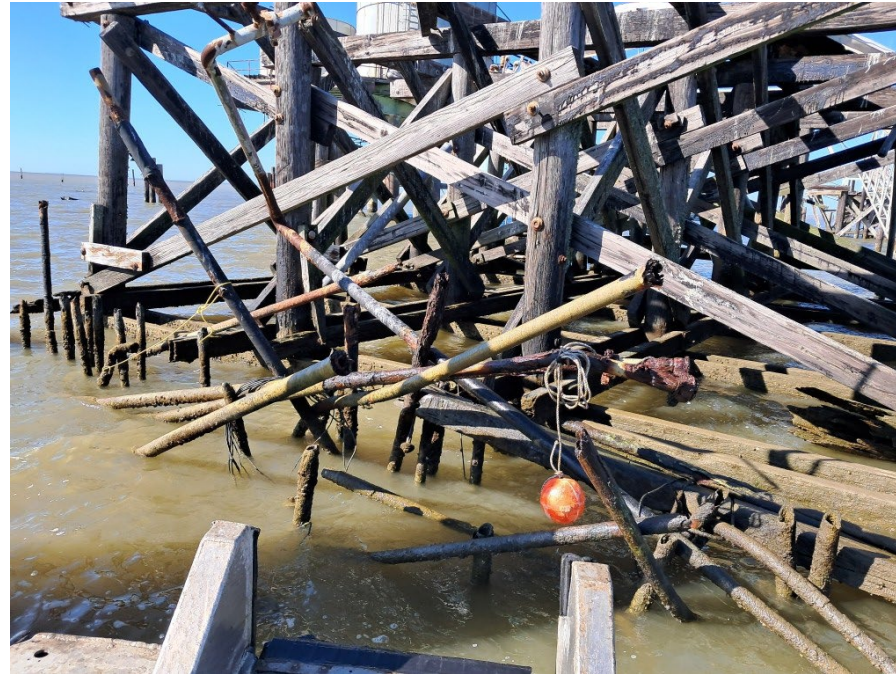
Unknown Flow Lines

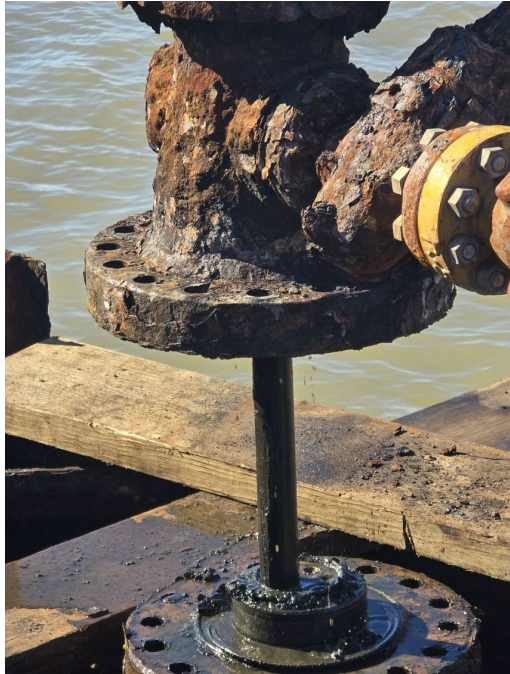
Tbg Hanger not Releasing

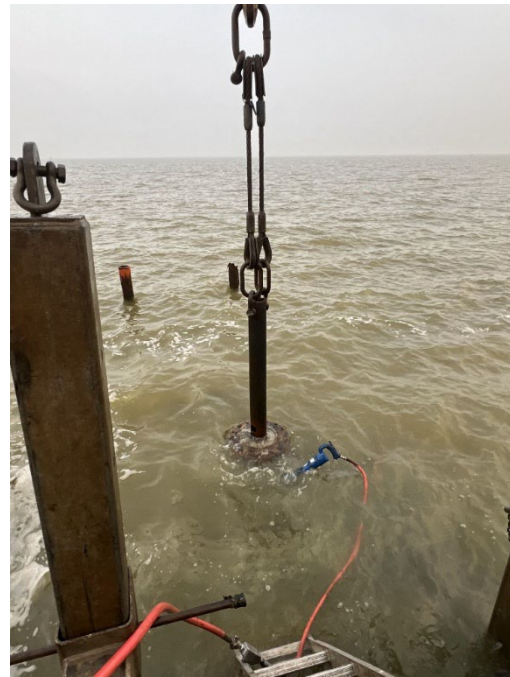
Casing Flange Underwater

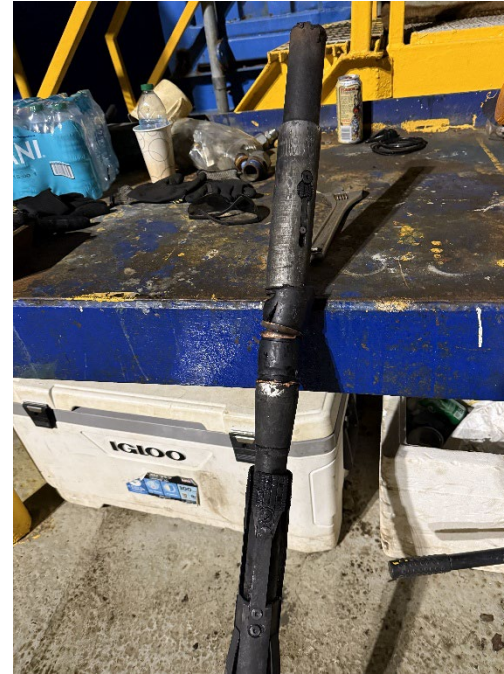
Leaking Packer Pulled

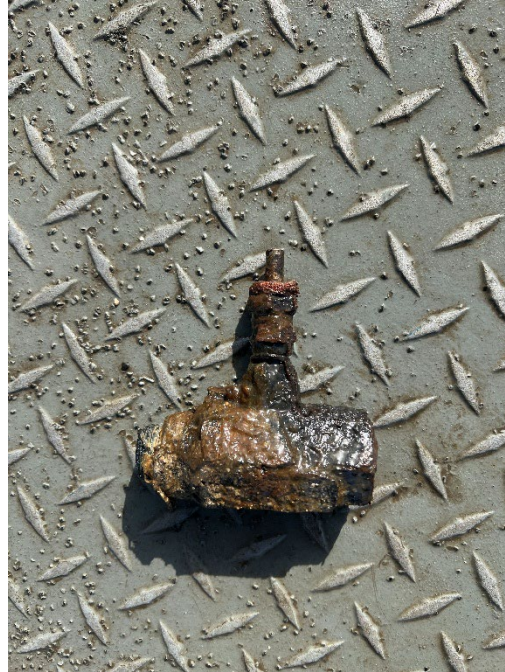
Corroded Needle Valve

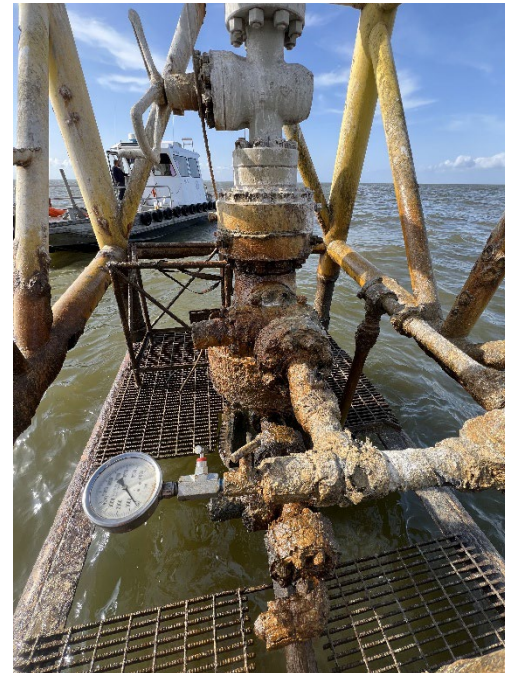
>1,000 psig still on the well

Needle Valve & New Gauge Installed
