West Galveston Island Bayside Marsh Restoration

TCEQ Contract No. 582-16-60135

Final Report

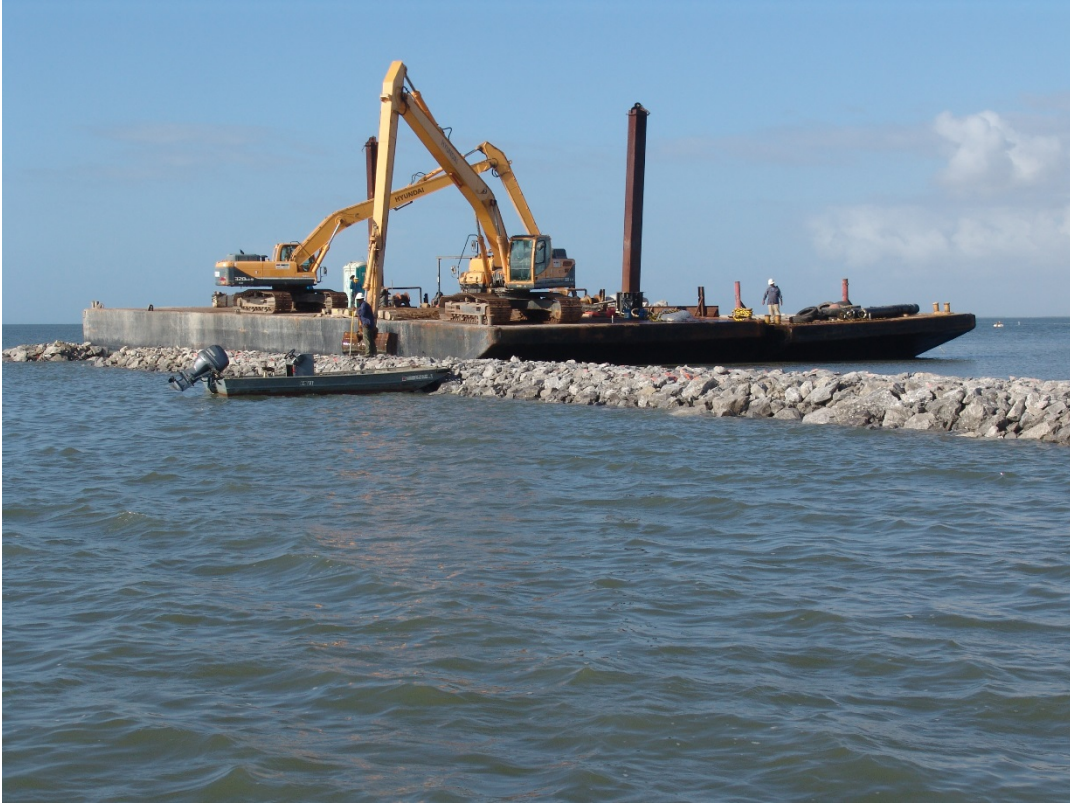
Figure 1. Construction of Breakwater. Excavators moving rock from barge to breakwater.

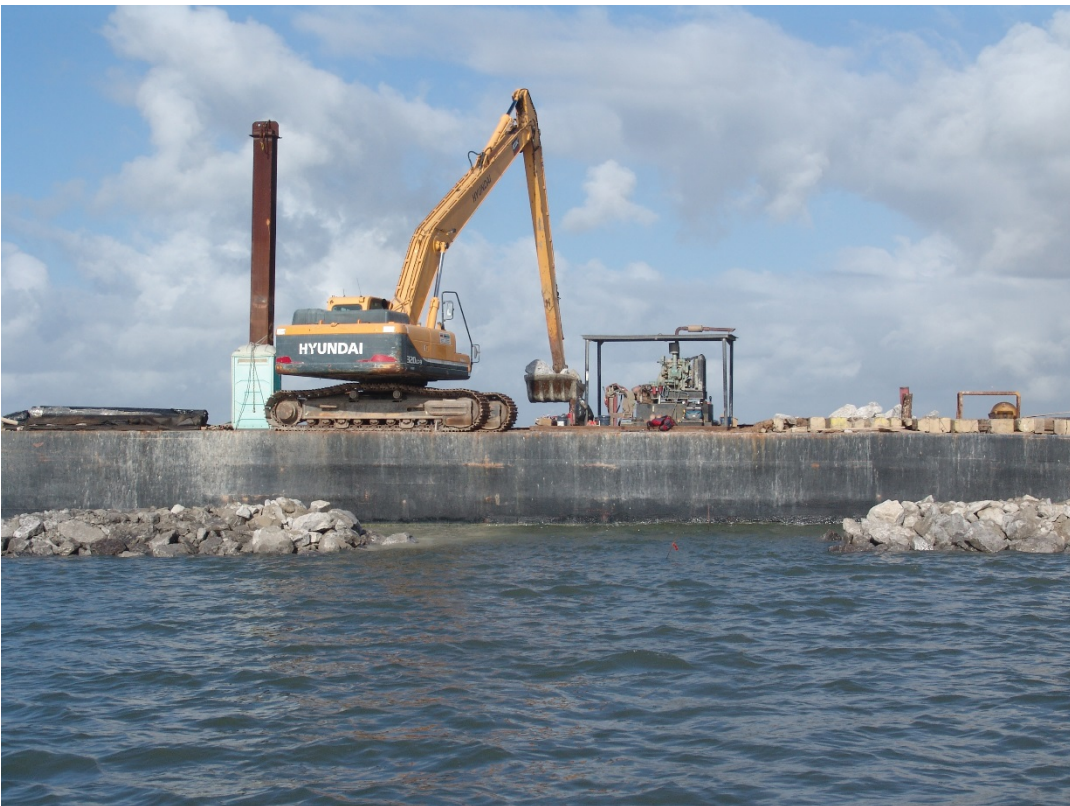
Figure 2. Construction of Breakwater. Excavator moving rock from barge to breakwater.

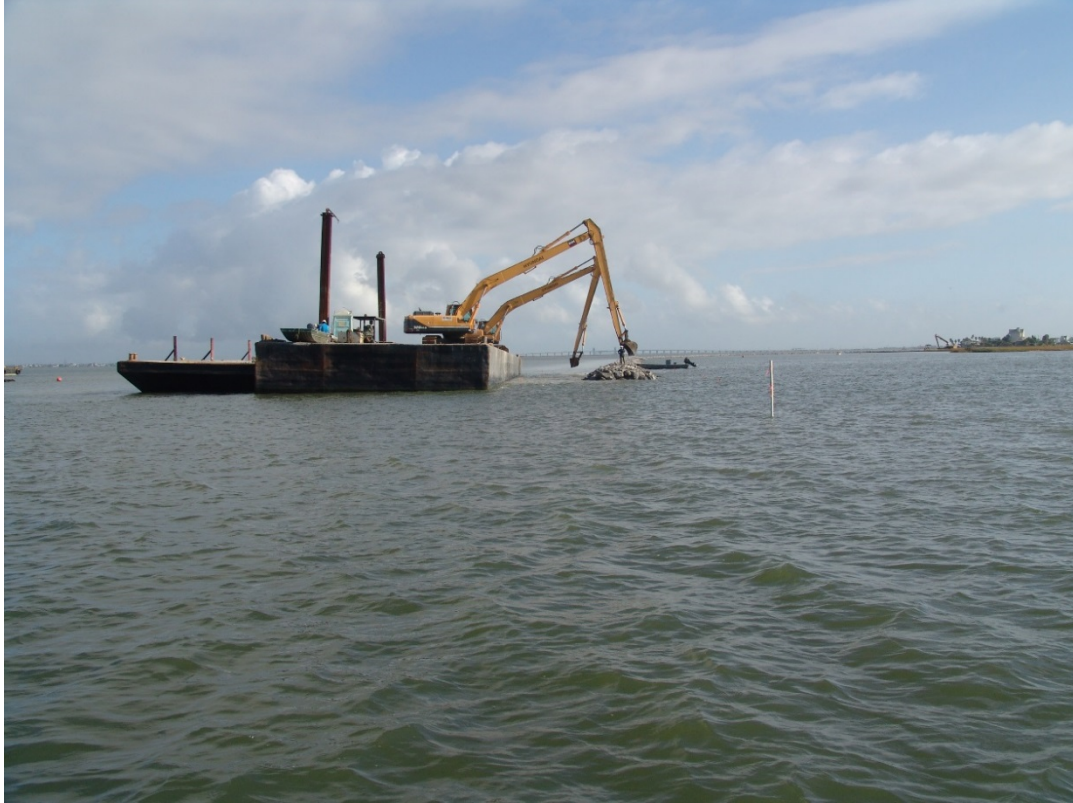
Figure 3. Construction of Breakwater. Excavators moving rock from barge to breakwater.

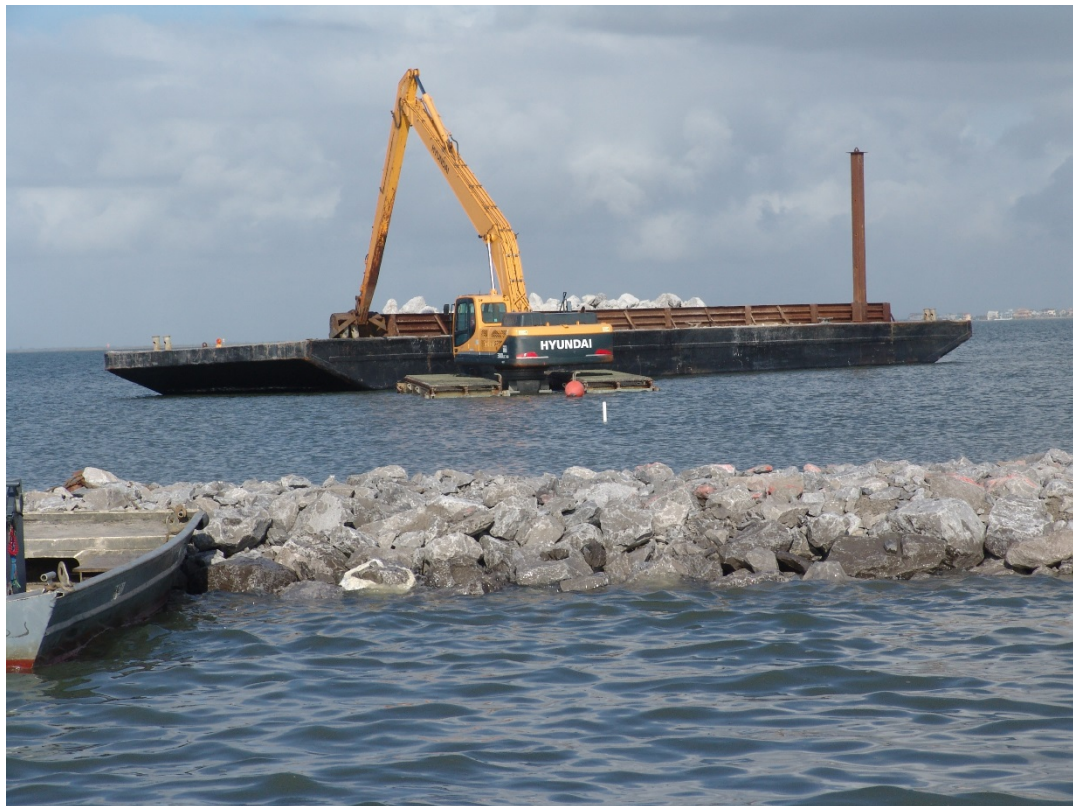
Figure 4. Smaller barge with shallower draft being brought to barge with excavator.

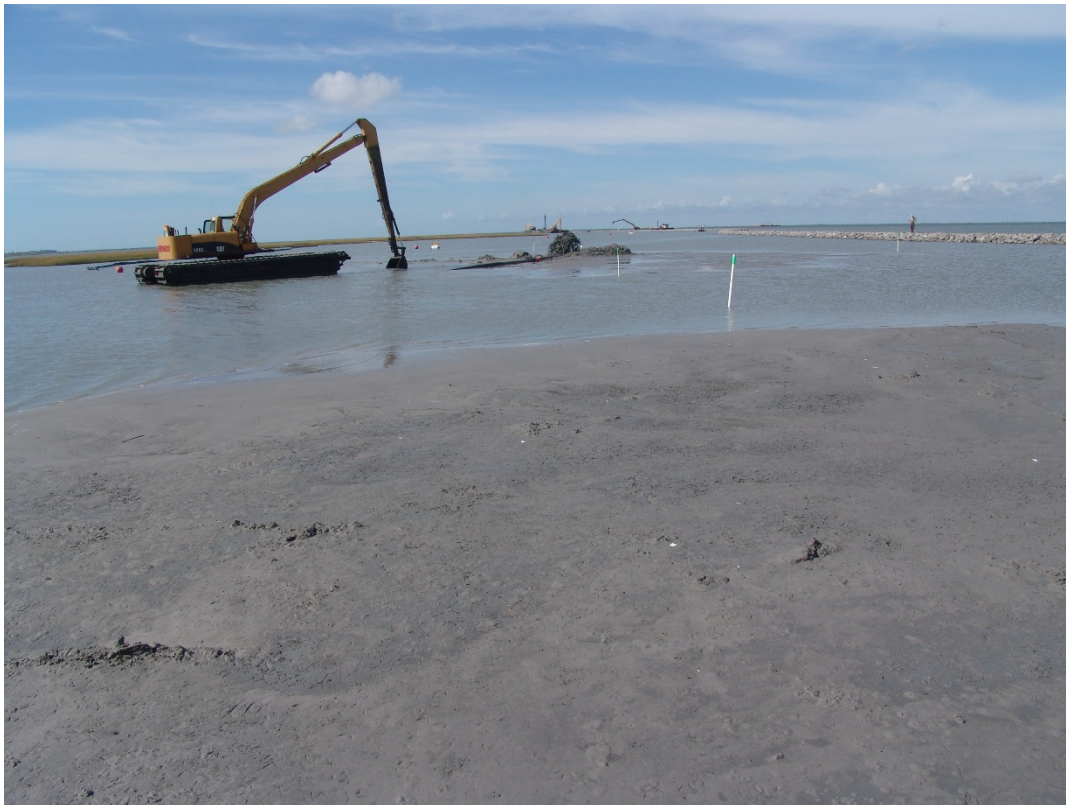
Figure 5. Hydraulic dredging of dredged material to construct marsh mound.

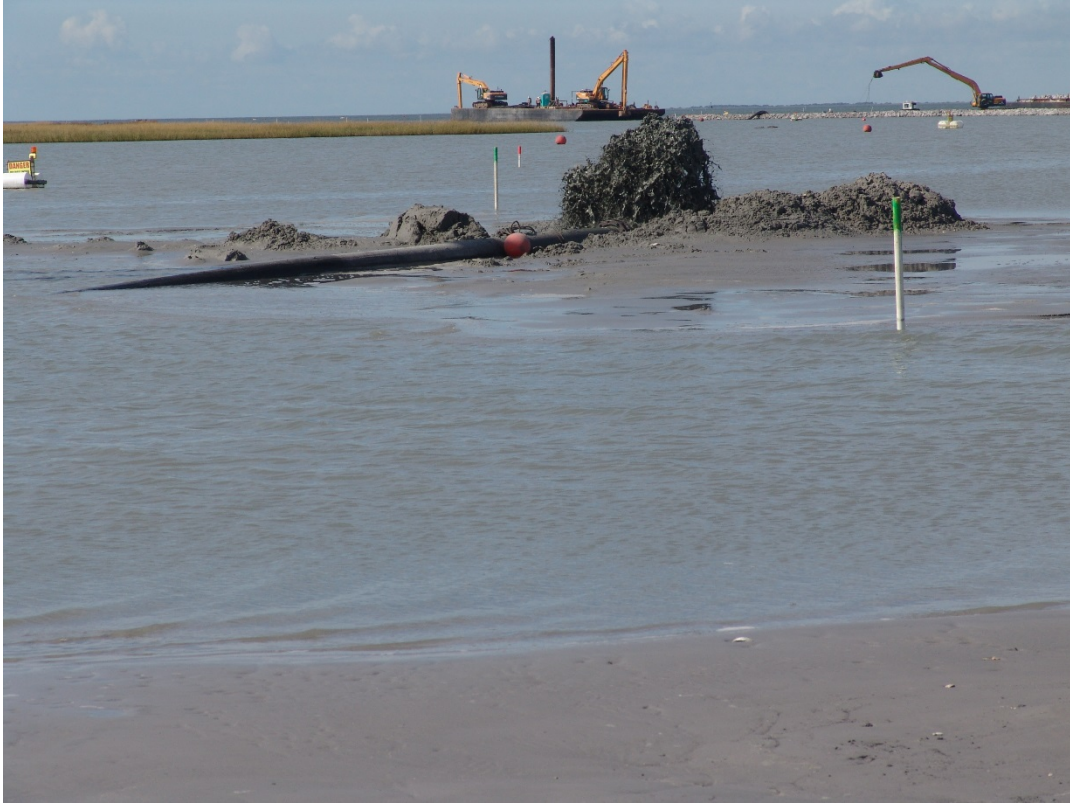
Figure 6. Hydraulic dredging of dredged material to construct marsh mound. Construction of rock breakwater in background.

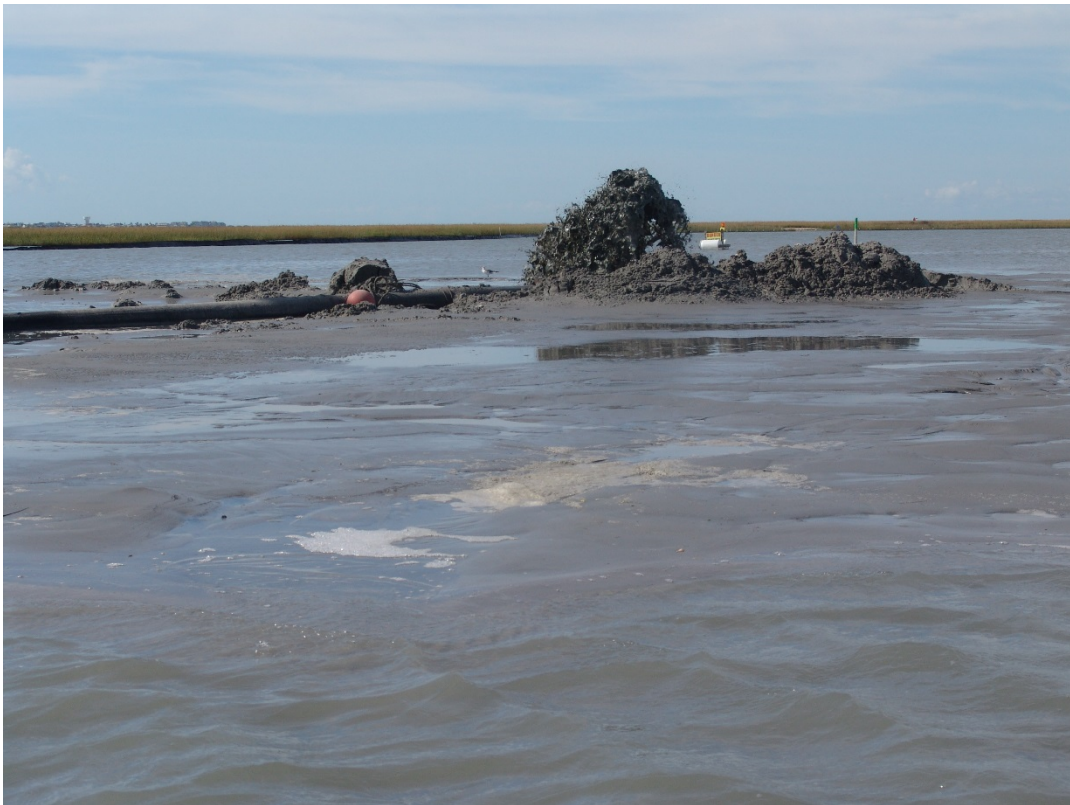
Figure 7. Hydraulic dredging of dredged material to construct marsh mound.

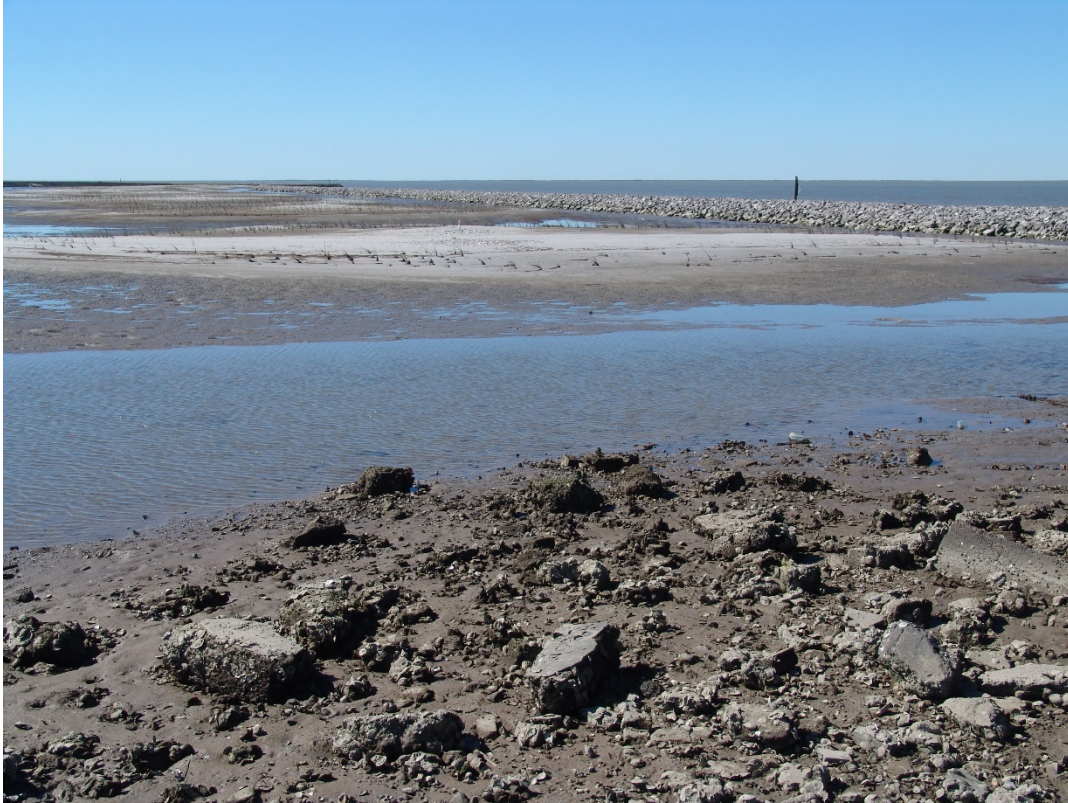
Figure 8. Completed marsh mounds. Rock breakwater in background.

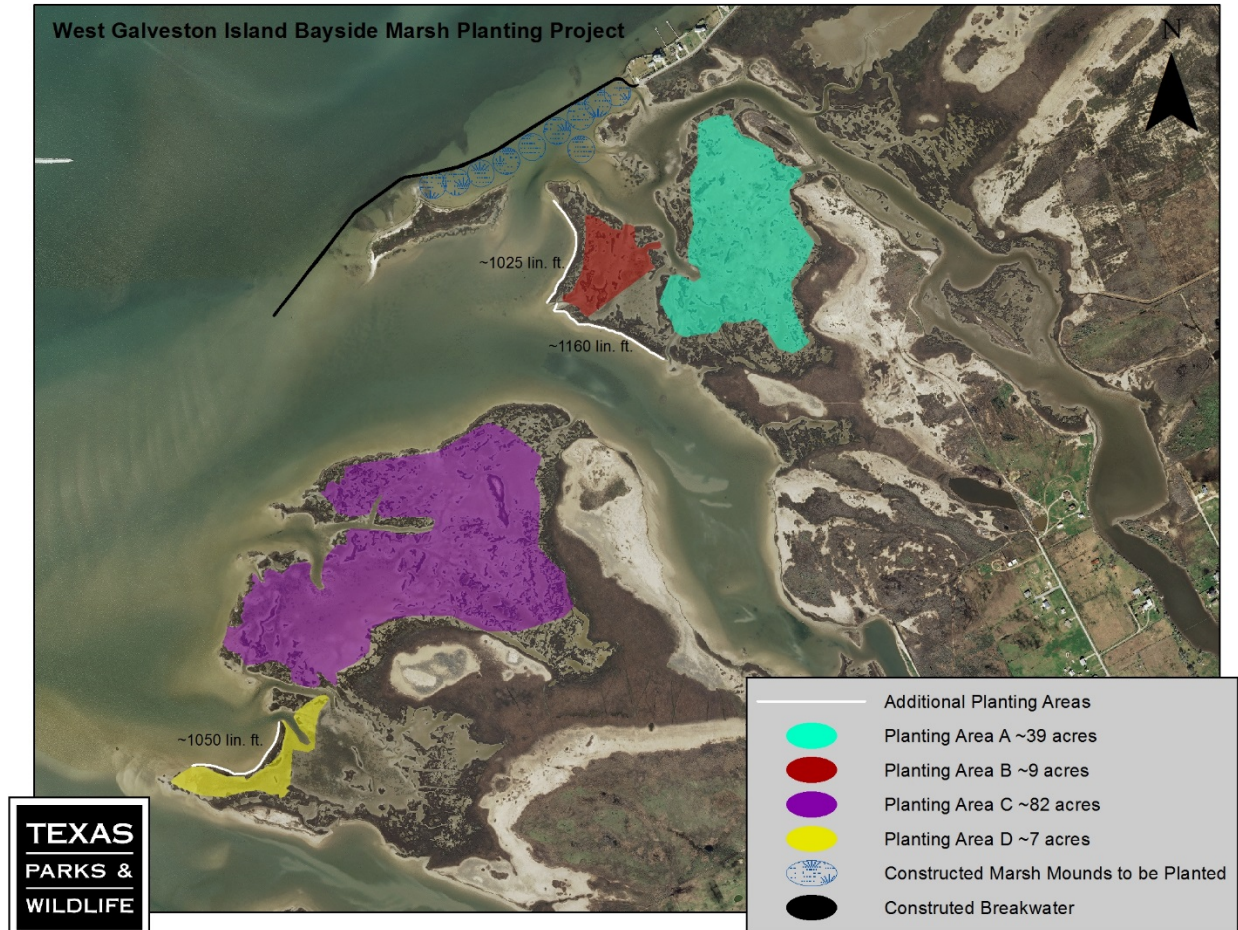
Figure 9. Project planting areas.

Planting Areas A, B, C, D were planted with approximately 70,080. Planting Area A, was planted with 17,000 plant units on approximate 10-foot centers. Planting Area B, was planted with 3,950 plant units on approximate 10-foot centers. Planting Area C, was planted with 36,000 plant units on approximate 10-foot centers. Planting Area D, was planted with 13,130 plant units on approximate 5-foot centers. Three lengths of shoreline totaling 3,235 linear feet were planted with 12, 940 plant units, four rows one foot apart with a planting spacing of one foot. The 12 newly constructed Marsh Mounds were planted within the intertidal zone with 10,000 plant units, a minimum of 833 plant units per mound.

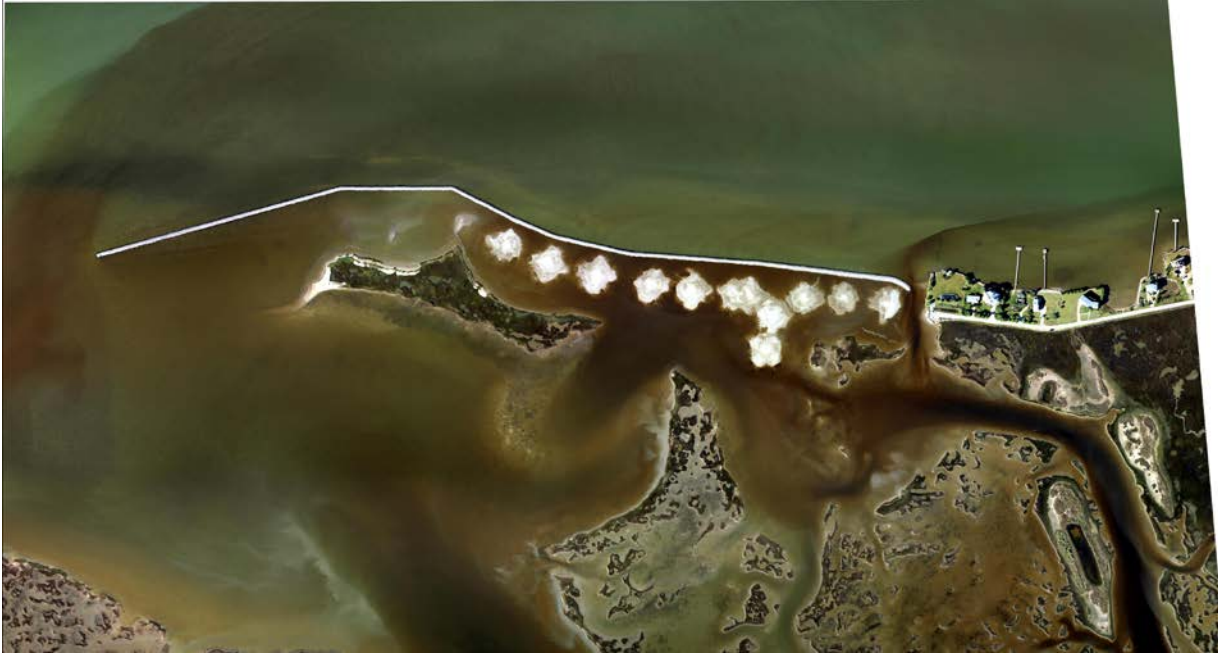
The West Galveston Island Bayside Marsh Restoration Project (Figure 10) constructed 3,800 linear-foot of rock breakwater that provides protection and enhancement to approximately 9.1 acres of existing estuarine marsh (emergent marsh, irregularly exposed mud flat, vegetated, non-vegetated sand flat, protected shallow open water) and approximately 13.8 acres of restored estuarine marsh complex (intertidal fringe marsh, salt flat marsh, sand flat and protected shallow water). After construction, the newly restored estuarine marsh complex, 3,235 linear feet of eroded shoreline, and 139 acres of former marsh (marsh that has converted to shallow water due to relative sea-level rise) were planted with 93,020 sprigs of *Spartina alterniflora*.

Figure 10. Aerial of completed project construction.
