**Restoration through Planting,  
Houston Point, TX**

Final Report  
Contract No. 528-13-32998

**Restoration through Planting, Houston Point, TX  
Final Report**

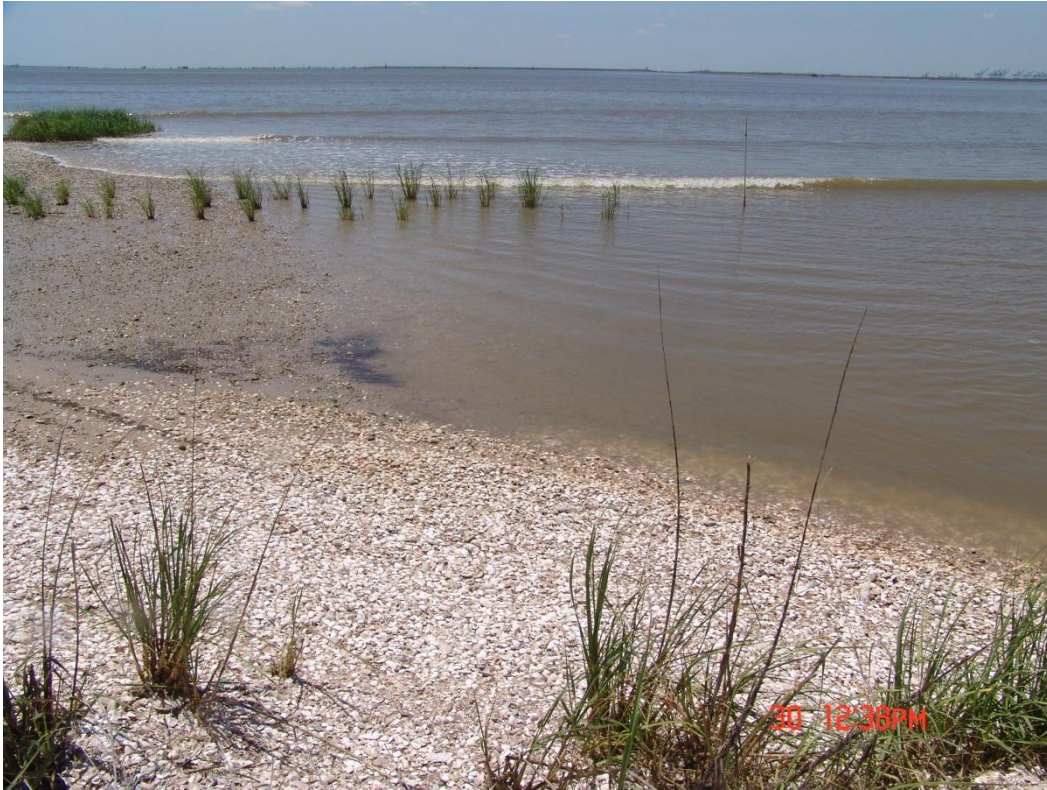
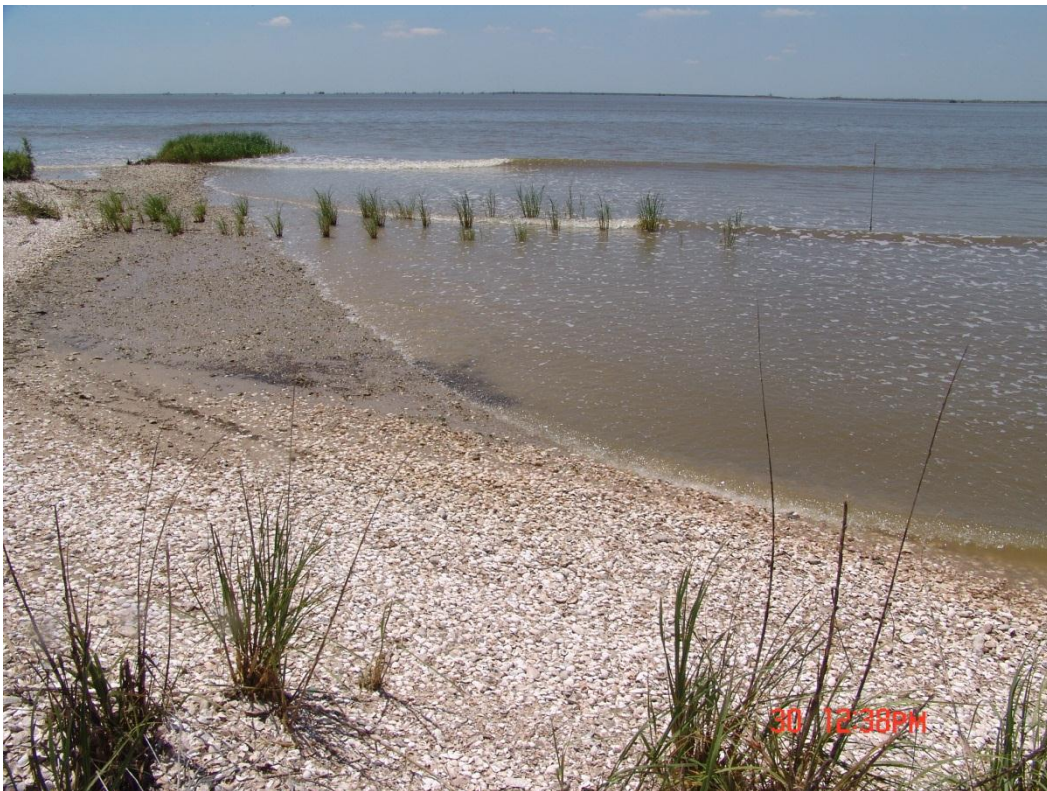
The minimal success of Transects 1, 2 and 3 is likely due to the constant ship wake that hits this shoreline (Appendix C, Figure 9 and 9) and the water depths being too deep to successfully

support *Spartina* along the three transects. The ship wake likely contributes to the deeper depths in this area.

**Figure 8. Transect 1 being hit by ship wake. April 30, 2015.**

**Figure 9. Transect 1 being hit by ship wake. April 30, 2015.**

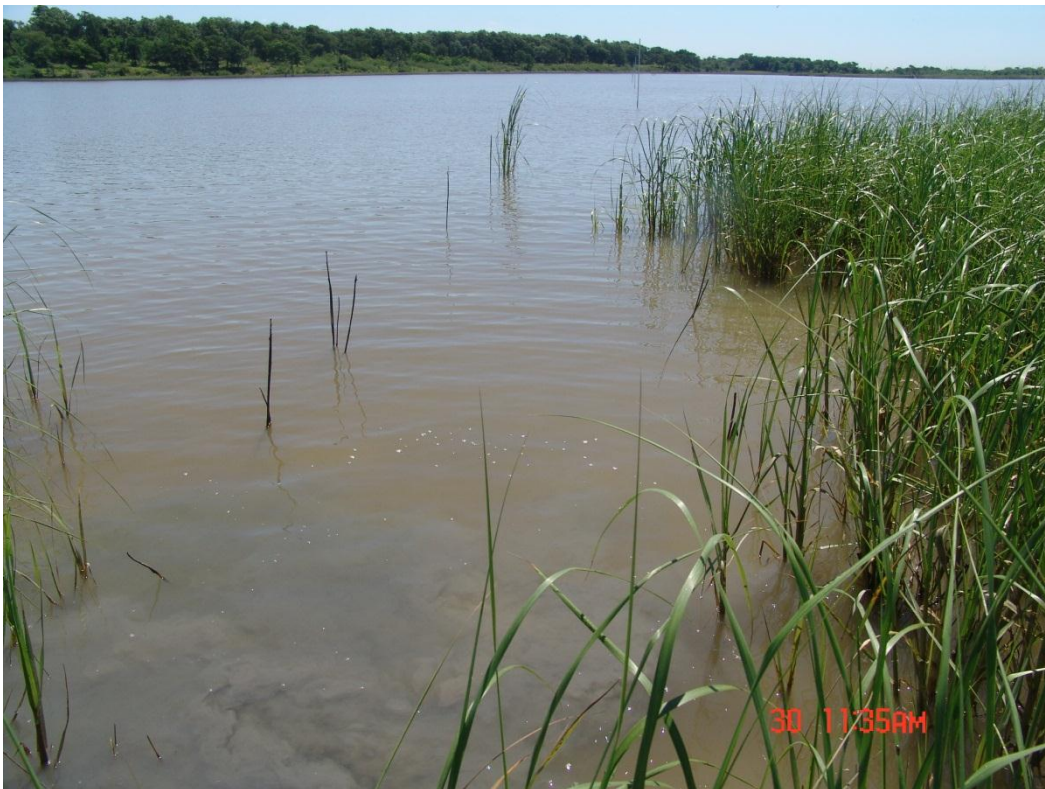
**Figure 15. Transect 5, west to east. April 30, 2015.**

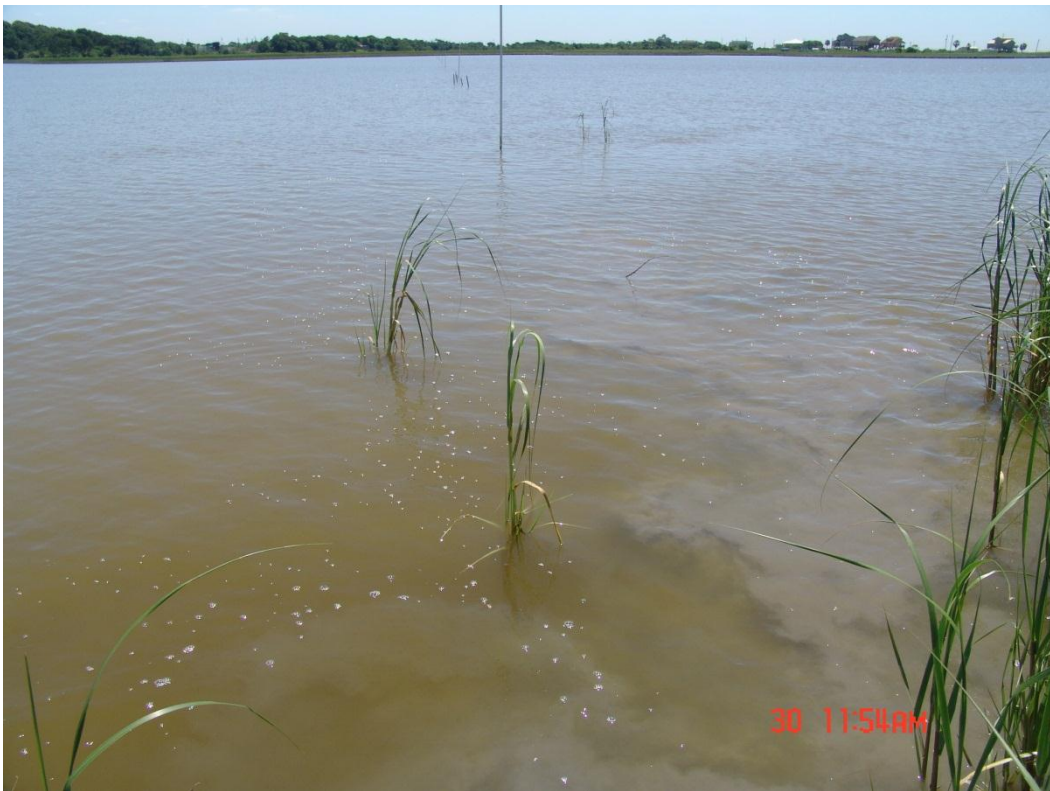
**Figure 17. Transect 7, rows 1-9 can no longer be seen intersecting it. April 30, 2015.**

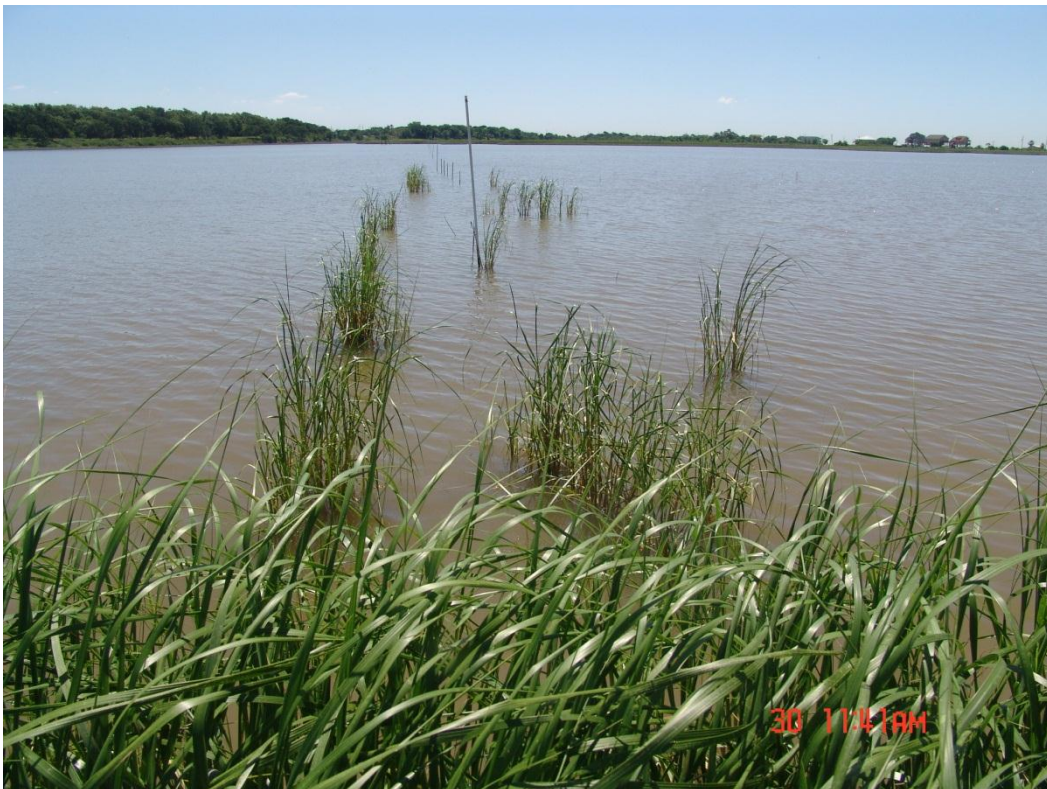
**Figure 19. Transect 6, rows 1-9 can no longer be seen intersecting it. April 30, 2015.**

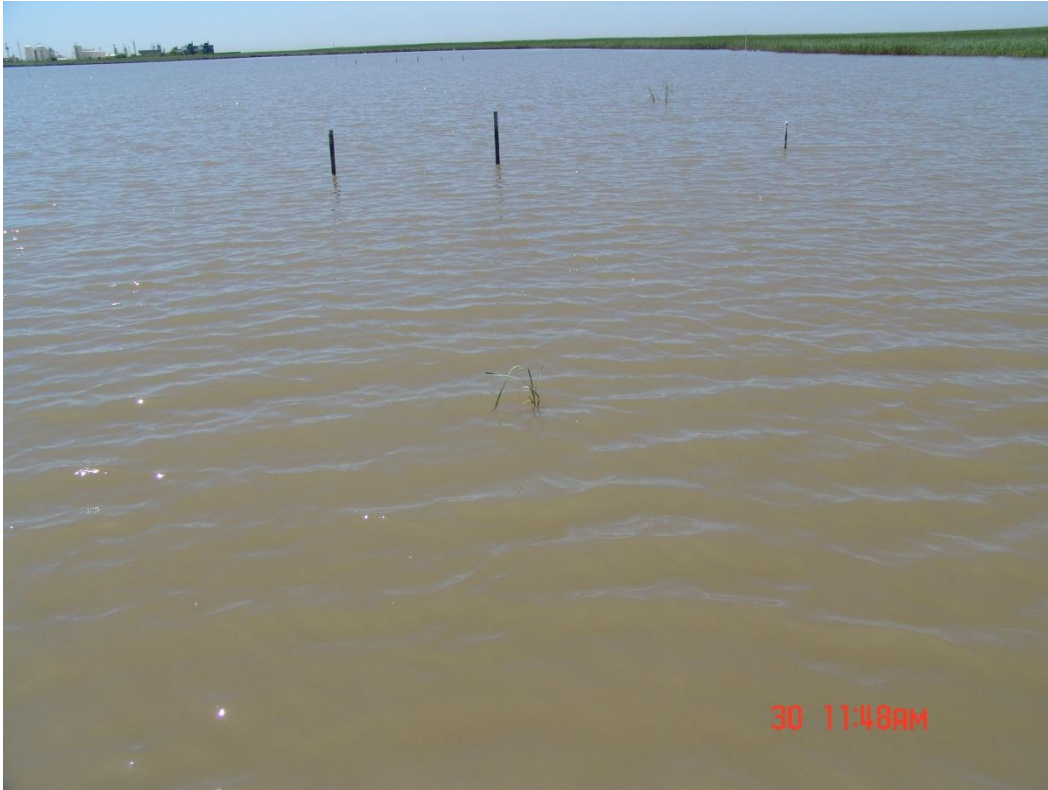
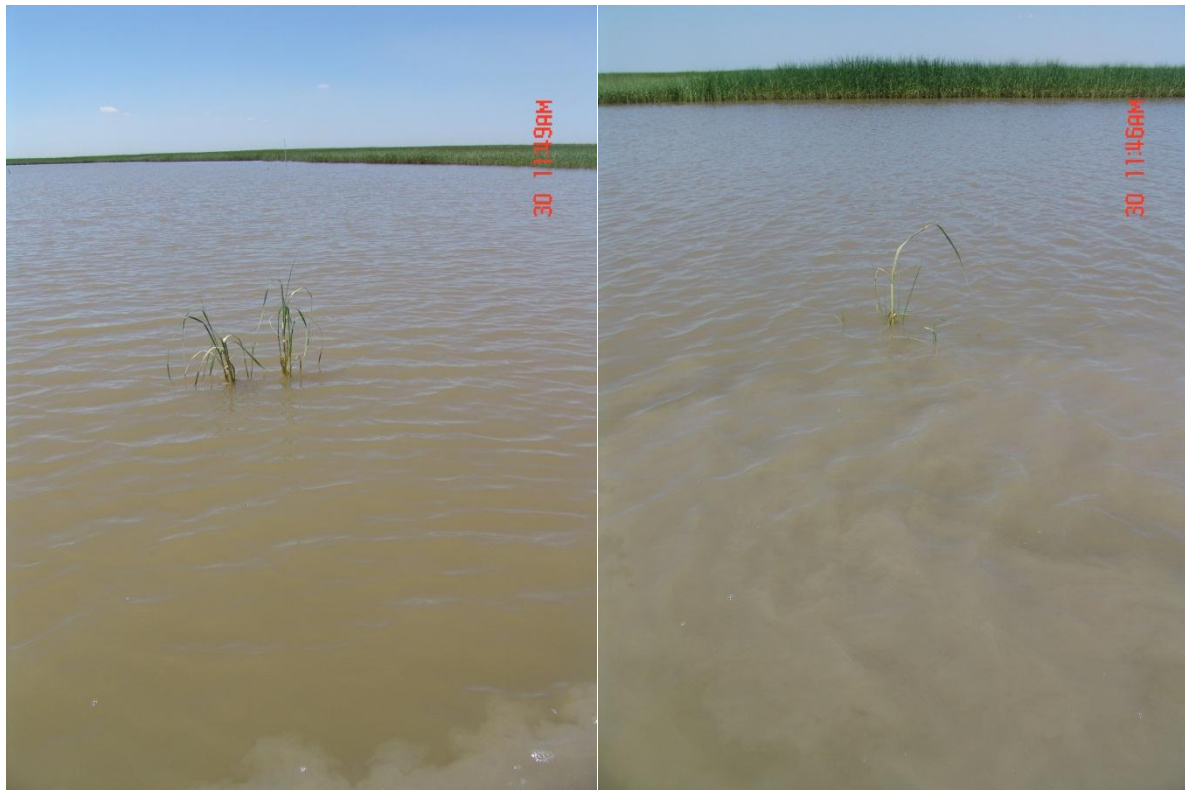
**Figure 20. Rows 1-9 are not visible, approximately 5 surviving planting units. April 30, 2015.**

**Figure 21. Rows 1-9 are not visible, approximately 5 surviving planting units. April 30, 2015.**

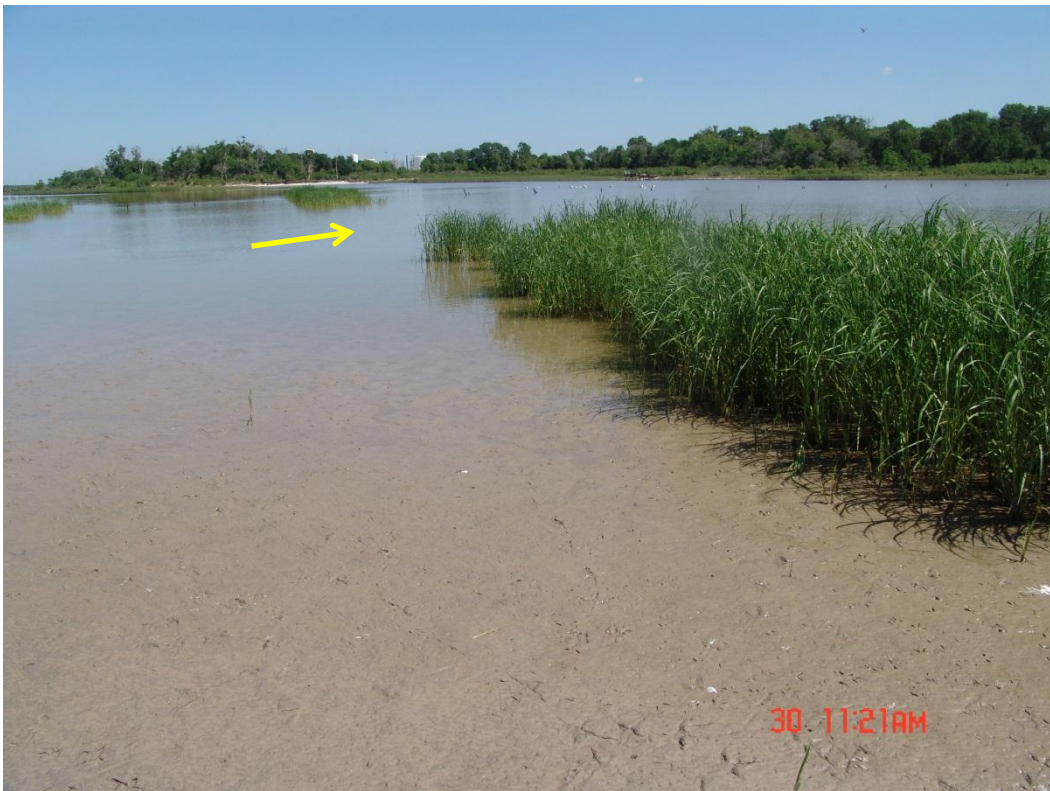
**Figure 23. Transect 10, south to north. Note the gap in vegetation. April 30, 2015.**

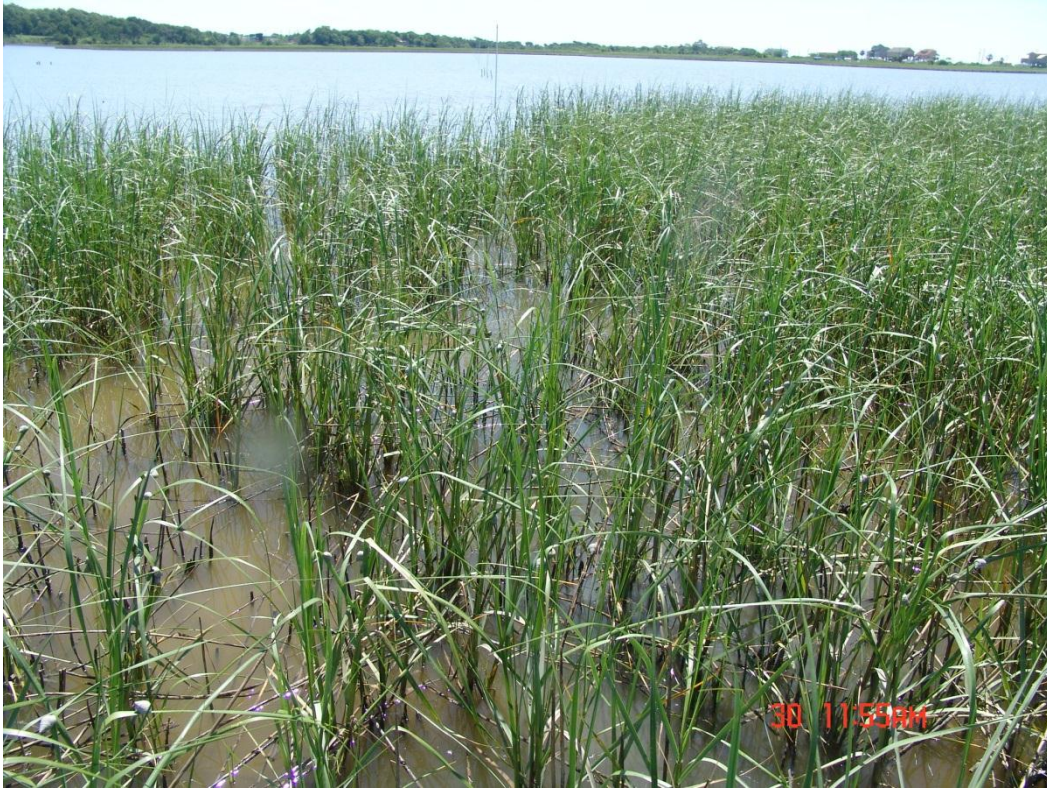
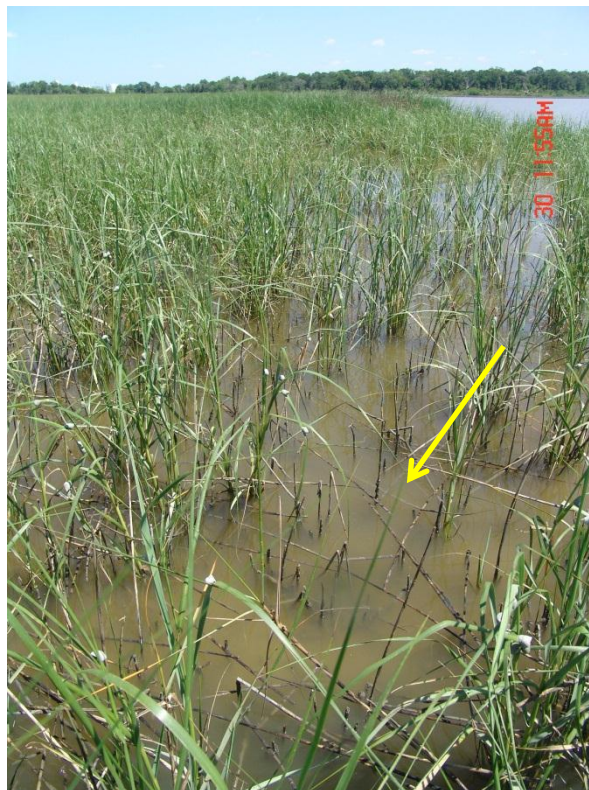
One possible explanation for the lack of success of *Spartina* growth at Transects 5, 6, and 7 and Rows 1-9 was a crude oil spill that occurred within the project area in October of 2014. Transect 7 was initially boomed inside the product spill until the TPWD Spills and Kills Region 4 Response Biologist conducted a site assessment and had the responsible party relocate the boom so that Transect 7 was not located with the spill boundary. The crude oil was successfully contained within a small area of Houston Point however; the exact boundary and potential impacts from the spill are not known. The eastern shoreline along Transects 5, 6 and 7 does appear to have experienced a vegetation die-off (Appendix C, Figures 48 and 49) however the cause is unknown.

**Figure 48. Marsh die-off along the eastern shoreline (this picture is adjacent to Transect 7). April 30, 2015.**

**Figure 49. Marsh die-off along the eastern shoreline (this picture is adjacent to Transect 7). April 30, 2015.**
