*“Coastal Prairie Wetland Restoration at Sheldon Lake State Park”*

*Final Report*

TCEQ Contract No.: 582-13-32746

## **Appendix B: Photodocumentation of the Project Tasks**

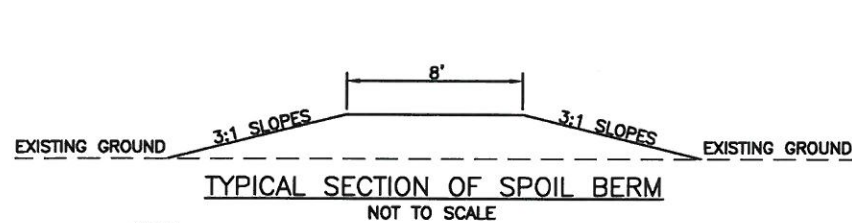
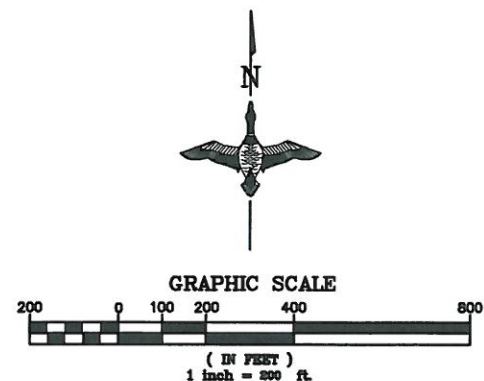
PROJECT NO. DU-TX-82-5  
**SHELTON LAKE**  
**STATE PARK - PHASE IV**  
**CONTOUR MAP & DESIGN**  
DESIGNED BY: AJS  
DRAWN BY: LSM  
SURVEYED BY: RKW  
CHECKED BY:  
DATE: 02/15

NOTE:  
ALL SPOIL BERM FOOTPRINT AREAS SHALL BE SCARIFIED OR DISKED TO A DEPTH OF 6" PRIOR TO PLACEMENT OF FILL MATERIAL.

NOTE:  
SPOIL PLACEMENT AREAS SHALL BE CONSTRUCTED AS NEEDED FOR EXCAVATION. PLACEMENT CUBIC YARDAGE DISPLAYED ON THIS SHEET REFLECTS AVAILABLE VOLUME WITHIN EACH SPOIL PLACEMENT AREA, AND NOT REQUIRED FILL.

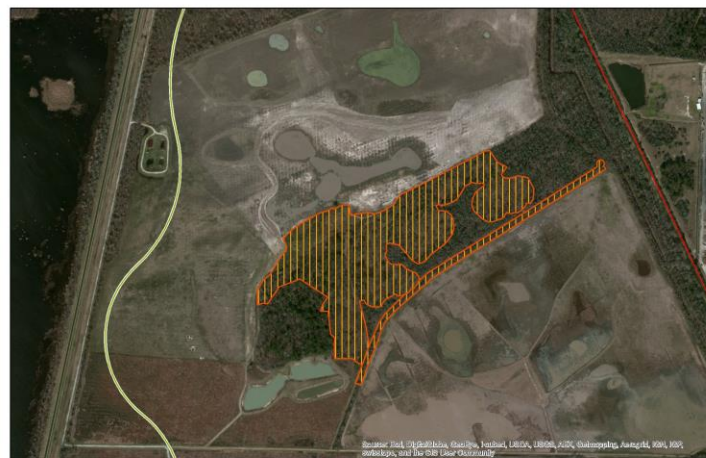
## Mulching of the Chinese Tallow trees on the Meander Ridge

Sheldon Lake State Park  
Prairie Wetland Restoration Phase IV  
2010 True Color Aerial Photo

A total of 22 acres of exotic Chinese Tallow were removed from the meander ridge from within the existing wetland ponds, and the remaining 16 acres of the meander ridge were hand-treated to kill the Chinese tallow. The hand-treatment allowed for the existing stands of native hardwood trees to remain intact and provide cover for potential future recreational development in the area (i.e. trails).

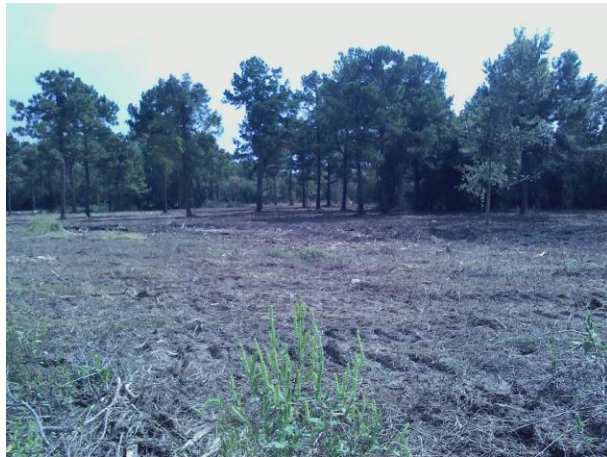
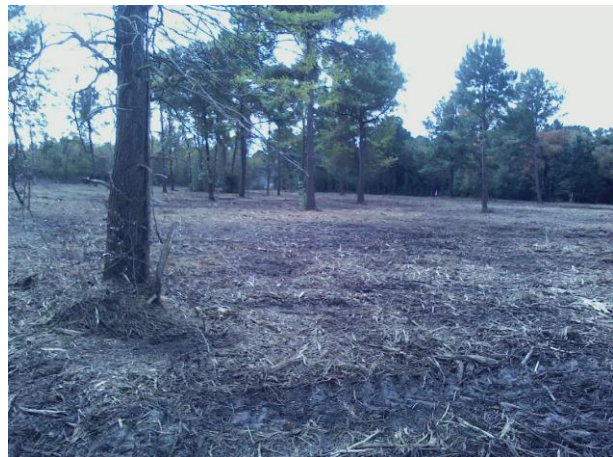
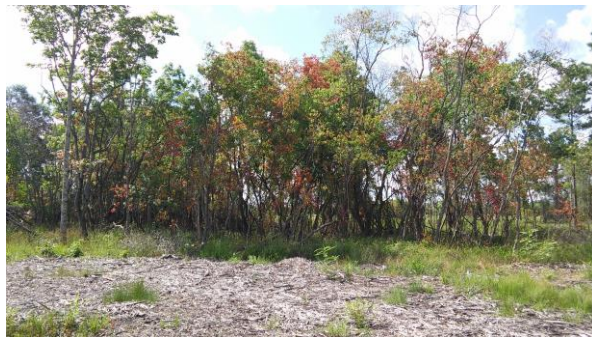
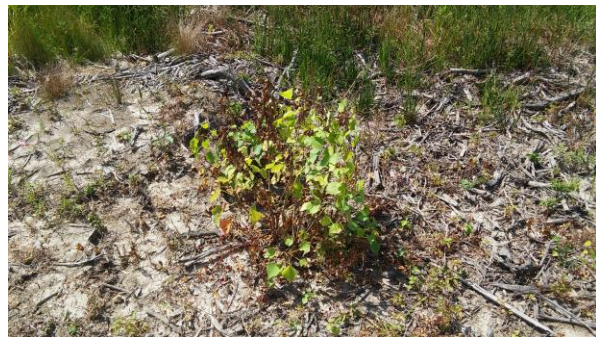
Sheldon Lake State Park  
Prairie Wetland Restoration Phase IV  
2010 True Color Aerial Photo

Hand-Applied Herbicide (16.7 acres)

An additional herbicide treatment was utilized on the mulched zone to kill off the tallow seedlings and saplings which were not mechanically removed or destroyed (retreatment of 22 acres).

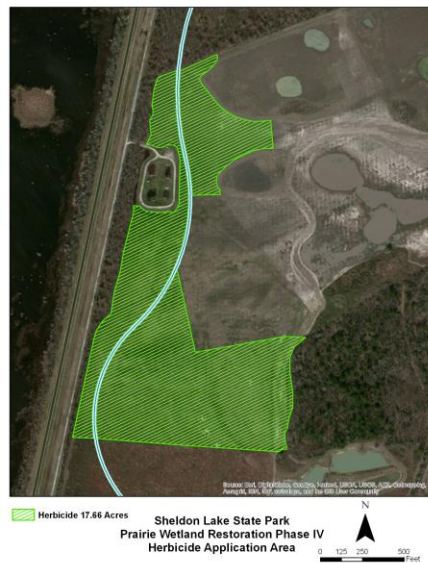
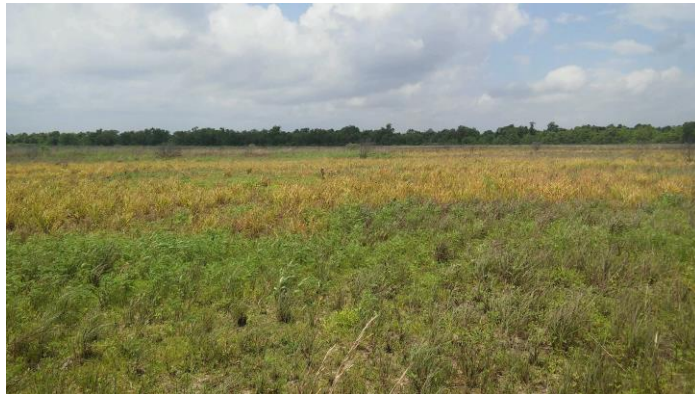
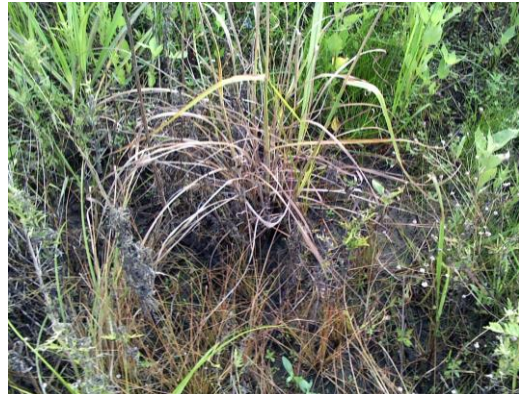
## Herbicide Treatment of the Adjacent Prairie

A total of 17 acres of adjacent prairie were treated for Chinese tallow and the invasive grass, Vassey grass (*Paspalum uruvillei*).

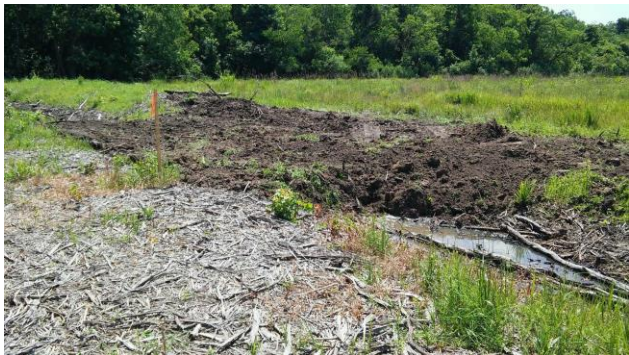
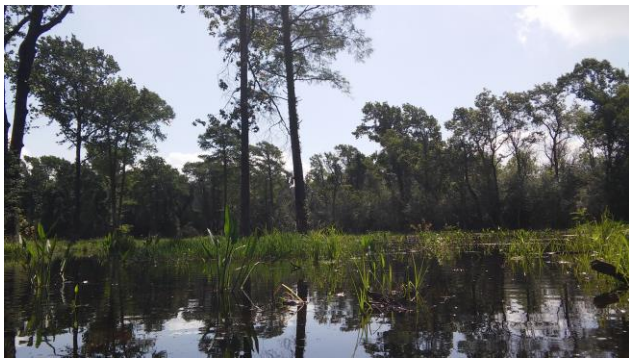
## Hydrologic restoration of the Meander Ridge

The strategic placement of the earthen plugs along the ditch ensures that the water does not flow off the meander ridge wetlands, but remains in the wetlands to naturally percolate through the soils or transpire.

Based on these conditions, the emergency status and the pending deadline for the contract, Extension requested an emergency extension of time which was granted by TCEQ. With the extension of time, Ducks Unlimited (subawardee to Extension) was able to hire and supervise the contractor to restore the meander ridge hydrology (hydrologic function to the 38 acres of wetlands for this section). Similarly, the re-treatment of the Chinese Tallow on the meander ridge was also completed and the necessary prairie seeding material was purchased and stored.
