FINAL REPORT

Living Shoreline at Trinity Bay Discovery Center

TCEQ Contract # 582-18-80340

August 30, 2019

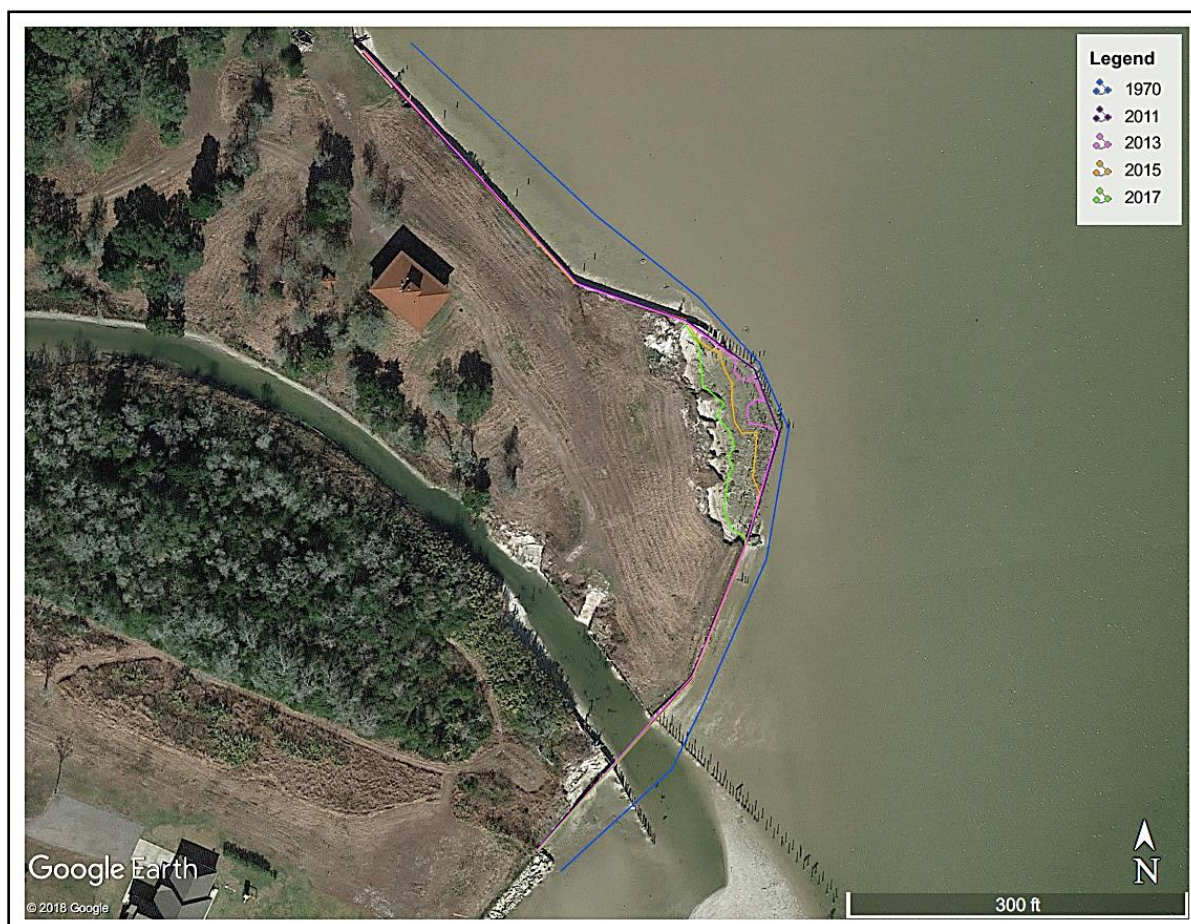
Figure 1. Approximate locations of Trinity Bay Discovery Center shoreline over time, indicating erosion on southeastern point since the failure of the bulkhead in 2012.

Like many shorelines along this part of the bay system, the TBDC shoreline has experienced historical erosion and loss of valuable fringing marsh. To abate this erosion and continued loss of property, the previous landowners of the (now-named) TBDC installed a bulkhead along the entire length of the property's shoreline over 20 years ago. Now the bulkhead is failing and the predominate wind and wave action has exacerbated the shoreline erosion. Approximately 240 feet of bulkhead failed entirely along the southeastern corner of the property. This location receives the greatest wave action and without protection lost nearly 60 feet of land.

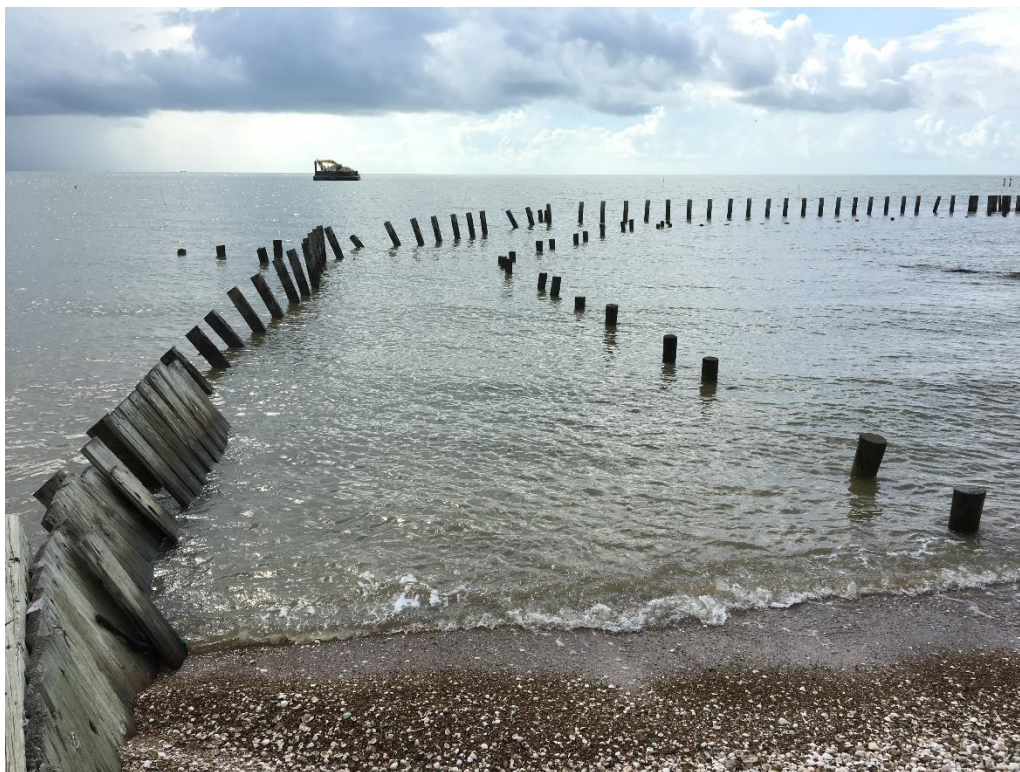
Figure 2. View of northeast shoreline BEFORE debris removal facing east/southeast

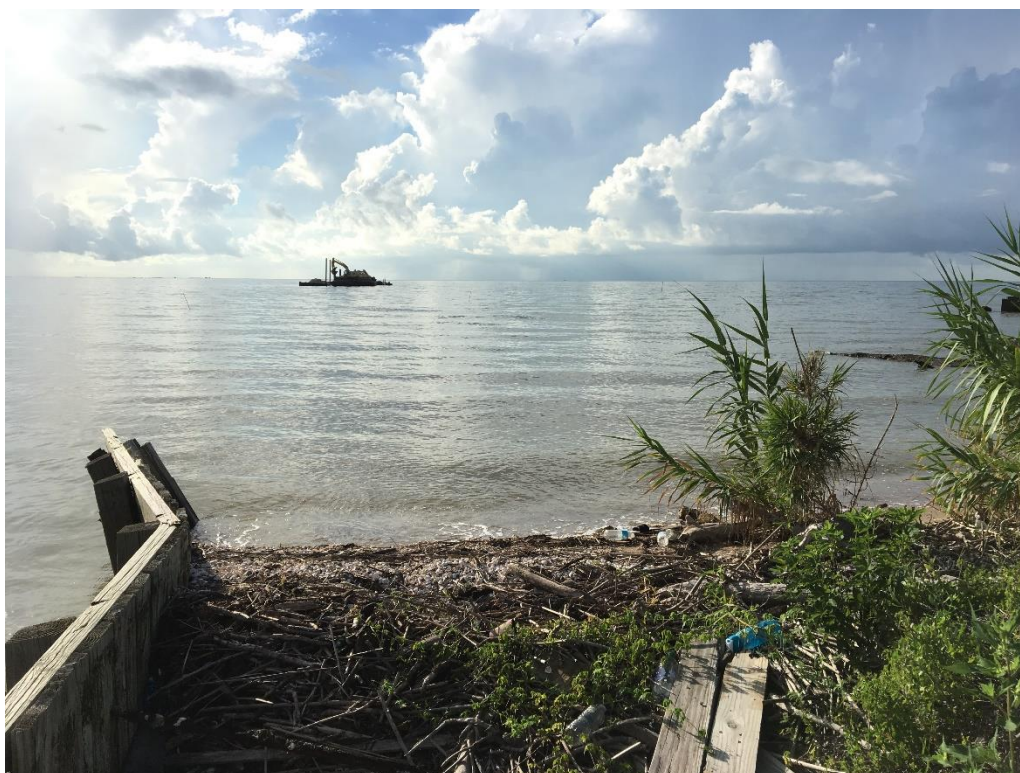
Figure 3. View of northeast shoreline AFTER debris removal facing east/southeast

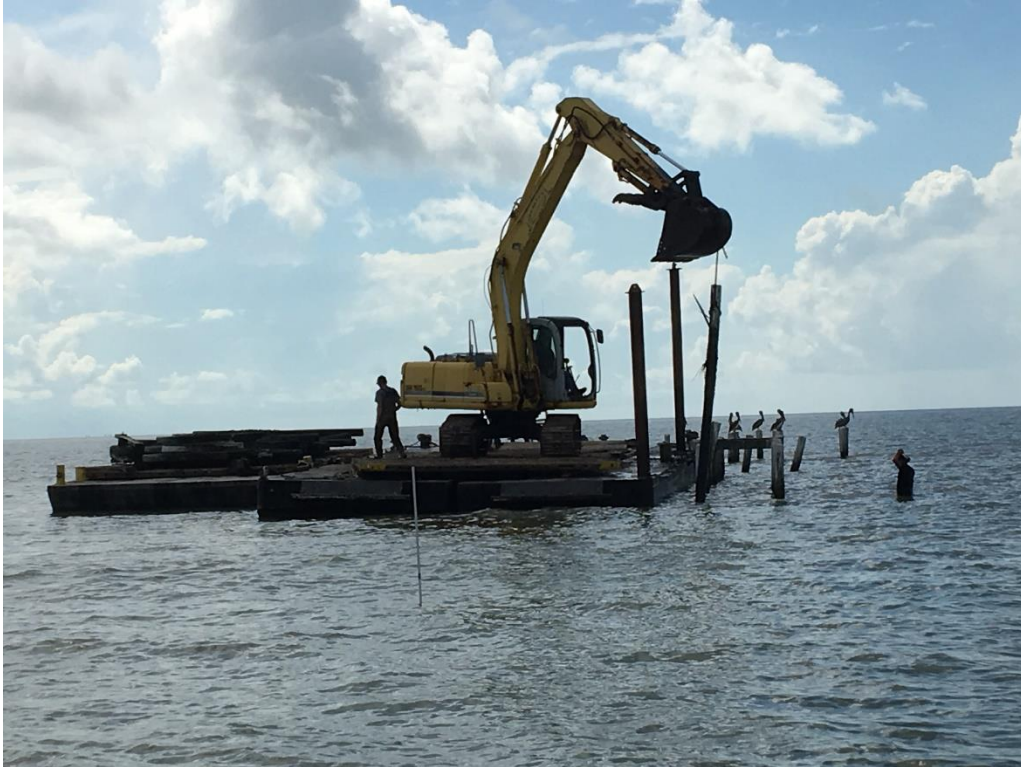
Figure 4. Removal of pier pilings/debris

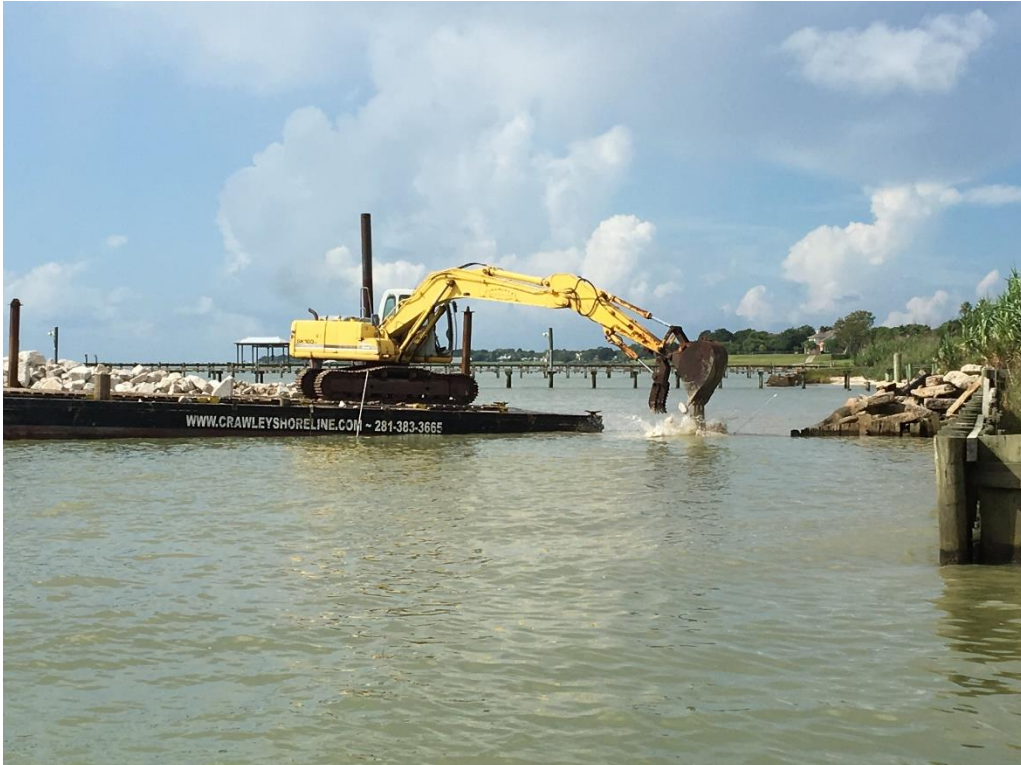
Figure 5. Start of construction of the southernmost section of rip-rap breakwater

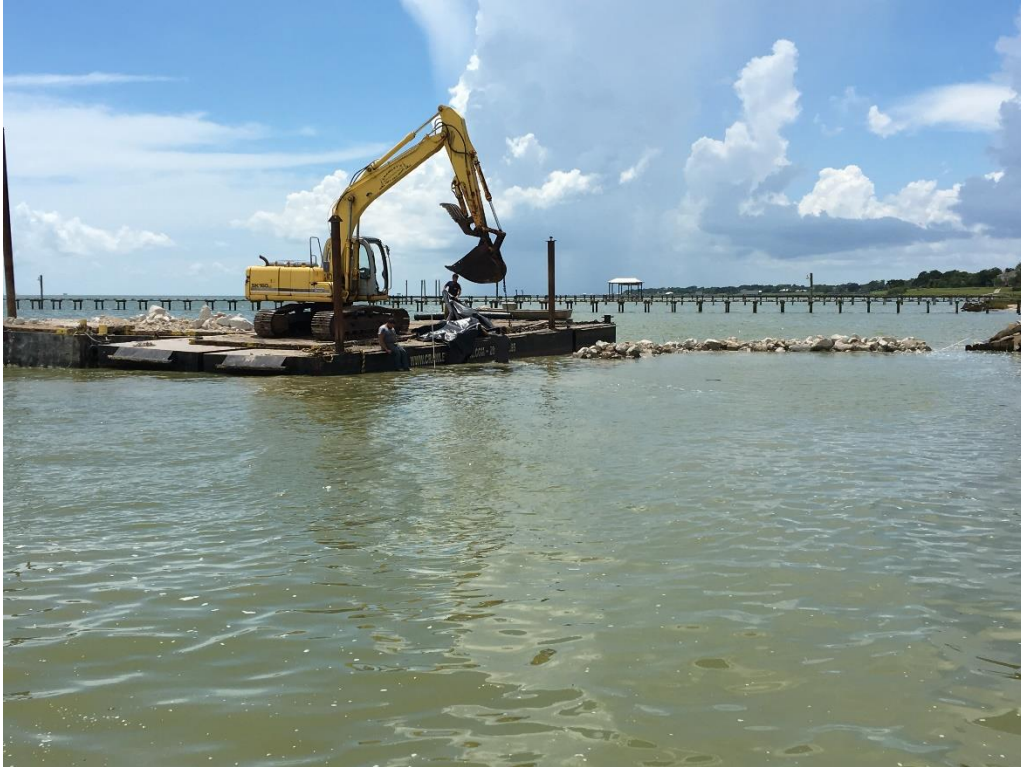
Figure 6. Construction Day 1

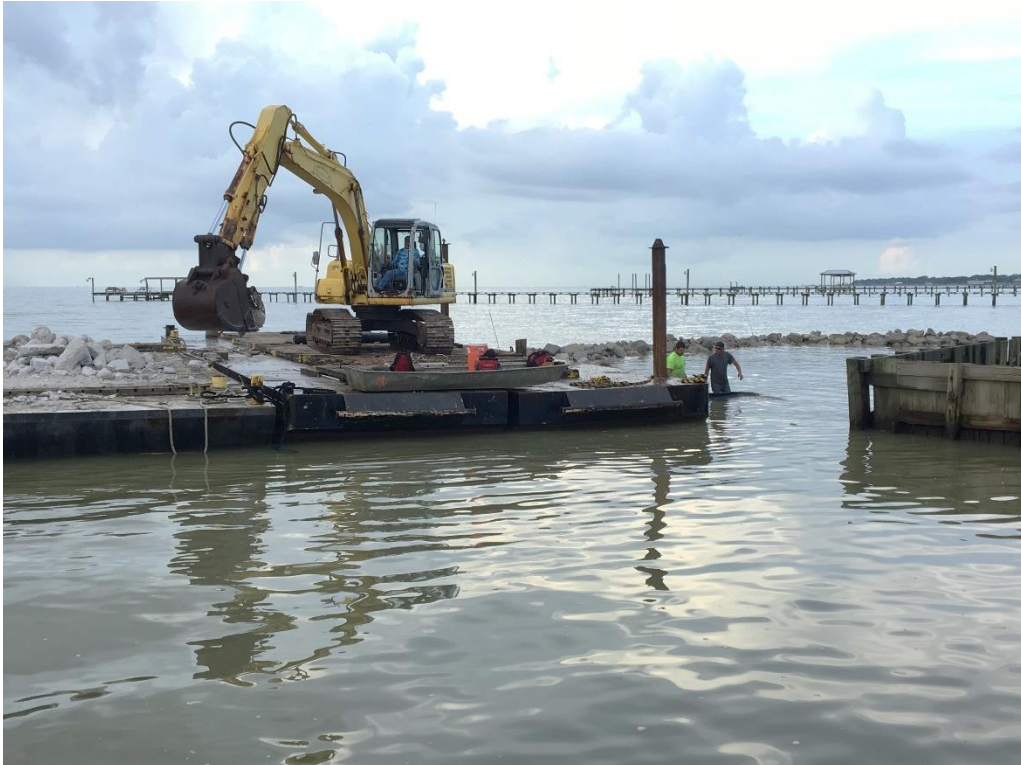
Figure 7. Construction Day 2

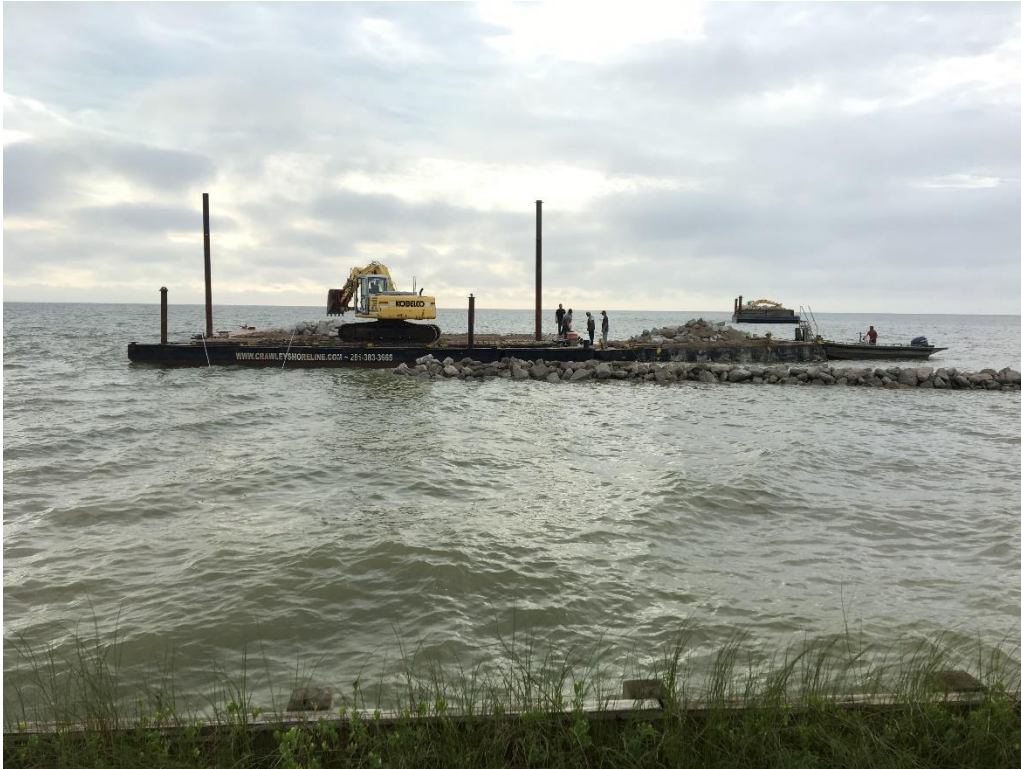
Figure 8. Ongoing construction of rip-rap breakwater

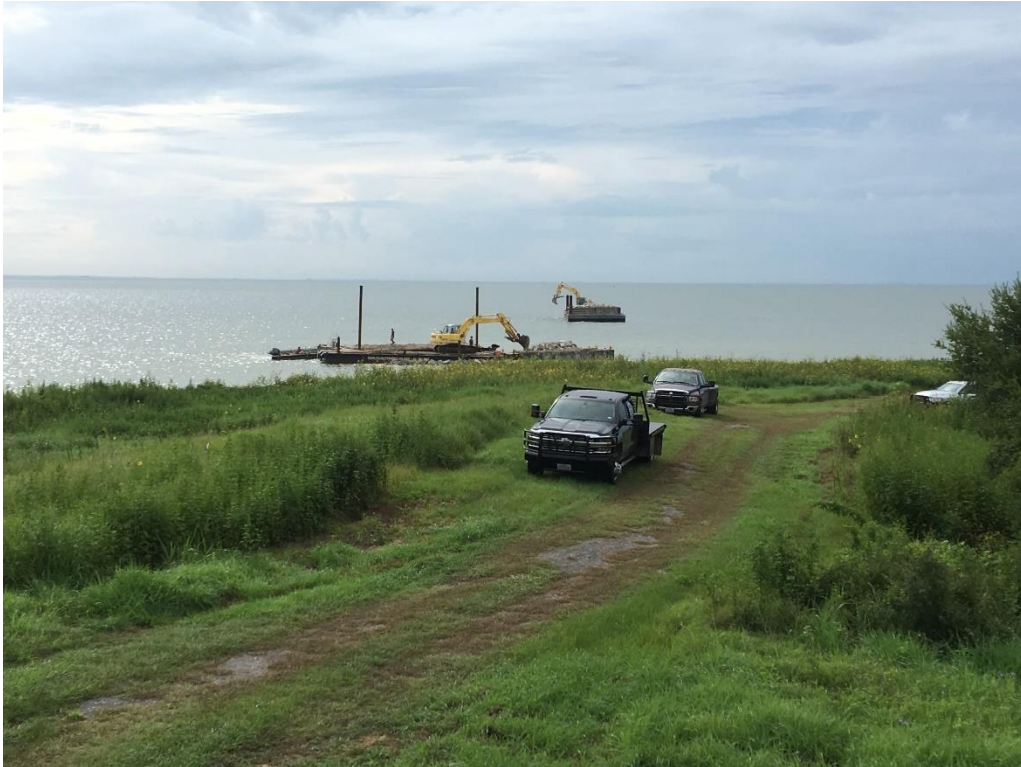
Figure 9. Ongoing construction of rip-rap breakwater

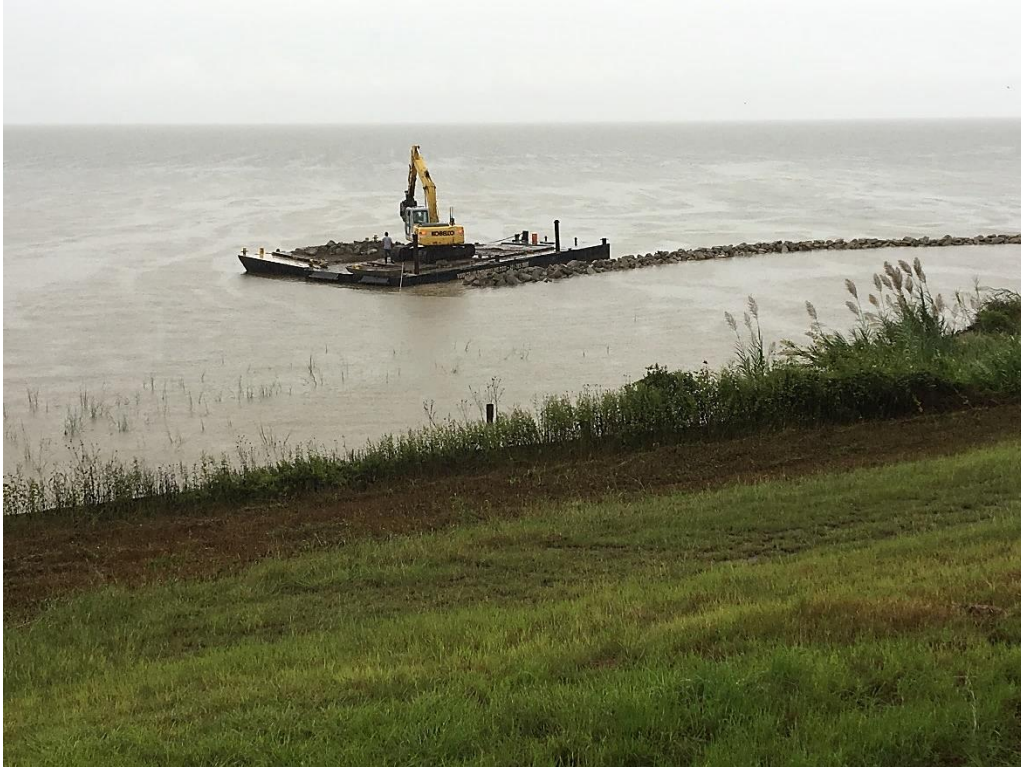
Figure 10. Last day of construction – October 1, 2018

During the last week of August, Crawley's received the initial delivery of project materials and mobilized construction equipment. Crawley's completed the debris removal activities on August 27, 2018 and began construction of the rip-rap breakwater on August 28, 2018. Construction was completed on October 1, 2018 and GBF, along with US Fish and Wildlife Service (USFWS), visited the site to perform a final walkthrough. Work was approved pending survey results. In early November 2018, as built surveys were conducted by Wells Land Survey (WLS). Additional cross-section drawings were provided by WLS on December 13, 2018.

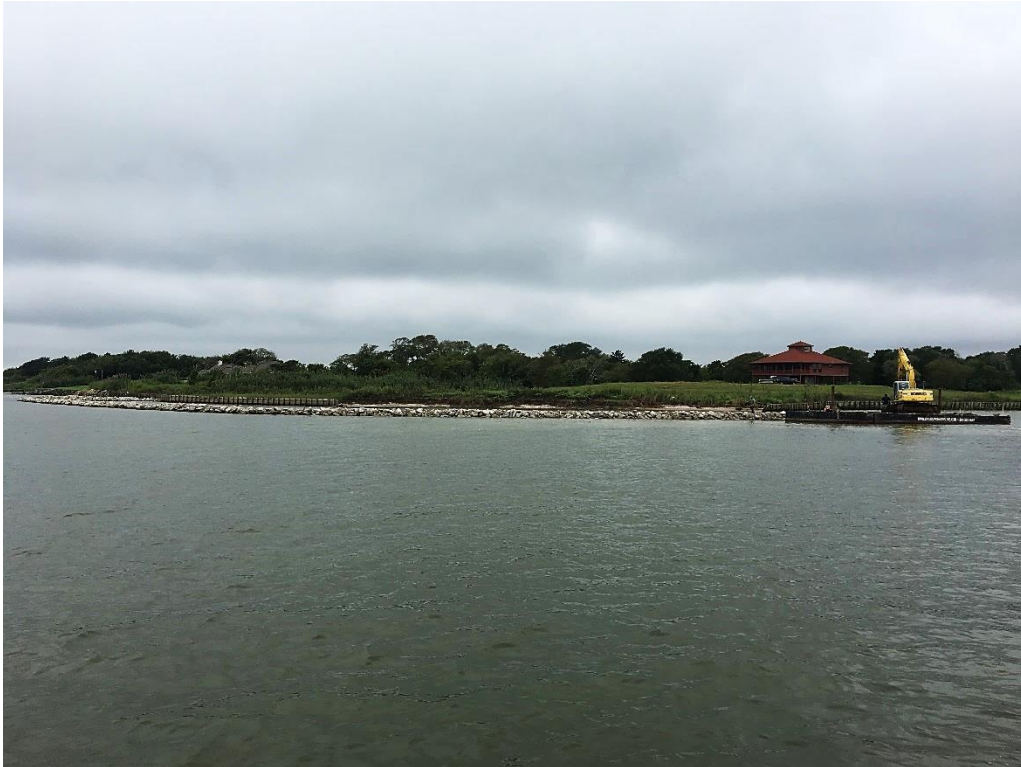
Figure 11. View of rip-rap breakwater from offshore

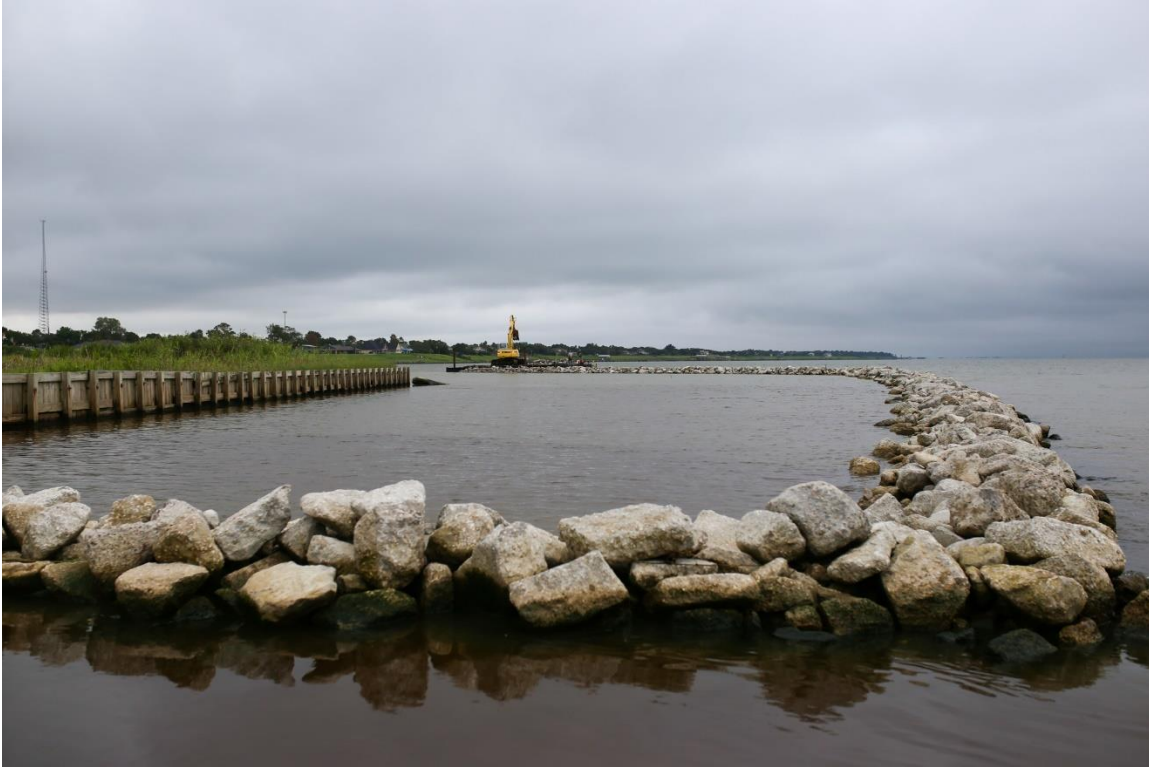
Figure 12. View of rip-rap breakwater looking north

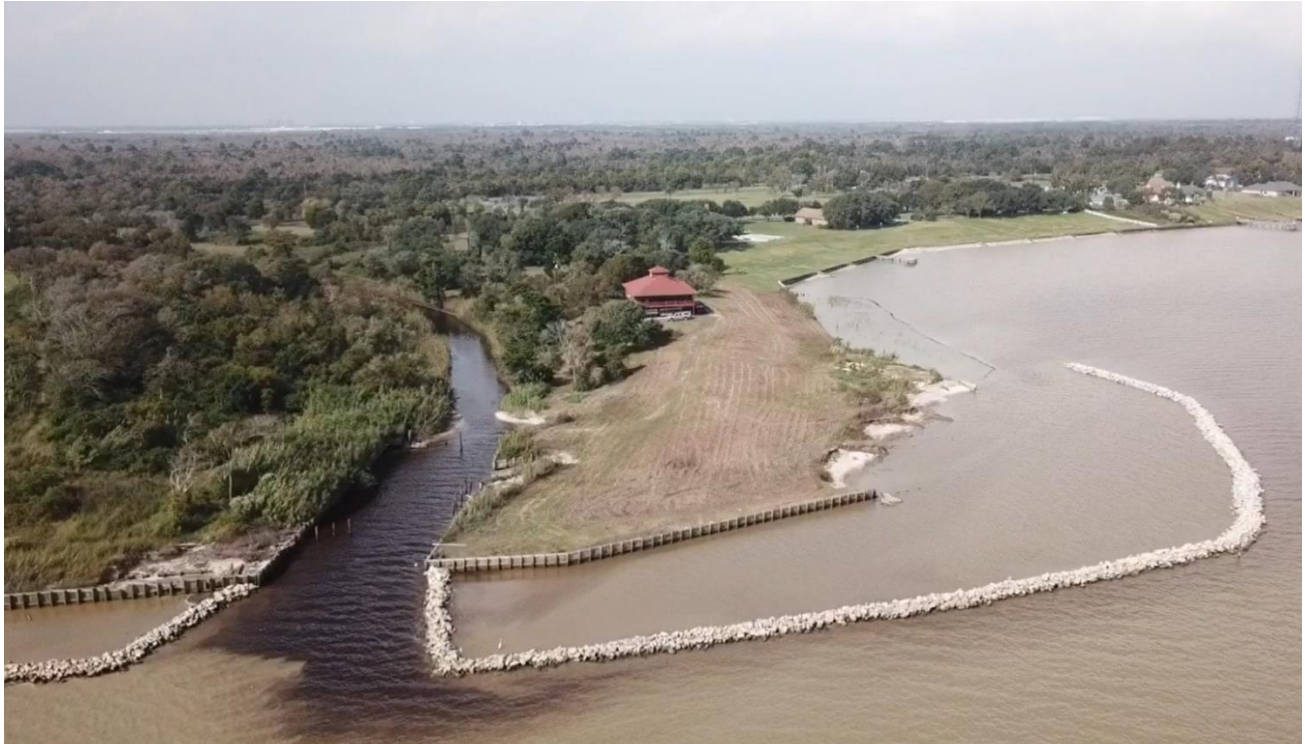
Figure 13. Aerial view of complete rip-rap breakwater and 300-foot oyster shell breakwater

At this time, the construction efforts, both contracted and volunteer based, have resulted in 780 feet of rip-rap breakwater and 400 feet of oyster shell breakwater, protecting a total of 880 feet of shoreline. Reflective warning signs were placed bayward of the rip-rap breakwater to warn and inform boaters of the presence of the structure. The rip-rap breakwater was left open on the southernmost and northernmost ends and gaps were integrated into the oyster shell breakwater structure to enable ingress/egress of water and wildlife. The breakwater structures protect the 17-acre TBDC property and have established a two-acre calm water habitat area between the structures and the shoreline. This two-acre area has the potential to restore intertidal marsh as elevations allow. As of August 2019, over 0.50 acres of this area has been planted with smooth cordgrass by community volunteers and students.

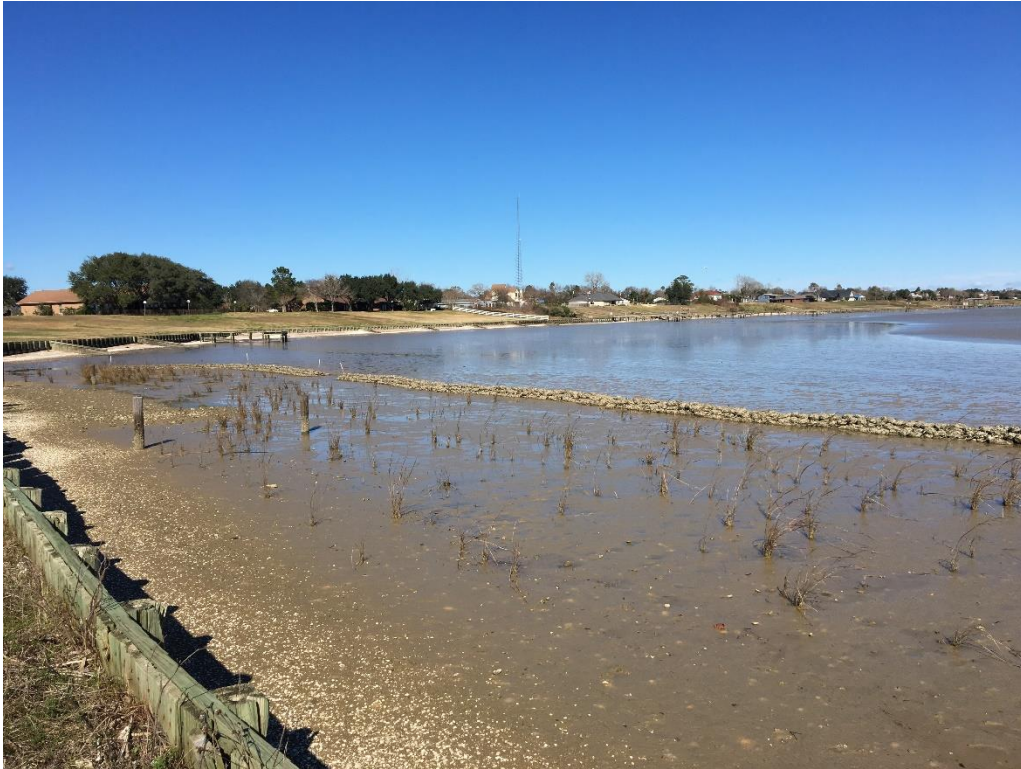
Figure 14. Oyster shell breakwater at low tide (December 2018)

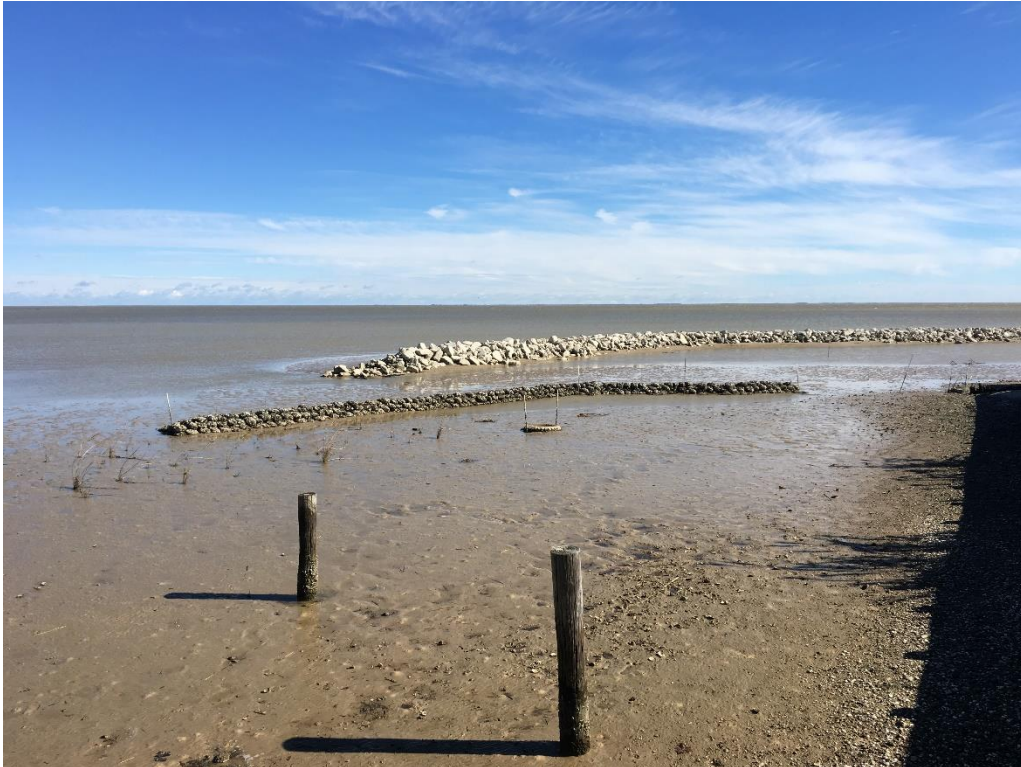
Figure 15. Oyster shell breakwater and rip-rap breakwater at low tide (December 2018)

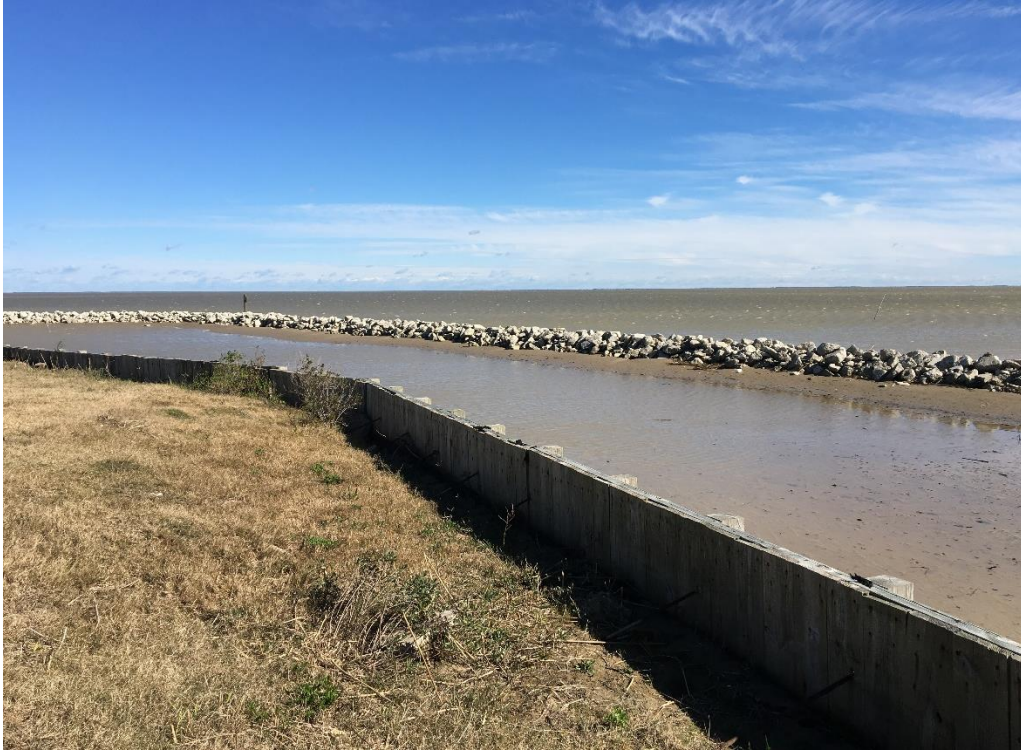
Figure 16. Rip-rap breakwater at low tide in December 2018, showing sediment accumulation directly behind the rocks

Based on the elevation data provided by Ducks Unlimited and an assessment of the mean high tide level, GBF decided on a preferred elevation of +2.5' NAVD for the rip-rap breakwater. While this height has proven effective at reducing wave action and depositing sediment shoreward, GBF staff have observed water overtopping the breakwater on at least three occasions in early 2019. If extreme high tide conditions persist, it may be prudent to construct a larger structure, perhaps to an elevation of +3.0' NAVD, on future shoreline protection efforts.

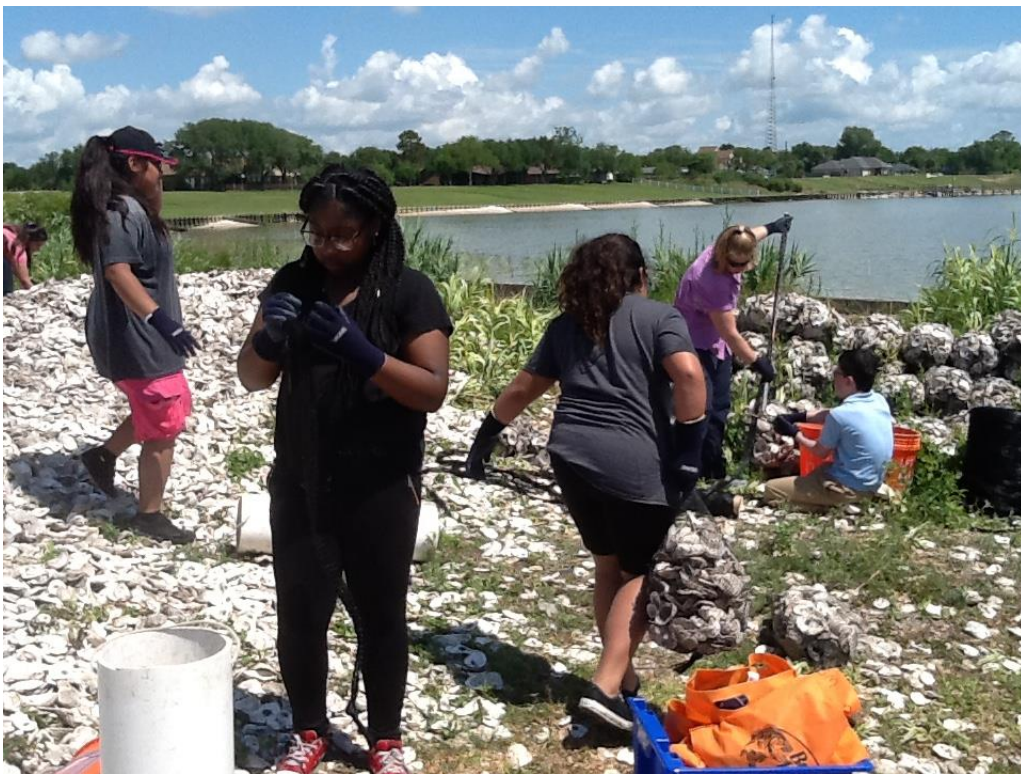
Figure 17. Student workday, building the oyster shell breakwater

From April to July of 2018, student volunteers from GBF's "Hip to Habitat" Program constructed 300 feet of the oyster shell breakwater along the northeastern shoreline of the property. The shells were obtained from GBF's Oyster Shell Recycling Program and the volunteer construction was supported by TX Parks and Wildlife Department (TPWD) as well as Houston Wilderness funding. During this same time, GBF developed bidding and contract documents for the rip-rap breakwater portion of the project.

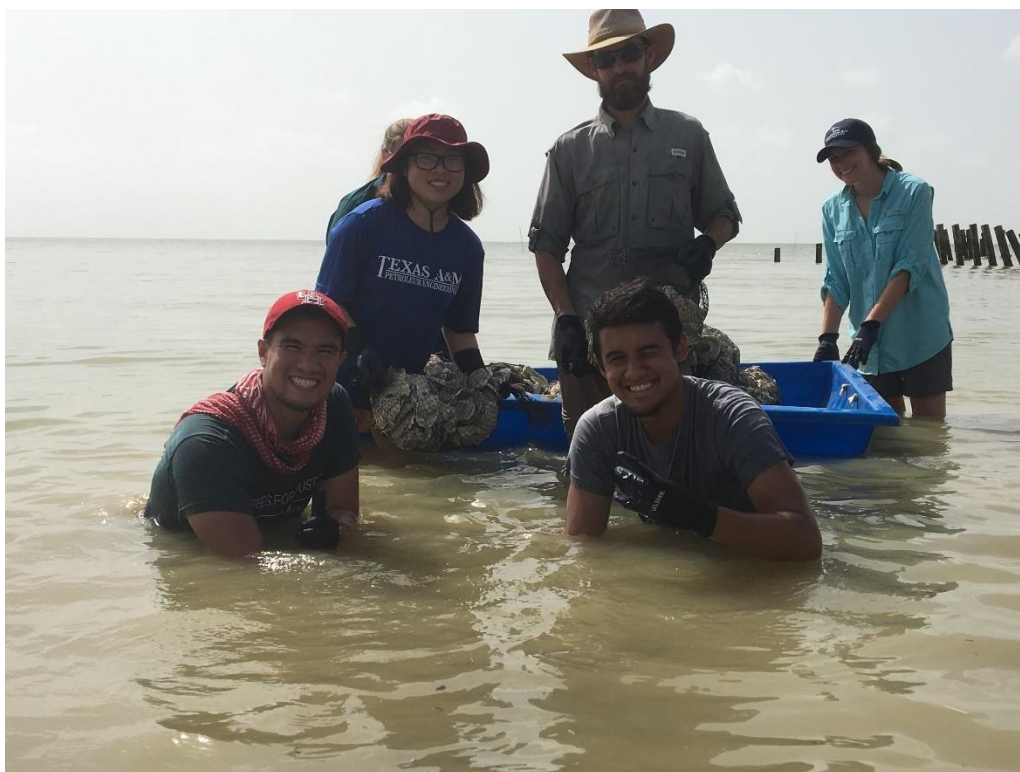
Figure 18. GBF interns/staff and Houston Wilderness building oyster shell breakwater (July 2018)

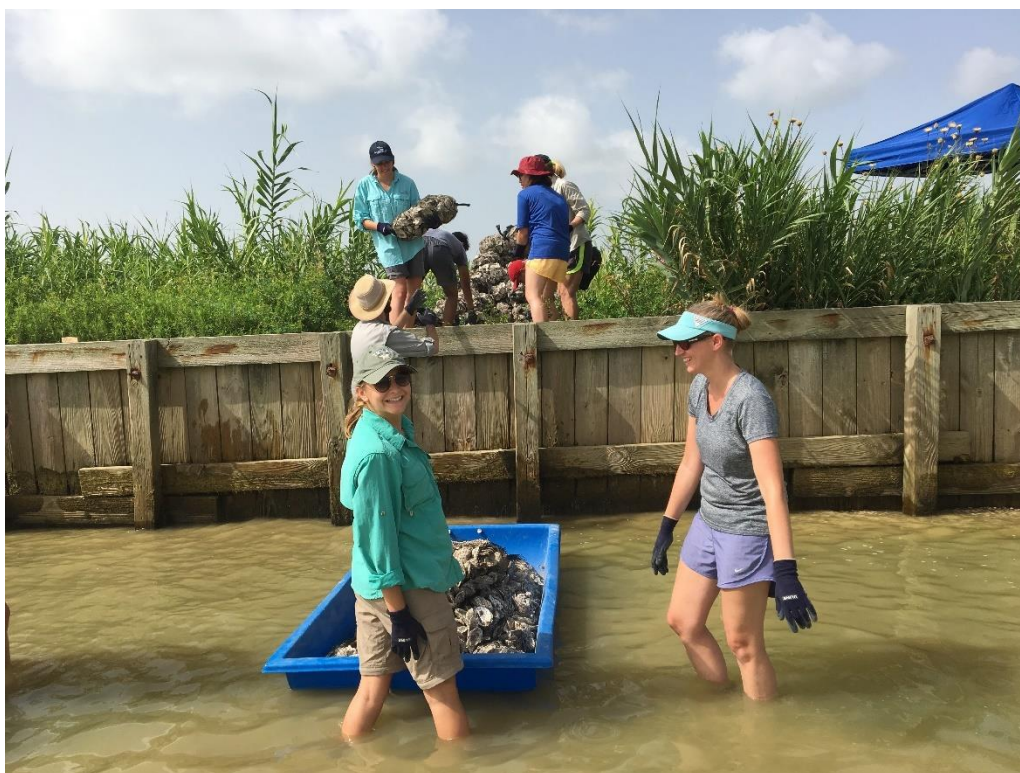
Figure 19. GBF interns/staff and Houston Wilderness building oyster shell breakwater (July 2018)

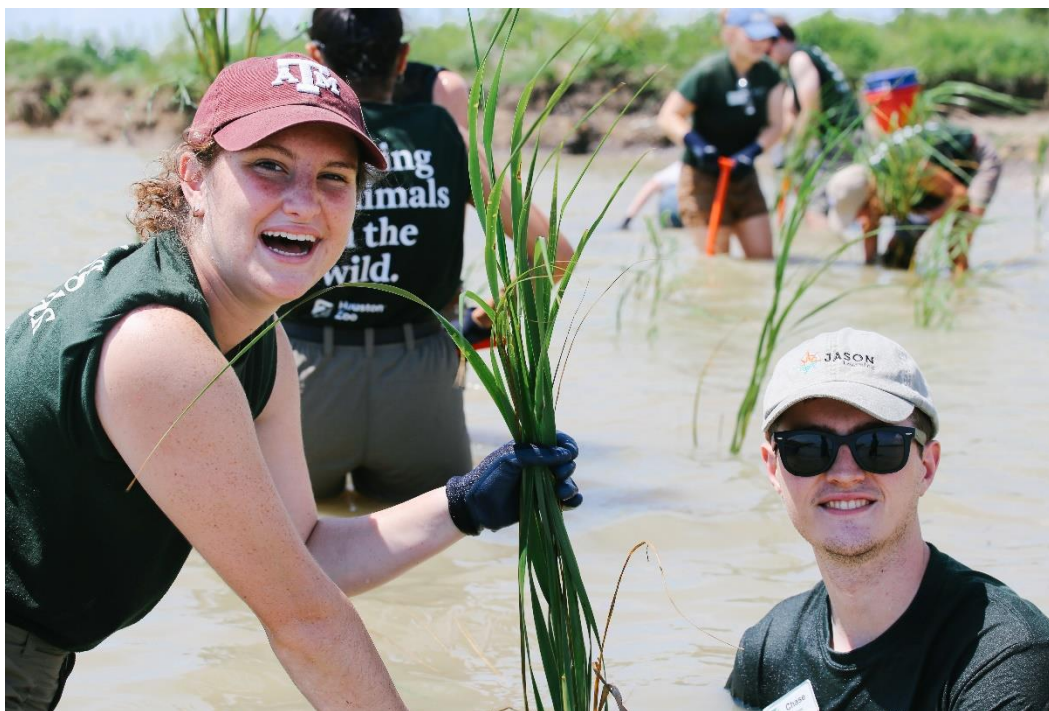
Figure 20. Houston Zoo interns planting smooth cordgrass (July 2019)

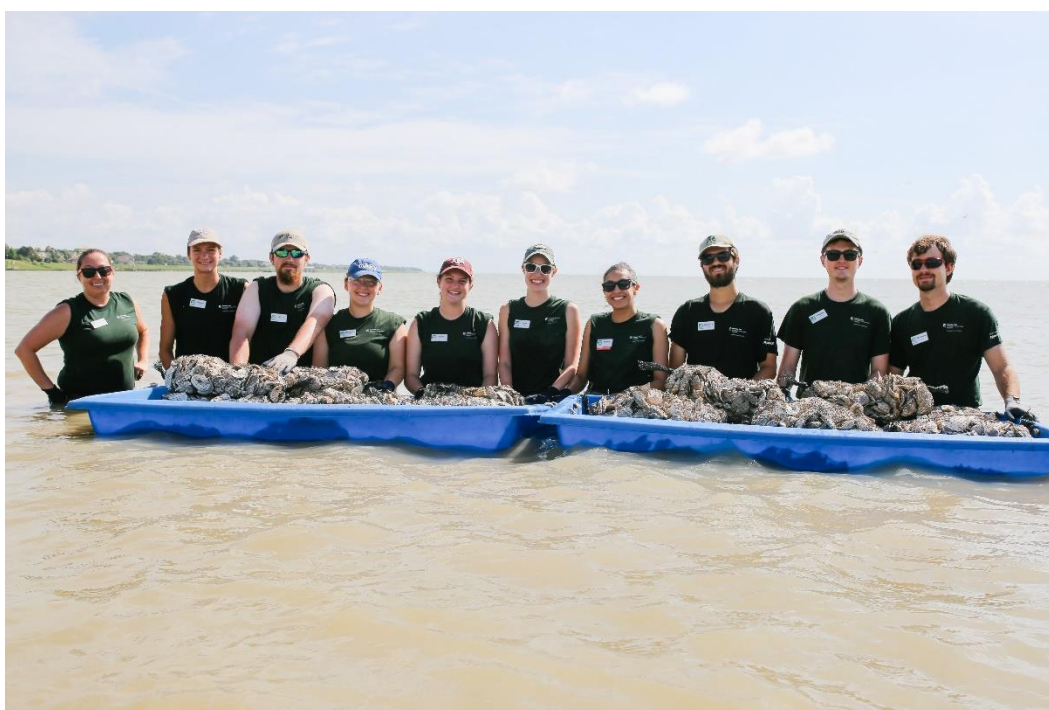
Figure 21. Houston Zoo interns building oyster shell breakwater (July 2019)

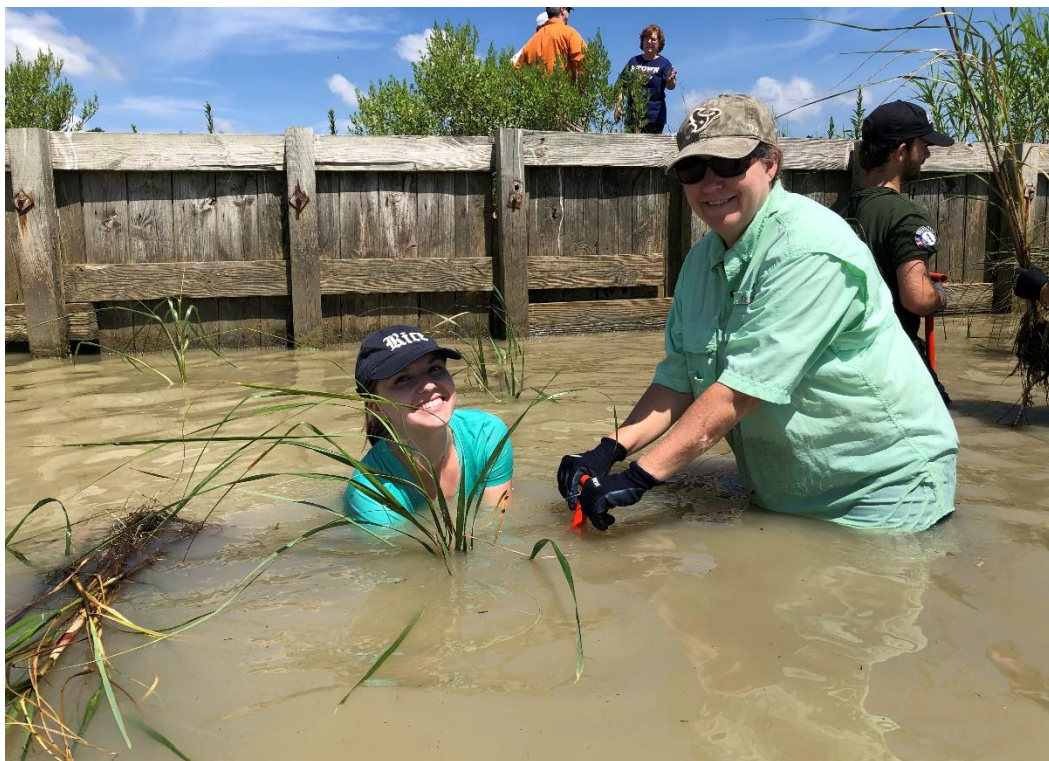
Figure 22. Accenture volunteers and TX Conservation Corps Crew planting smooth cordgrass (July 2019)

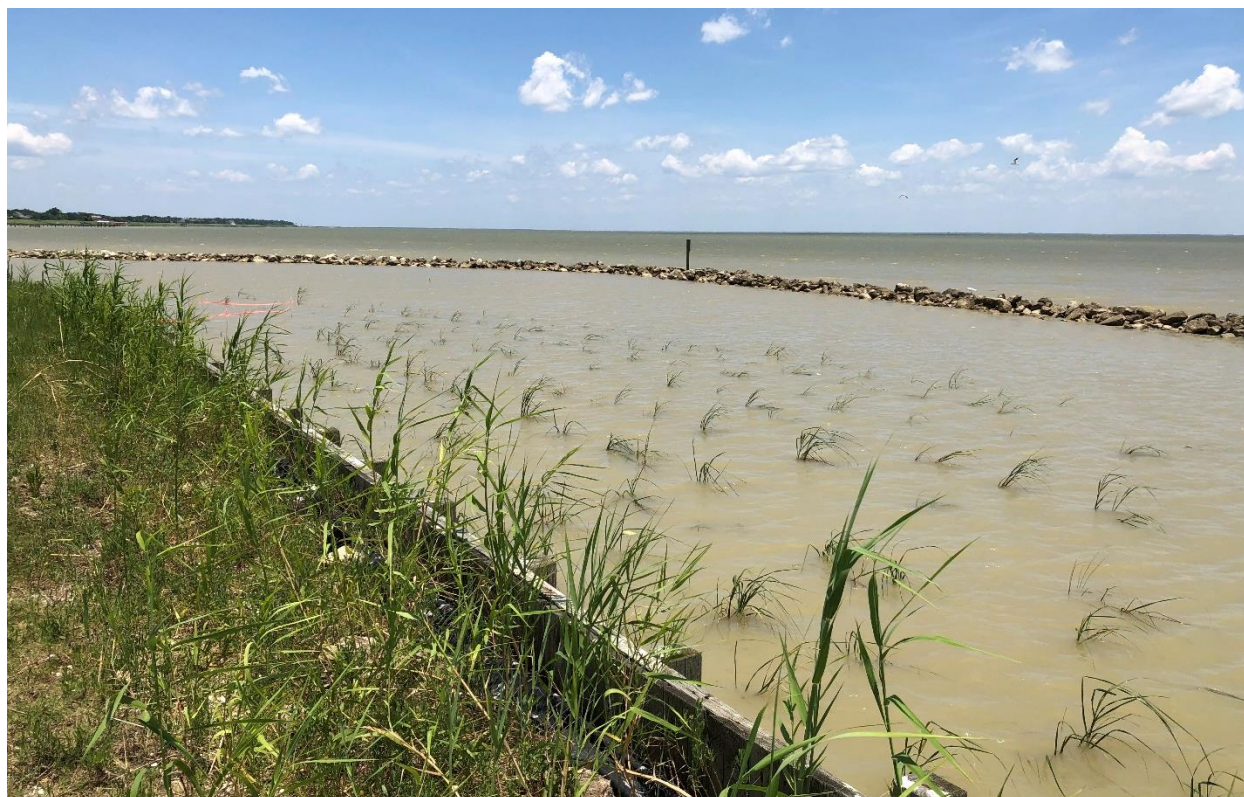
Figure 23. Area planted by Accenture volunteers and TX Conservation Corps Crew (July 2019)
