Final Report
on
The Oyster Lake Shoreline Protection and Marsh Restoration Project

TCEQ Contract # 582-15-53288

August 2016

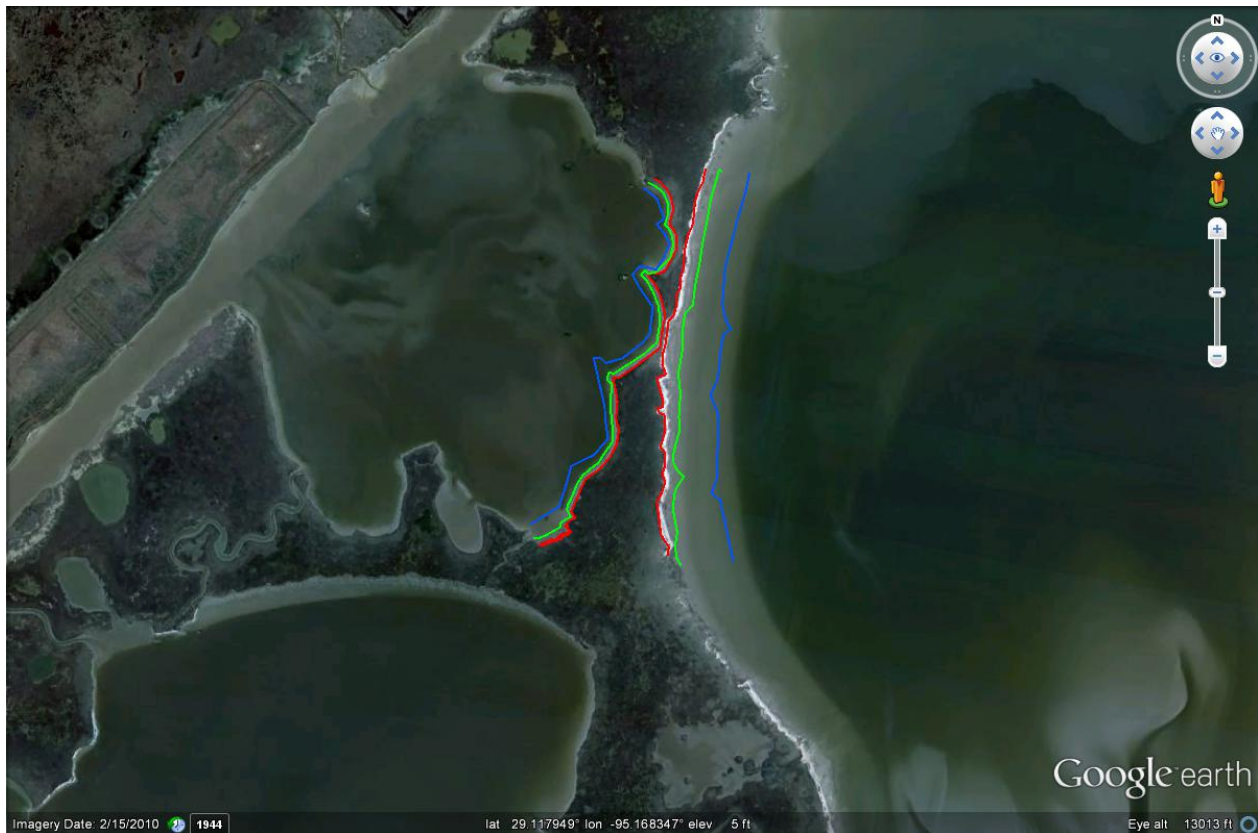
Approximate locations of Oyster Lake shorelines in 1944 (blue), 1995 (green), and 2010 (red), indicating severity of shoreline loss in this area

The Oyster Lake Shoreline Protection and Marsh Restoration project aimed to protect sensitive estuarine marsh habitat on the Brazoria National Wildlife Refuge (NWR) from continued erosion and habitat conversion. The project is located along approximately 5,200 feet of severely eroding shoreline between Oyster Lake and West Bay. Wind driven waves have impacted the shoreline with severe erosion and resulted in vegetation and soil losses. It is estimated that since 1944, up to 650 feet of shoreline has been lost on the West Bay side and up to 150 feet of shoreline has been lost from the Oyster Lake side. Furthermore, the rate of erosion appears to be more extreme in recent years, as just since 1995, up to 175 feet of shoreline has been lost on West Bay side and 55 feet from Oyster Lake side (see Figure 2).

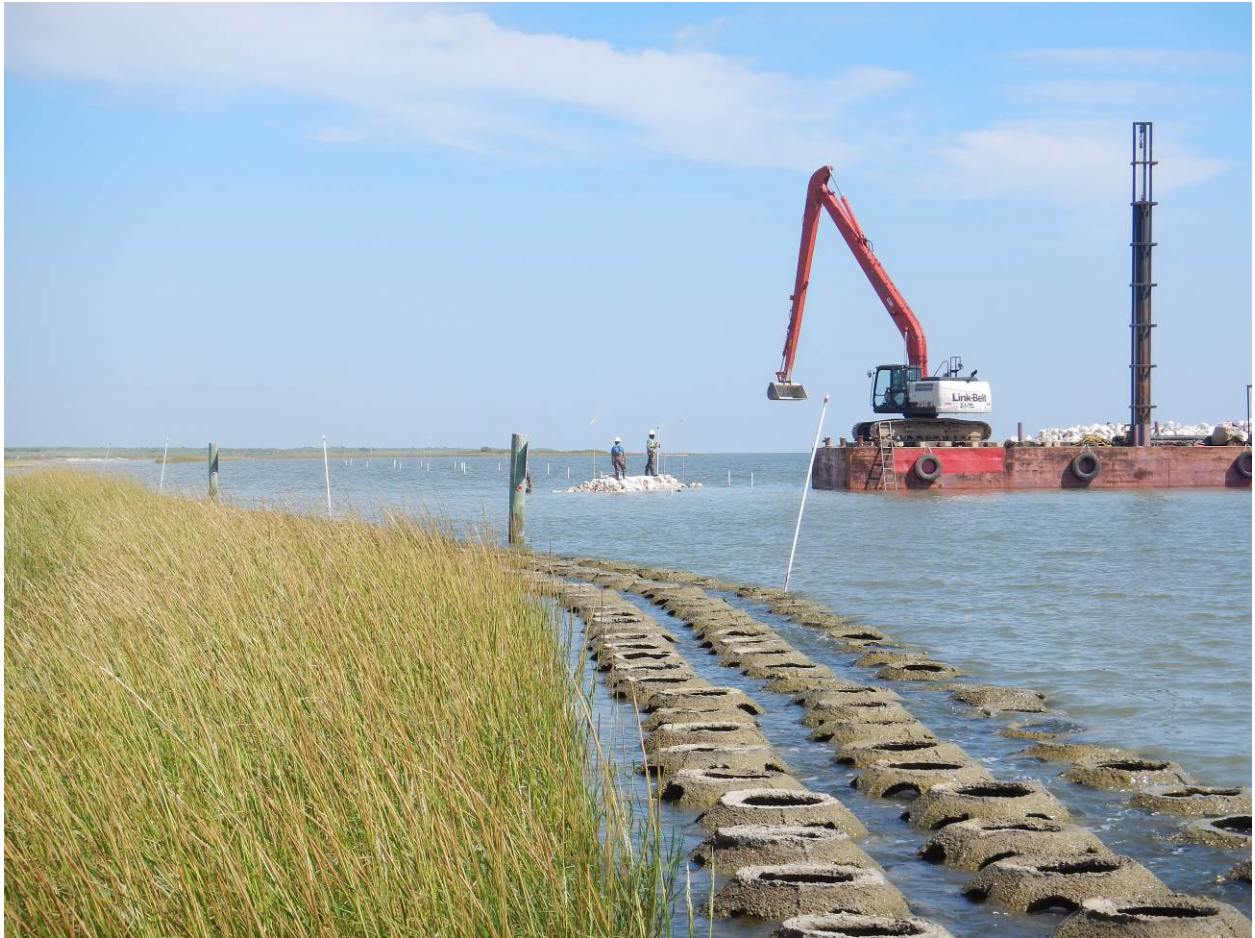
Beginning Construction, October 6, 2015

During the last week of September, Apollo received delivery of project materials and mobilized construction equipment. Breakwater construction began October 5, 2015.

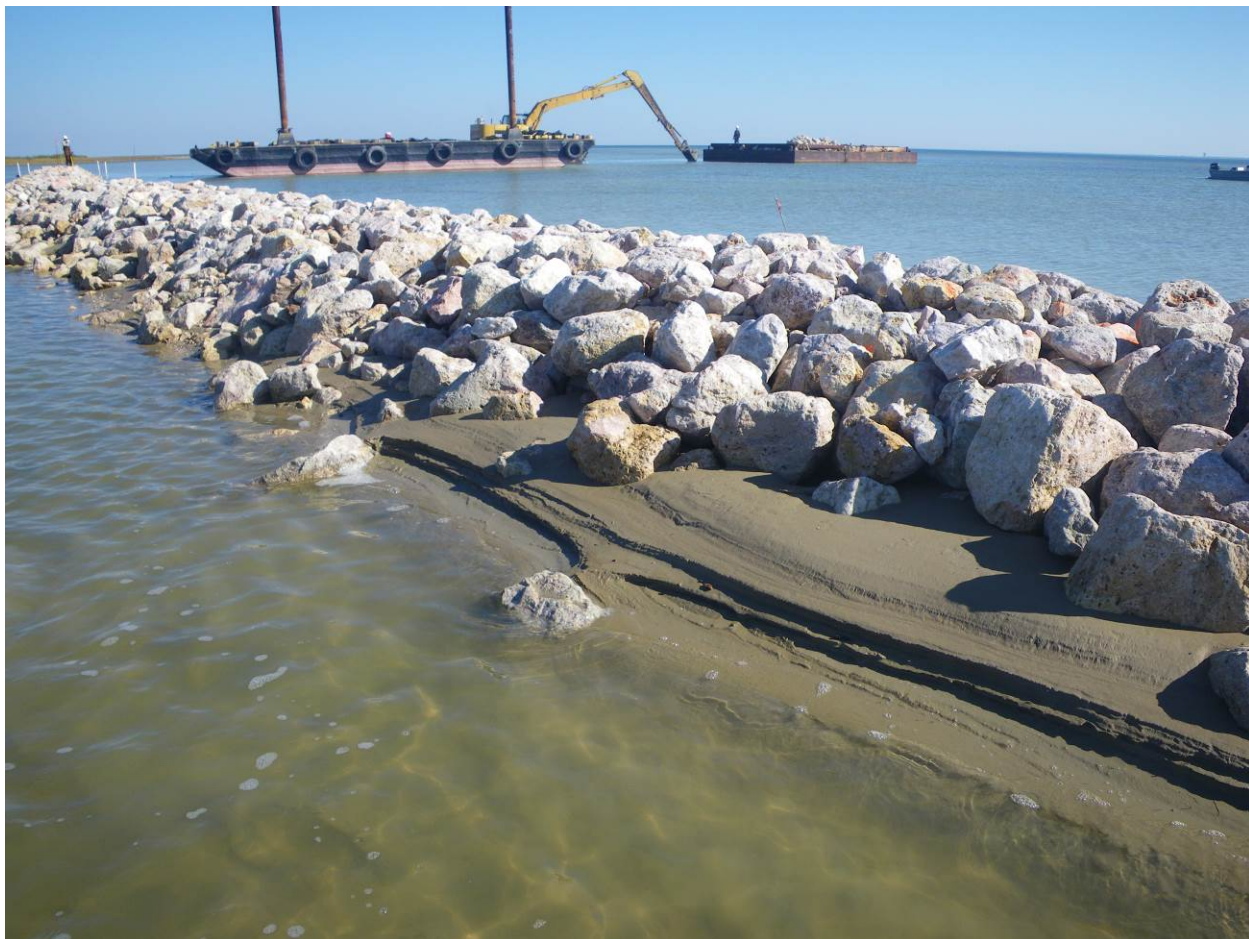
Project already showing signs of accretion; December 9, 2015

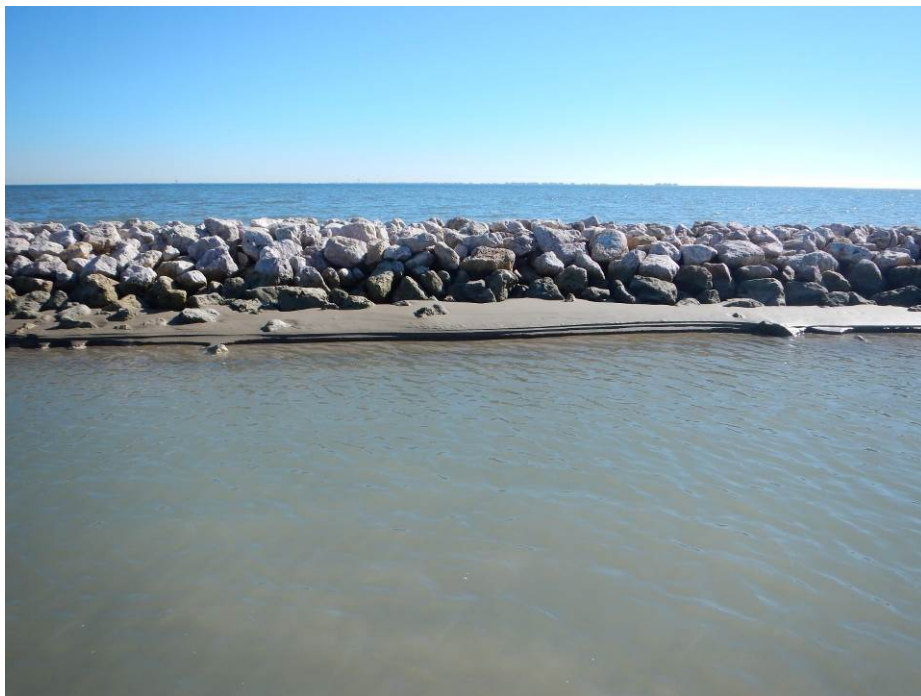
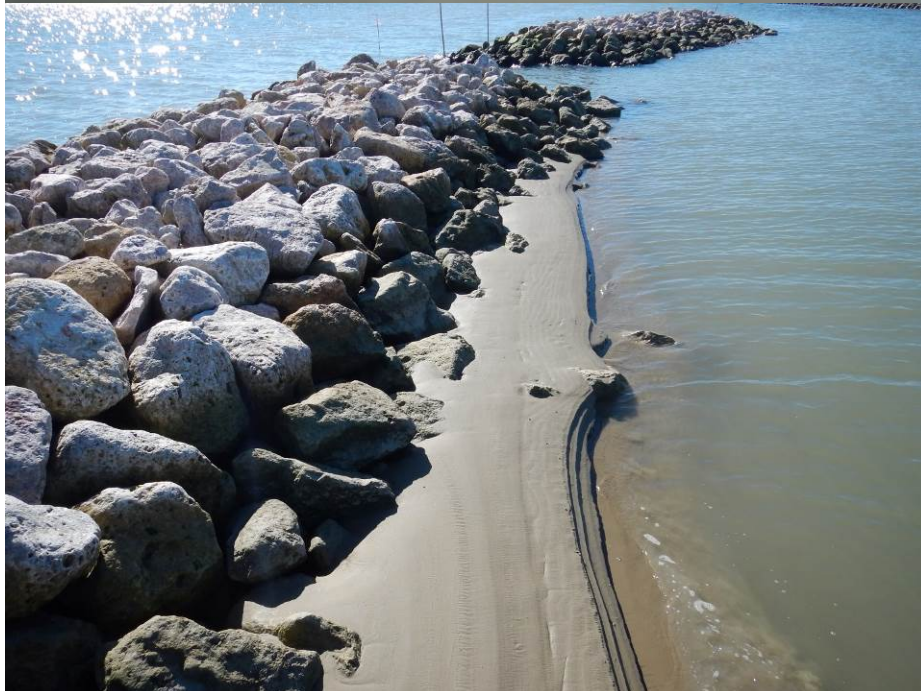
Accretion, 1/4/2016

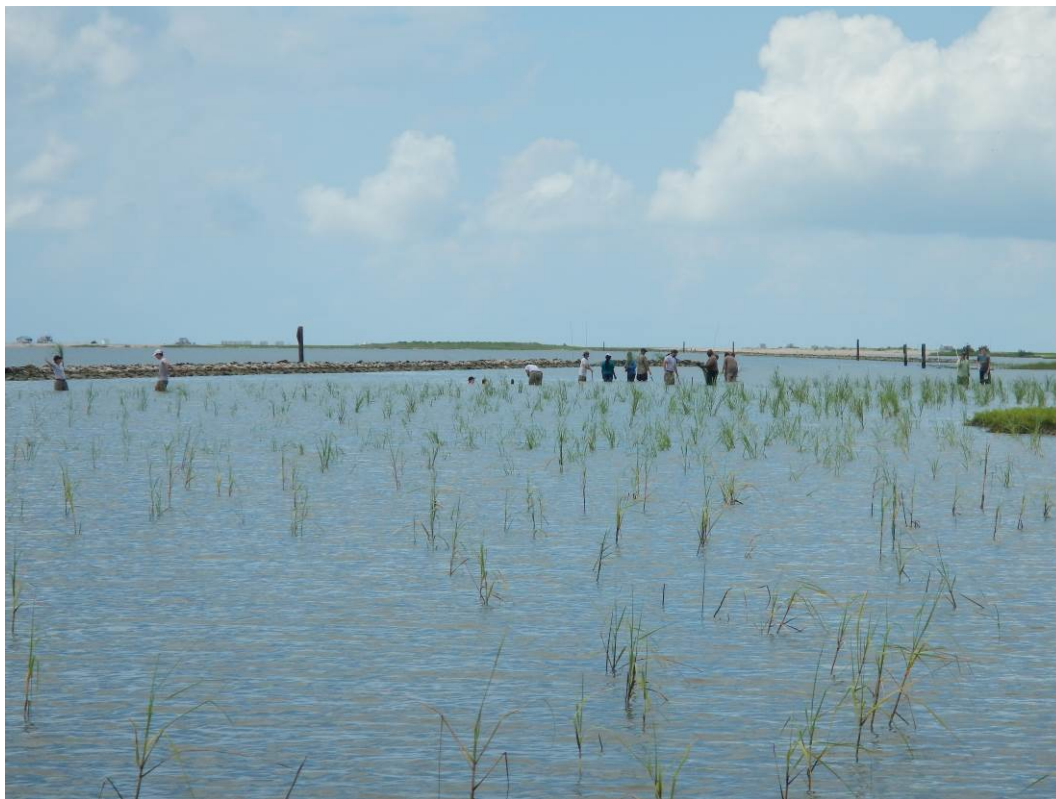
Planting event, 6/21/2016

The project resulted in the construction of an approximately 4,786-foot breakwater to protect approximately 5,150 foot of the Oyster Lake shoreline from continued erosion. Reflective warning signs and project partnership signs were placed just bayward of the breakwater to warn and inform boaters in the area. The breakwater ends were left open, not tying into the existing shoreline and gaps were integrated into the breakwater structure to enable ingress/egress for water and wildlife. The breakwater protects upwards of 60 acres of coastal wetland habitat and created a fourteen (14)-acre calm water habitat area between the breakwater and shoreline. This fourteen (14)-acre area has the potential to restore intertidal wetlands as elevations allow. At the time of this report 1.5 acres of this area has been transplanted with smooth cordgrass by community volunteers and project partners.

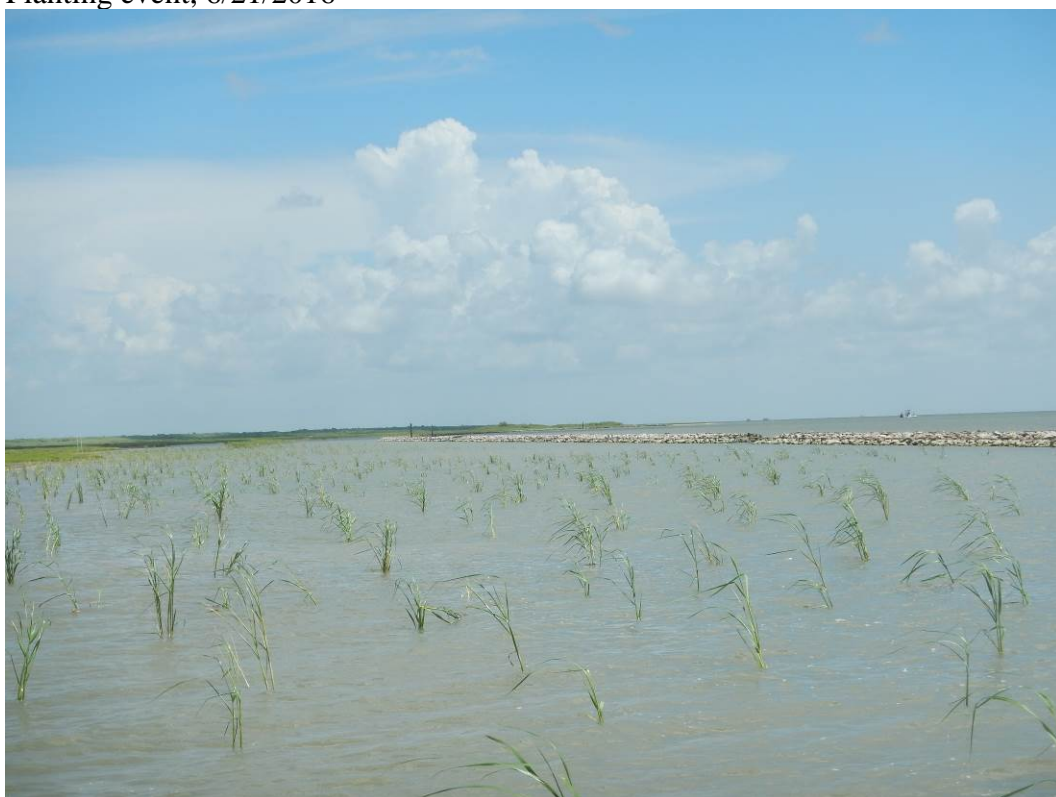
After planting event 6/25/16
