# Green Infrastructure Practices at the Ghirardi Family WaterSmart Park

Compiled by the  
Texas Community Watershed Partners  
A program of the Texas A&M AgriLife Extension Service

This report reviews the BMPs installed at the Ghirardi Family WaterSmart Park (GFWP) in League City, TX as a very real solution for reducing NPS loading into local waterbodies. It also evaluates water and soil data from the park and compares percent reduction values to those found for a North Texas site with similarly designed BMPs and comparable soil types.

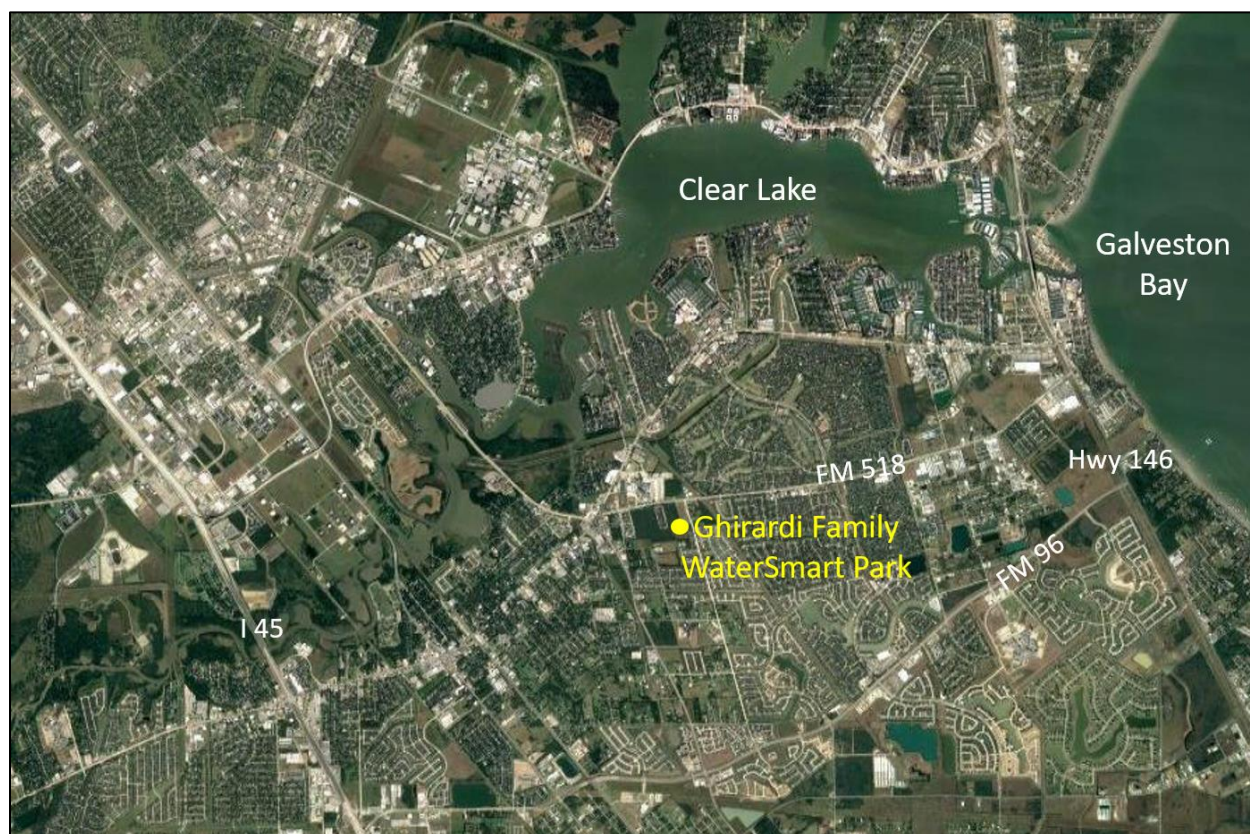
The 3.75 acre Ghirardi Family WaterSmart Park is located on Louisiana Street in the Meadows Subdivision of League City (Figure 2). The Park was substantially completed and opened for public use in March of 2014. It contains amenities such as shaded walking trails, a playground, picnic area, and restroom facilities as well stormwater BMPs. It is first and foremost a public park and recreation area but it is so much more.

Figure 2. Ghirardi Family WaterSmart Park is located within a suburban neighborhood of League City, TX

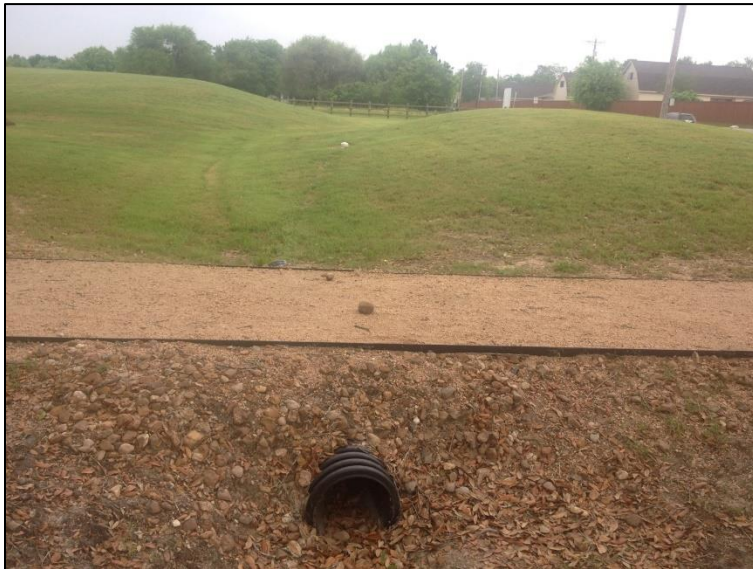
The bioswale (Figure 3) is completely vegetated with Bermuda grass, and collects overland flow from within the park, only grassed areas contribute runoff, there are no impervious surfaces in this watershed.

Figure 3. Bioswale vegetated with turf grass. Sampling point for this BMP is the pipe pictured.

Overall, TSS values for all BMP outflows are relatively low. The highest values were for the bioswale in the spring/winter and spring of 2017 and 2018 (Figure 7, Table 4). There was a large amount of sediment build up at the mouth of swale that was washed back into the pipe during large rain events; this likely is the reason for high TSS values, not soil washing in from the BMP watershed. The sediment was due to the theft of rock used to stabilize the swale outflow pipe, when the rock was in place, the lower TSS values were observed. Since sampling has ended, the rock has been replaced.

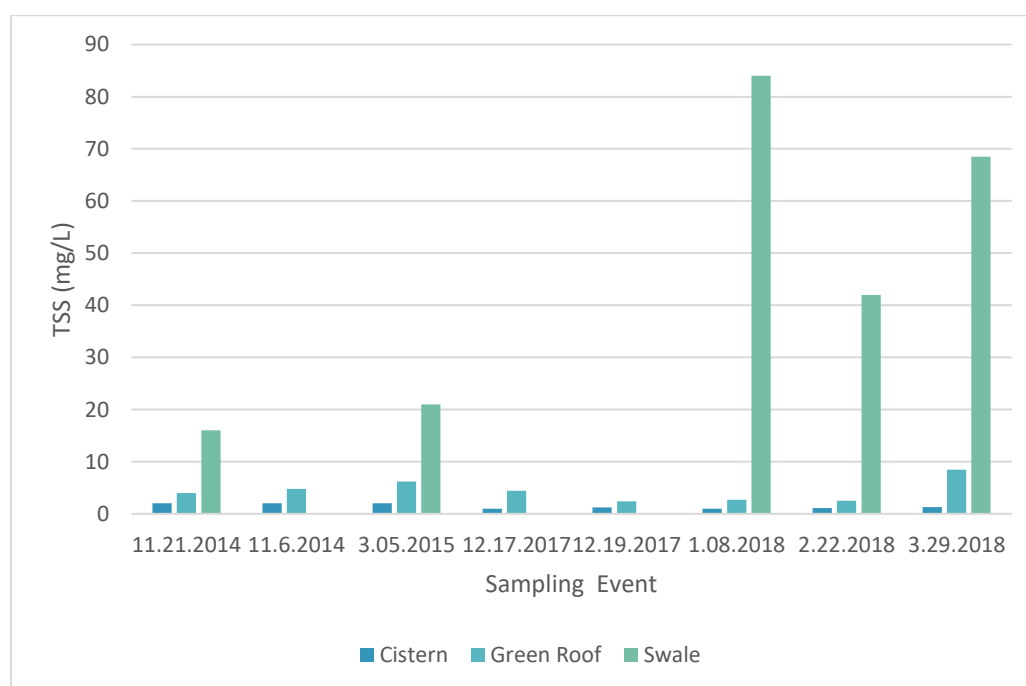
Figure 7. Measured Total Suspended Solids in outflows for all three BMPs

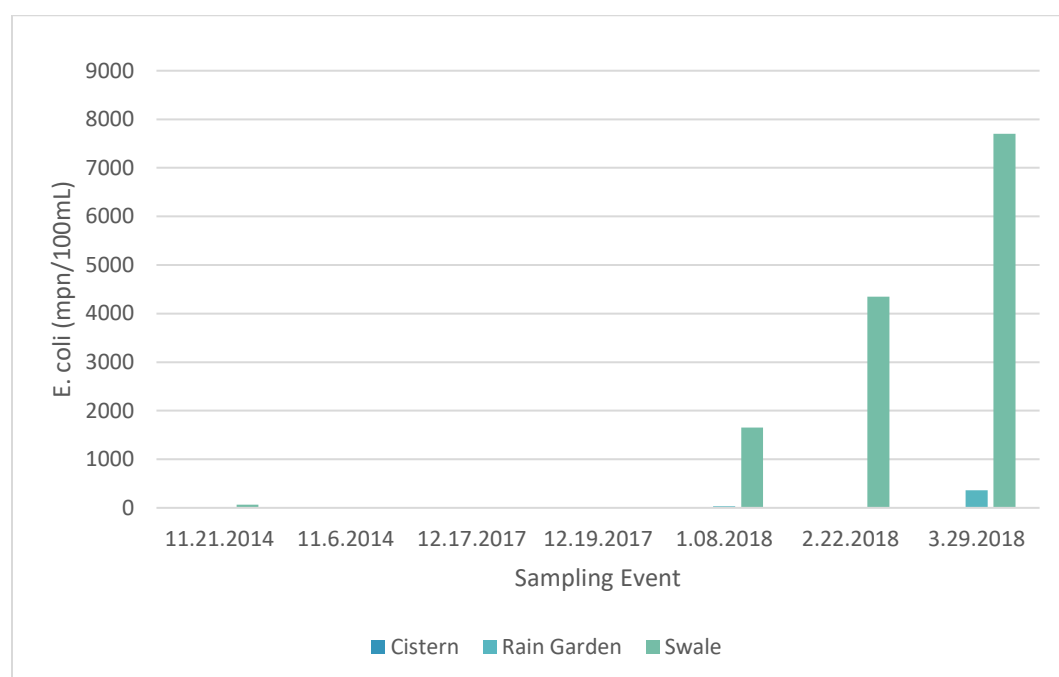
*E. coli* values are fairly similar across sampling dates, except for the bioswale (Figure 8, Table 5). During the winter/spring of 2018 high outflow values were observed for three sampling events. A large number of local residents walk their dogs in the park. While there is a pet waste station in the park, it is not near the watershed for the swale, a grassy area where pets can run and play. On more than one occasion dog waste was seen in the area near the sampling location for the bioswale which was likely the cause of high bacteria counts. No stormwater from outside of the park drains into the GFWP or the swale, therefore typical sub-urban sources of bacteria such as leaking sewer pipes are unlikely the cause of the elevated *E. coli* values.

Figure 8. Measured bacteria in outflows for all three BMPs
