Kemah Living Shoreline Habitat Protection and Restoration

TCEQ Contract # 582-20-10172

October 16, 2020

Final Report

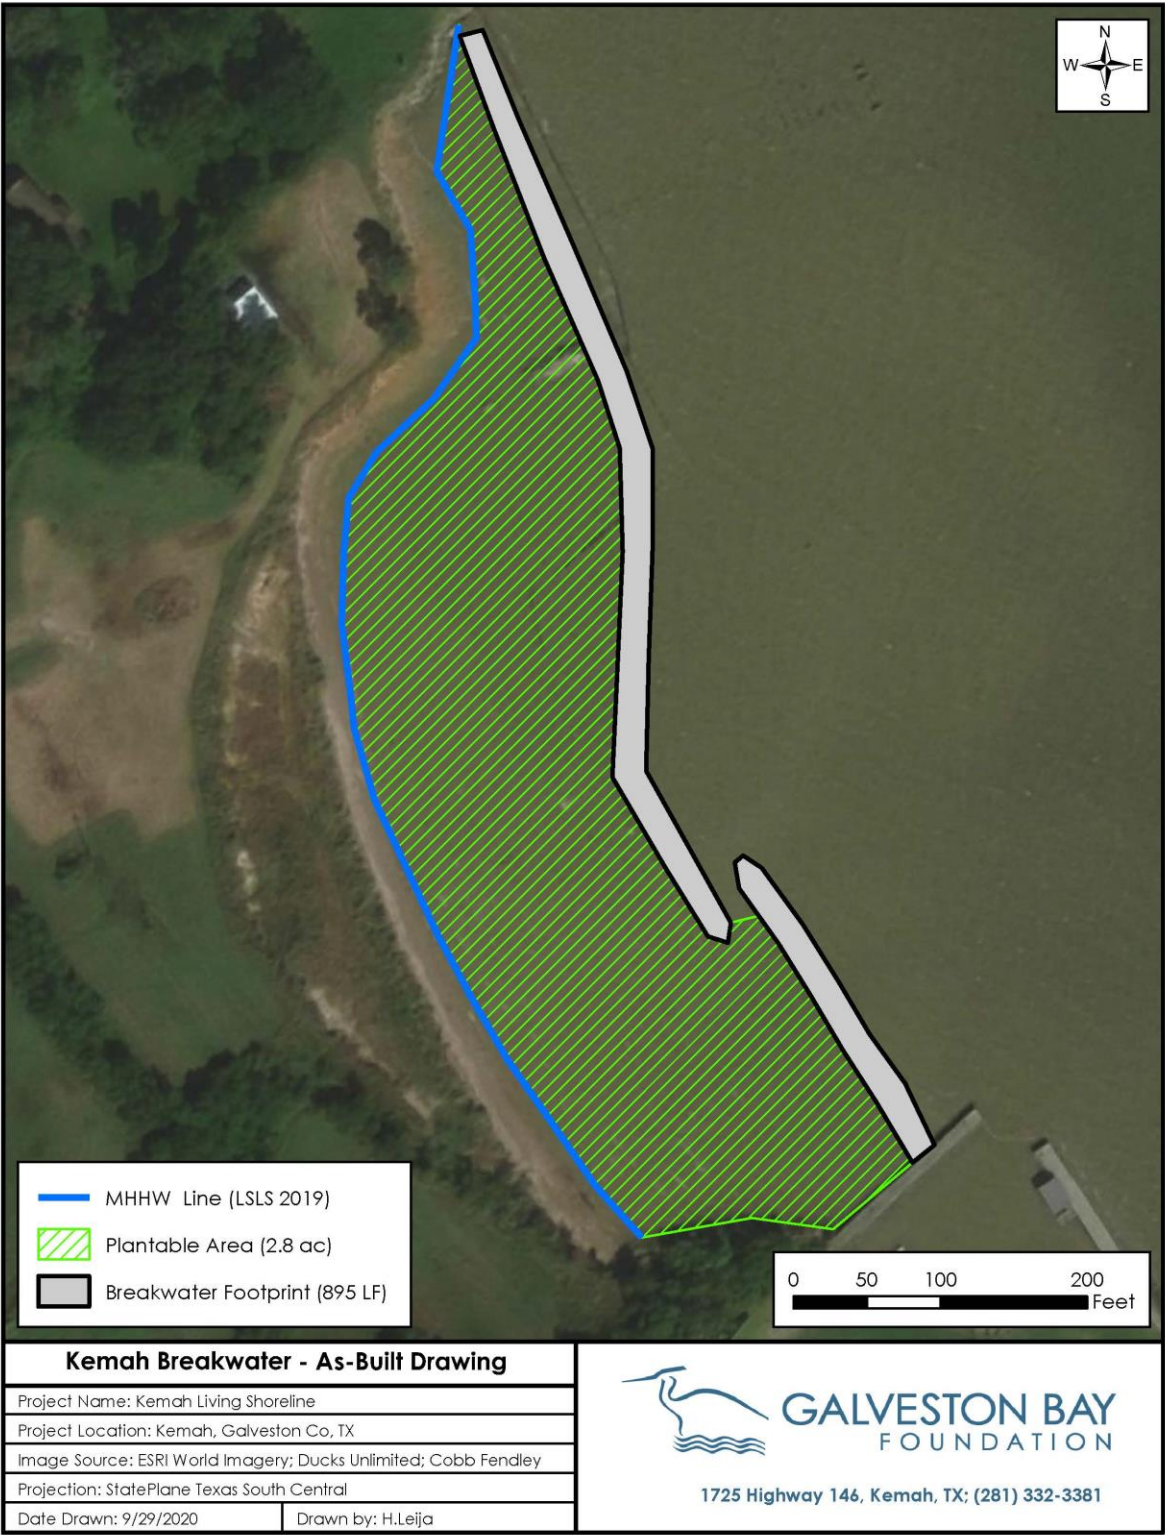
IX. PROJECT MAP

**Please note that the project map below shows a breakwater length of 895'. 895 was the length of breakwater surveyed as part of the final as built survey. An additional 10' of breakwater was constructed on the northern end of the project, tying into the neighboring properties bulkhead. The additional non surveyed 10' brings total breakwater length constructed to 905'.*

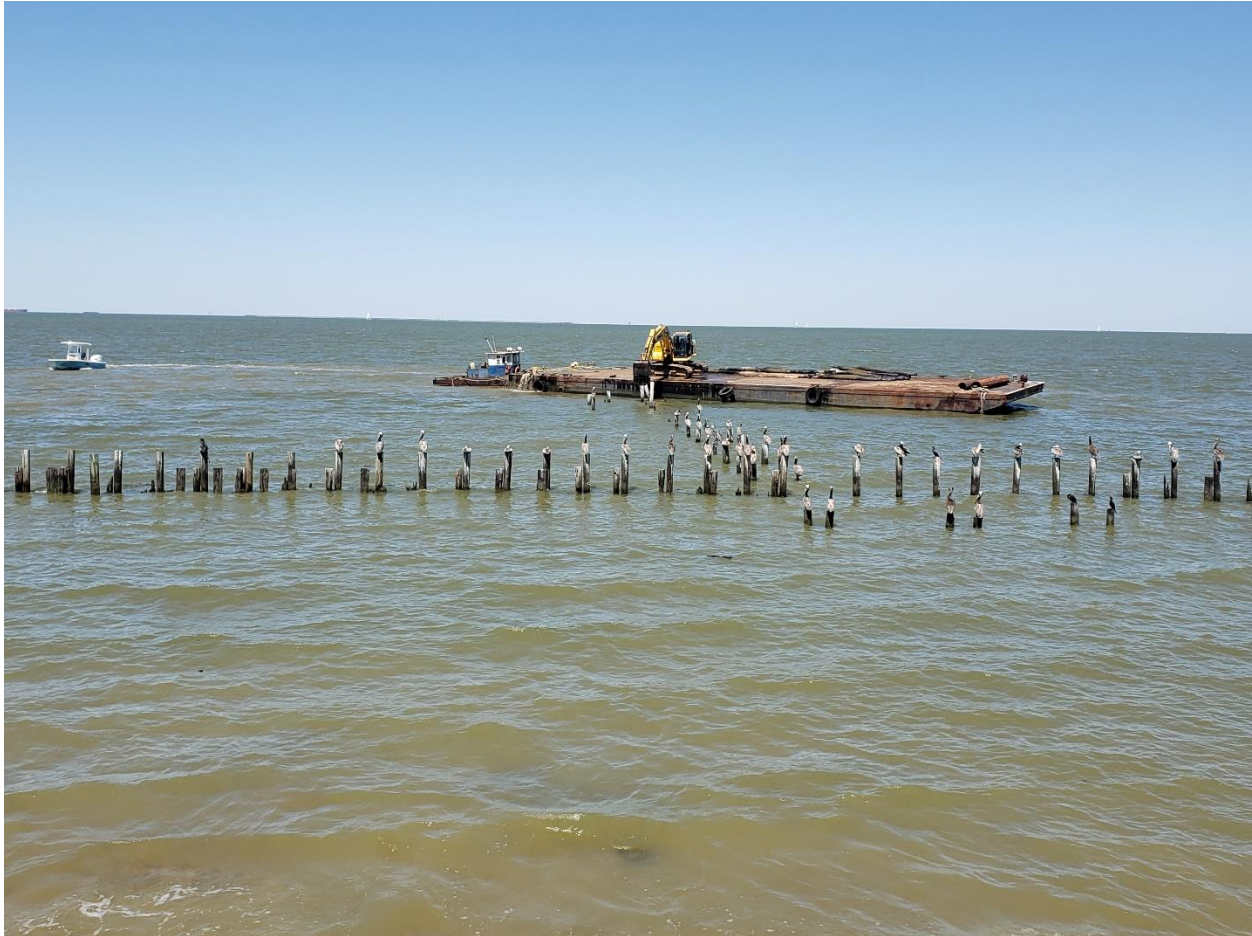
Figure 1: Equipment mobilizes onsite to remove derelict pier and bulkhead pilings and debris

The construction contractor began site prep work in June 2020. Site preparation consisted mainly of the removal of derelict pier pilings and bulkhead structures within and adjacent to the breakwater construction site. The contractor mobilized a barge and heavy equipment to the site to remove the structures. Structures were pulled from the bay bottom with a track hoe and the resulting debris was loaded onto the barge and hauled away for proper disposal.

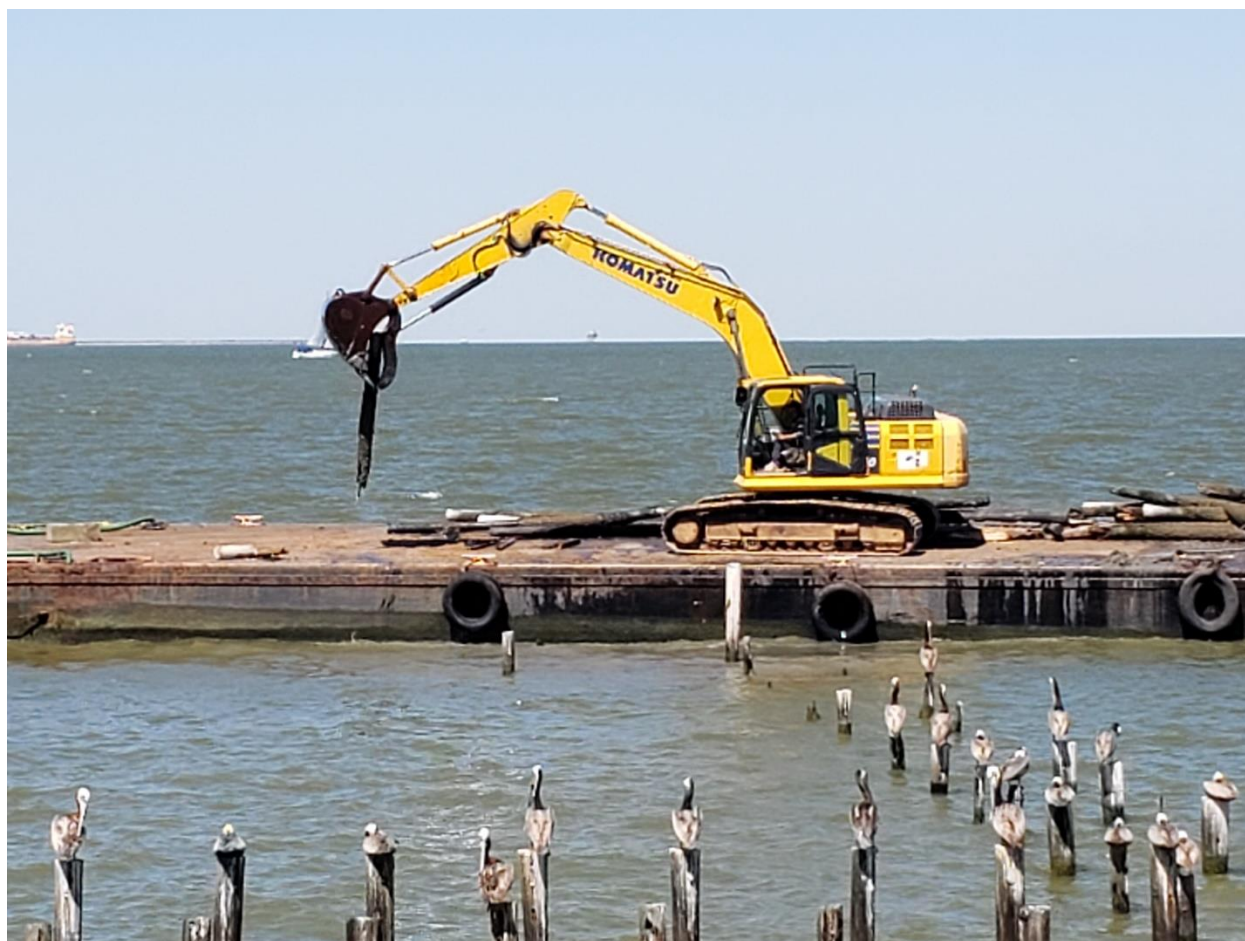
Figure 2: Derelict piling removal in process

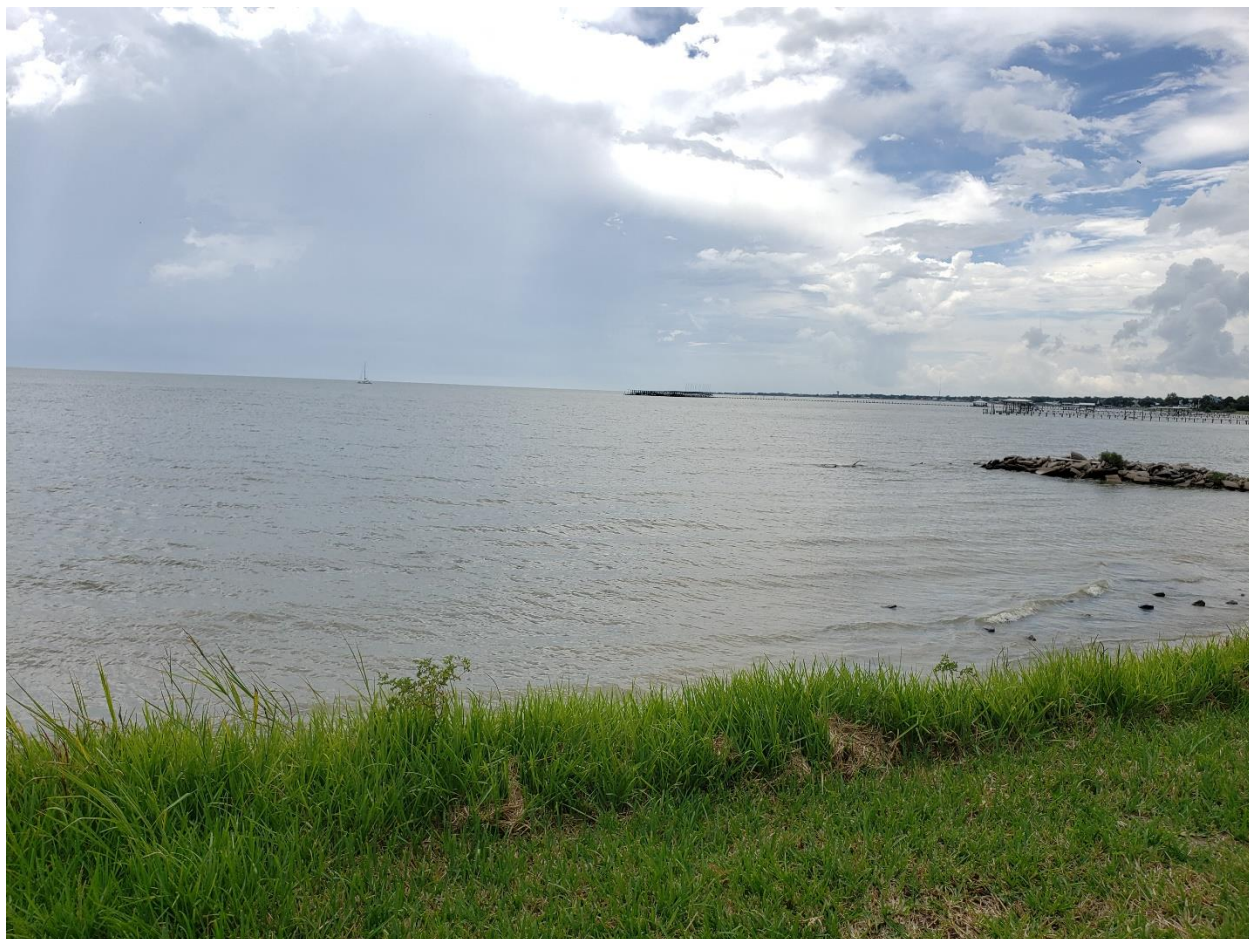
Figure 3: View post piling cleanup

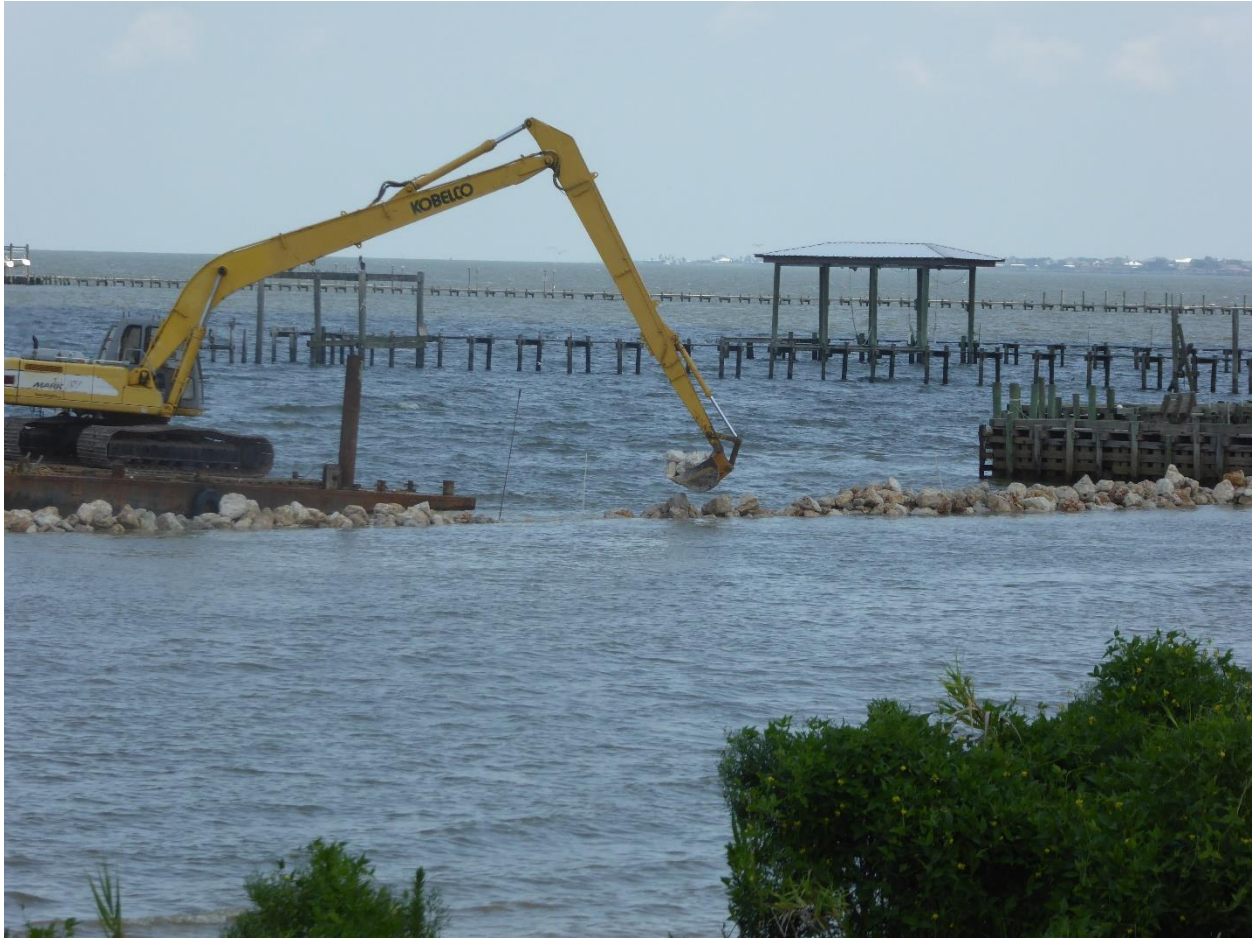
Figure 4: Day 1 of breakwater construction

The contractor returned to the site to begin construction of the breakwater on August 6, 2020. Construction equipment consisted of a track hoe on a barge that placed rip-rap brought to the project site via additional shallow draft barges. Construction progressed quickly until the threat of tropical weather to the area caused a few minor delays. Due to the uncertain predicted paths of Hurricanes Marco and Laura, the contractor temporarily demobilized his equipment from the project site after completing work on August 21, 2020. Prior to this delay, construction was on path to be completed by the end of August. The contractor returned to the site on August 31st and completed construction on September 4, 2020. Final survey documents were submitted and approved on September 23, 2020 and project construction is considered complete.

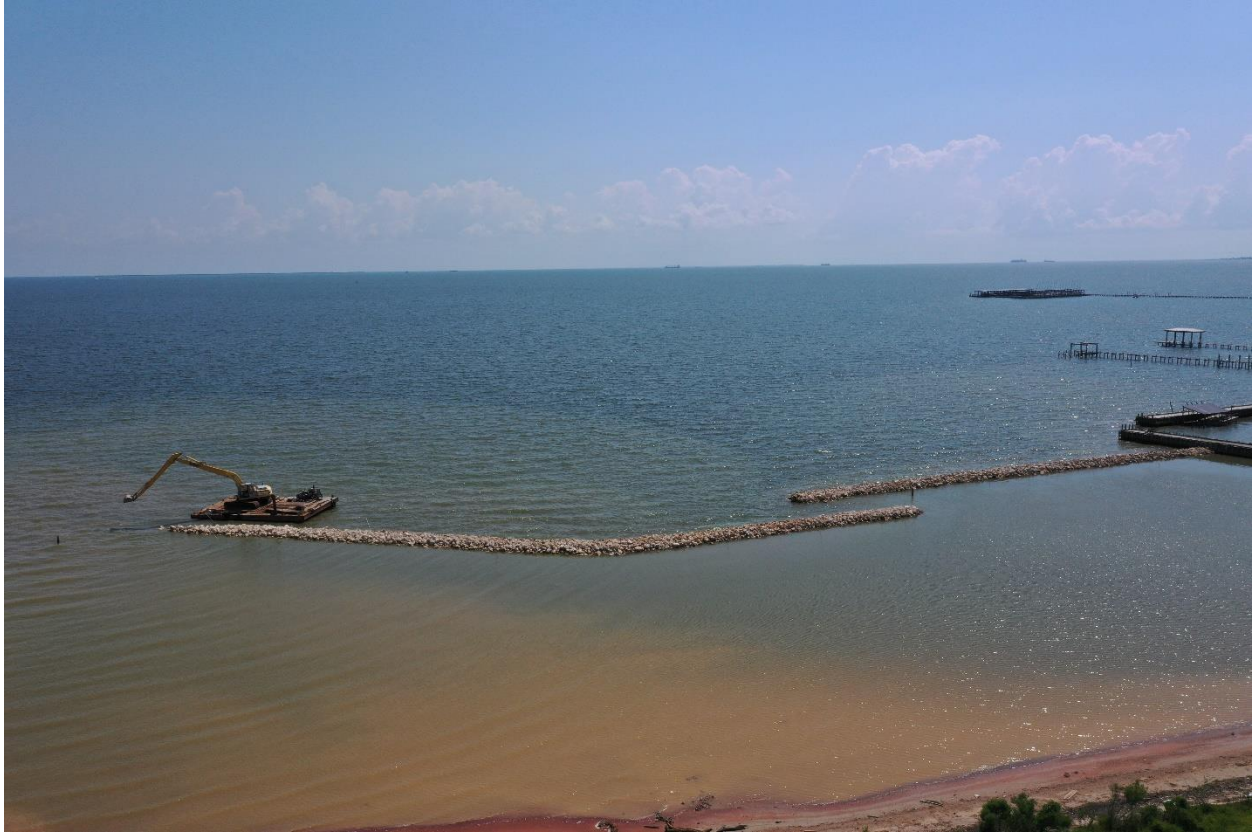
Figure 5: Breakwater at approximately 50% completion

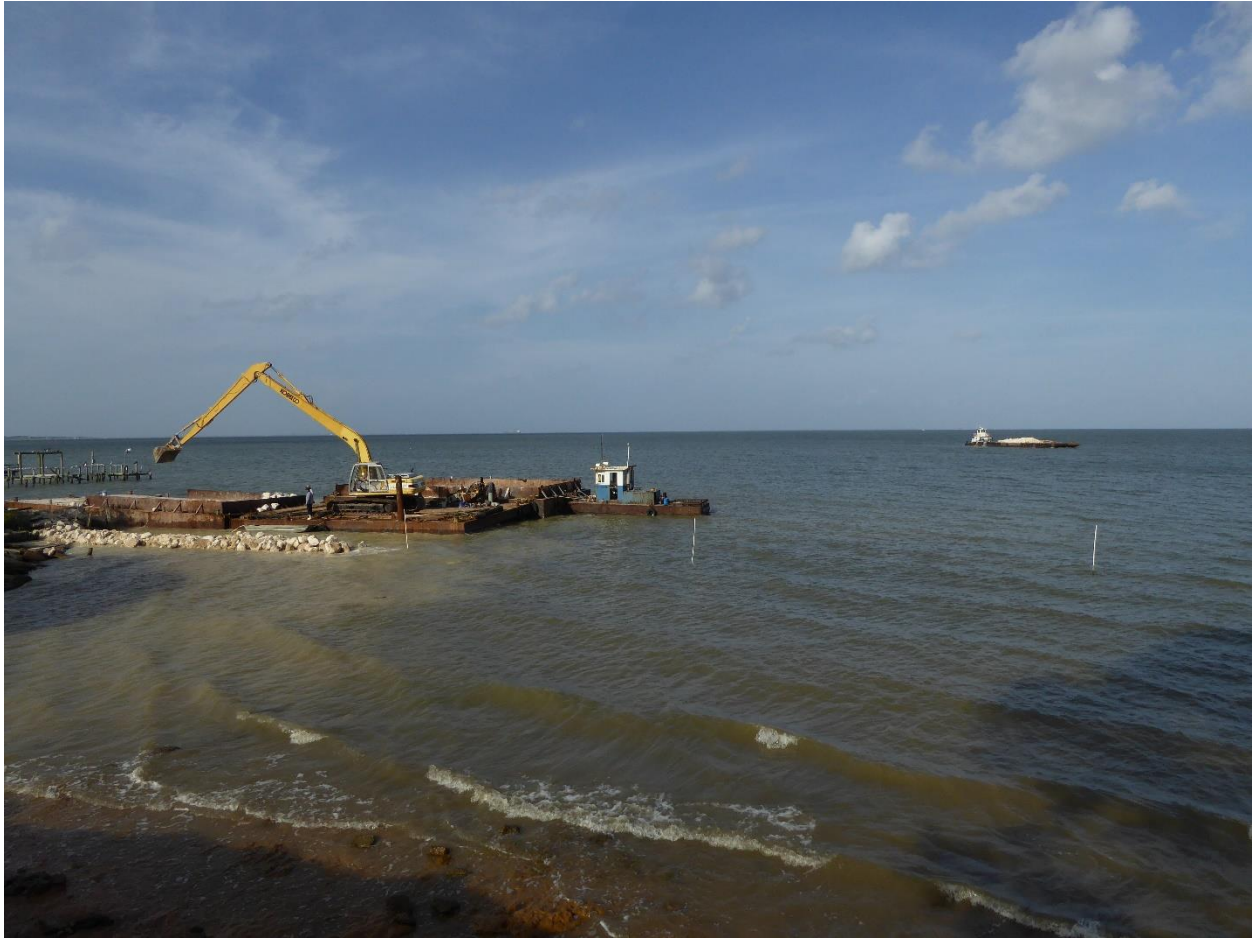
Figure 6: Construction along northern property line. Background: Barge bringing additional rip-rap

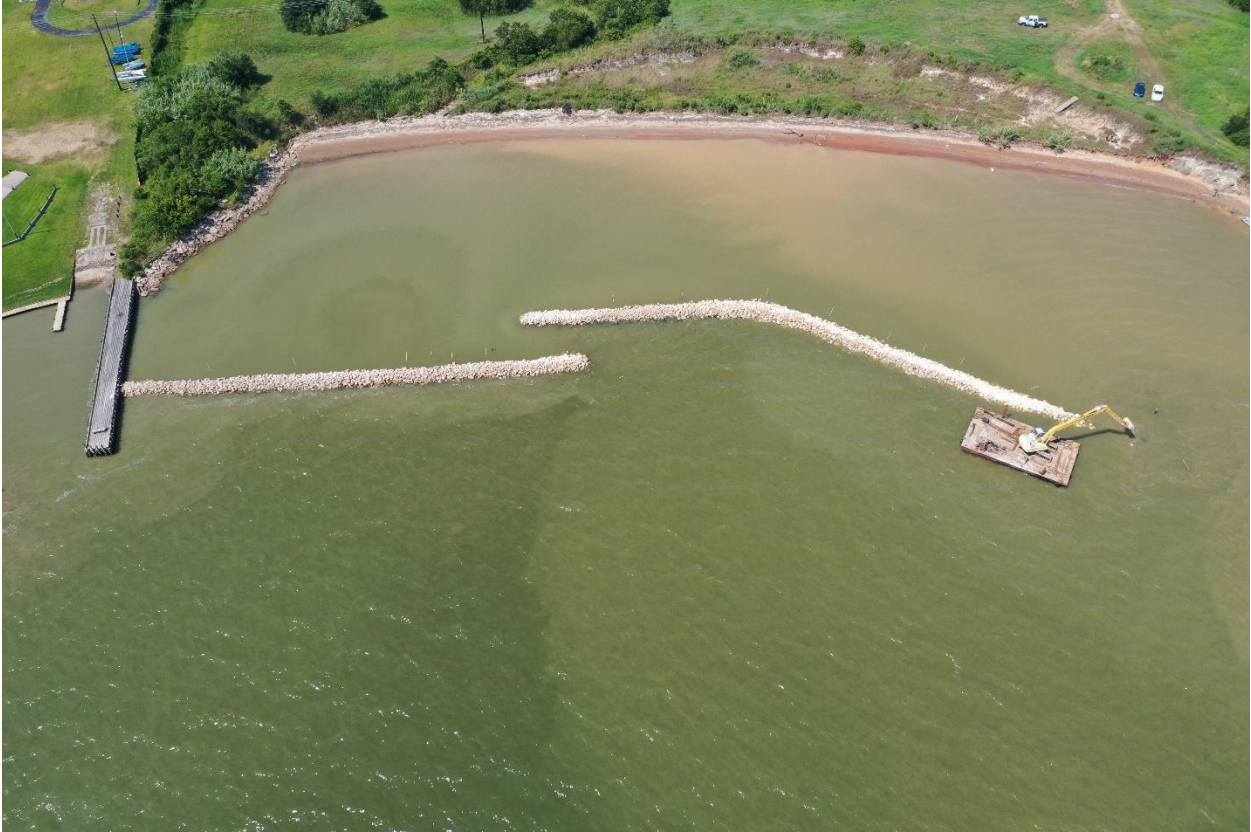
Figure 7: Aerial view after concrete debris has been removed

additional to the construction of the breakwater, derelict pier, bulkhead, and concrete rubble debris was cleaned up from the project site.

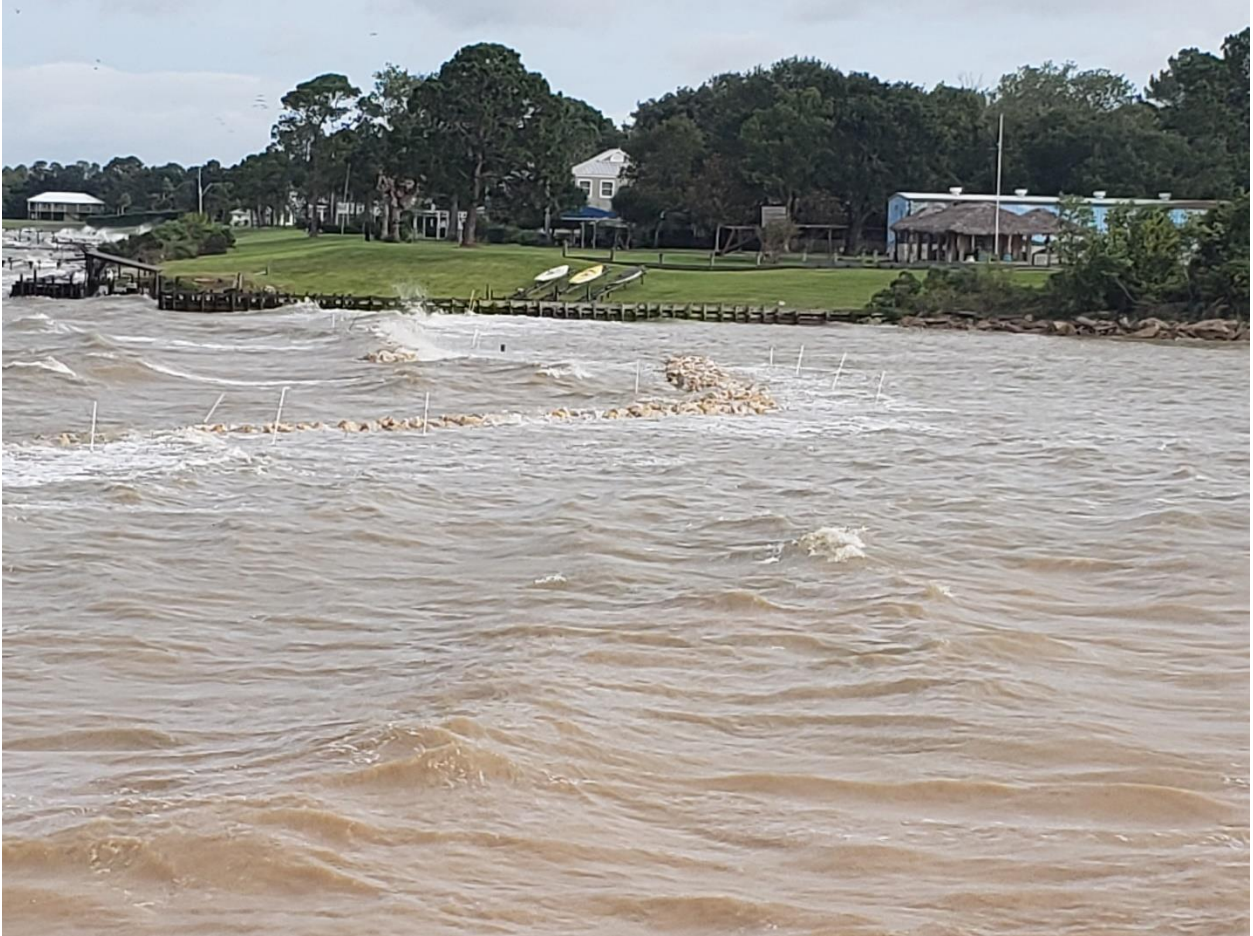
Figure 8: Breakwater performance during Hurricane Laura (western LA landfall)

The engineering and design consultant's conceptual design analysis recommended that the breakwater crest elevation be +2.2 NAVD88 for typical conditions to be effective in reducing wave energies and slowing erosion. Due to GBF staff seeing the trend of higher tides within Galveston Bay and the large fetch at the project site, GBF decided to construct the breakwater to a minimum elevation of +3.0 NAVD88. Initially, it appears that this was a good direction to take. The breakwaters have seen impacts from three tropical systems and multiple cool fronts during and after construction. Anecdotal observations of the structure during these adverse weather conditions have shown positive effects of the increased elevation.

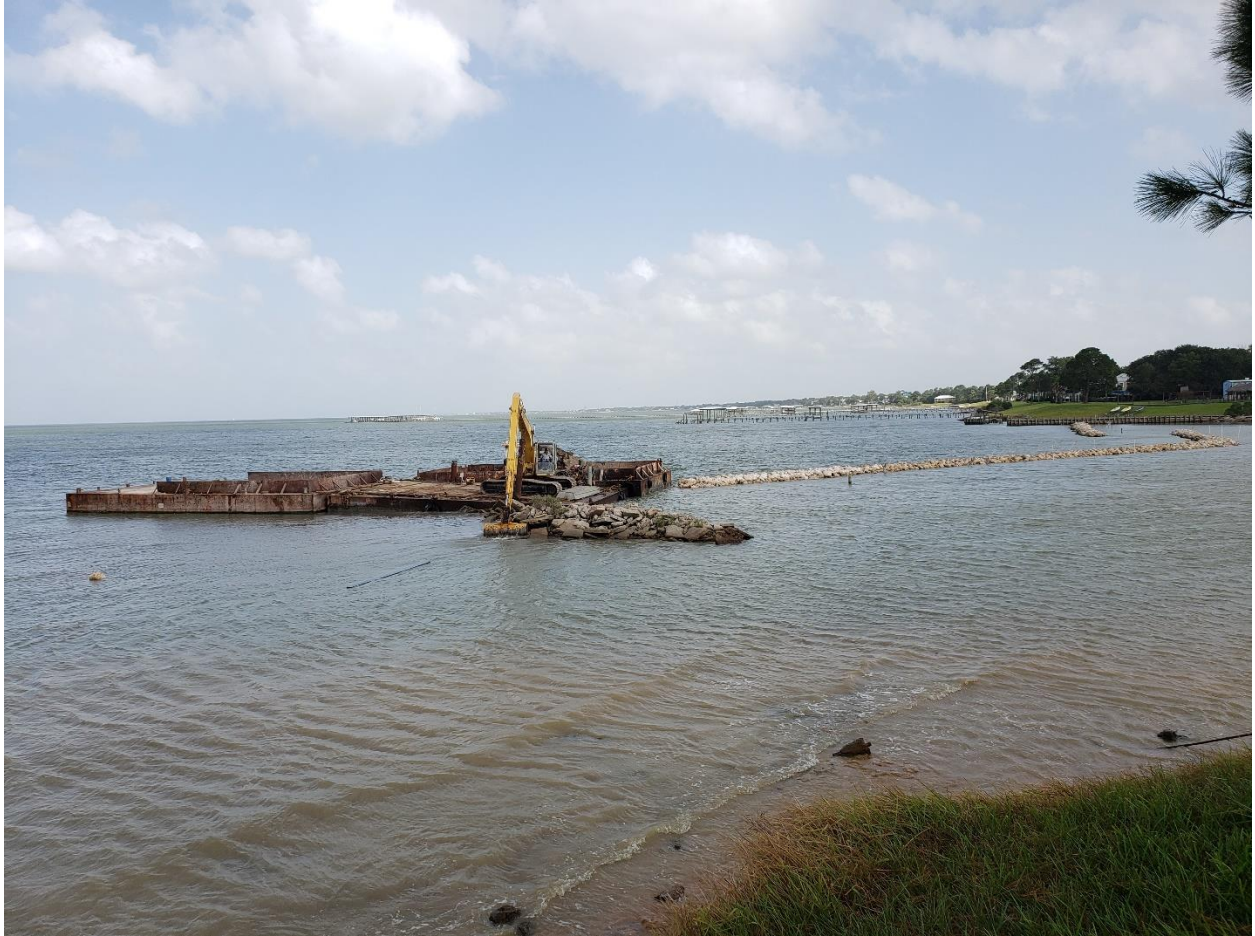
Figure 9: Removal of large concrete debris pile

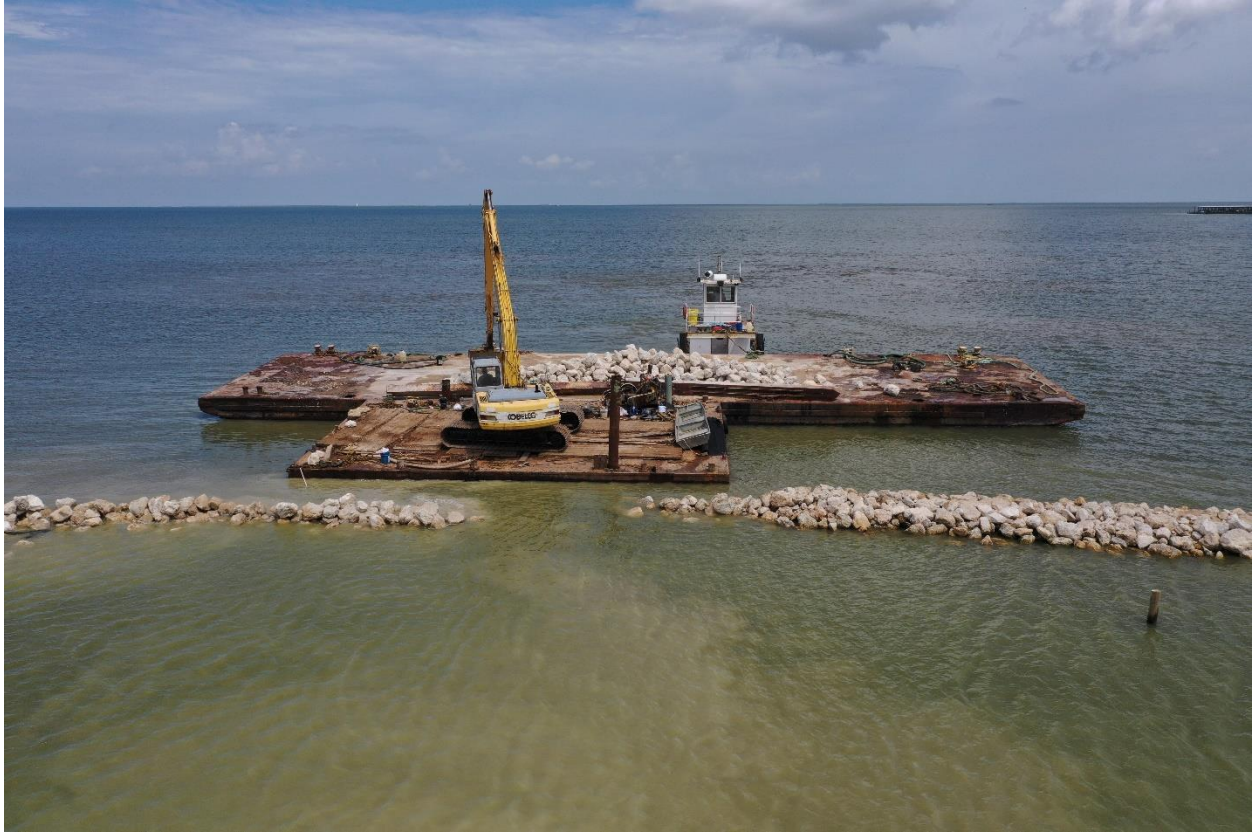
Figure 10: Final stretch of construction

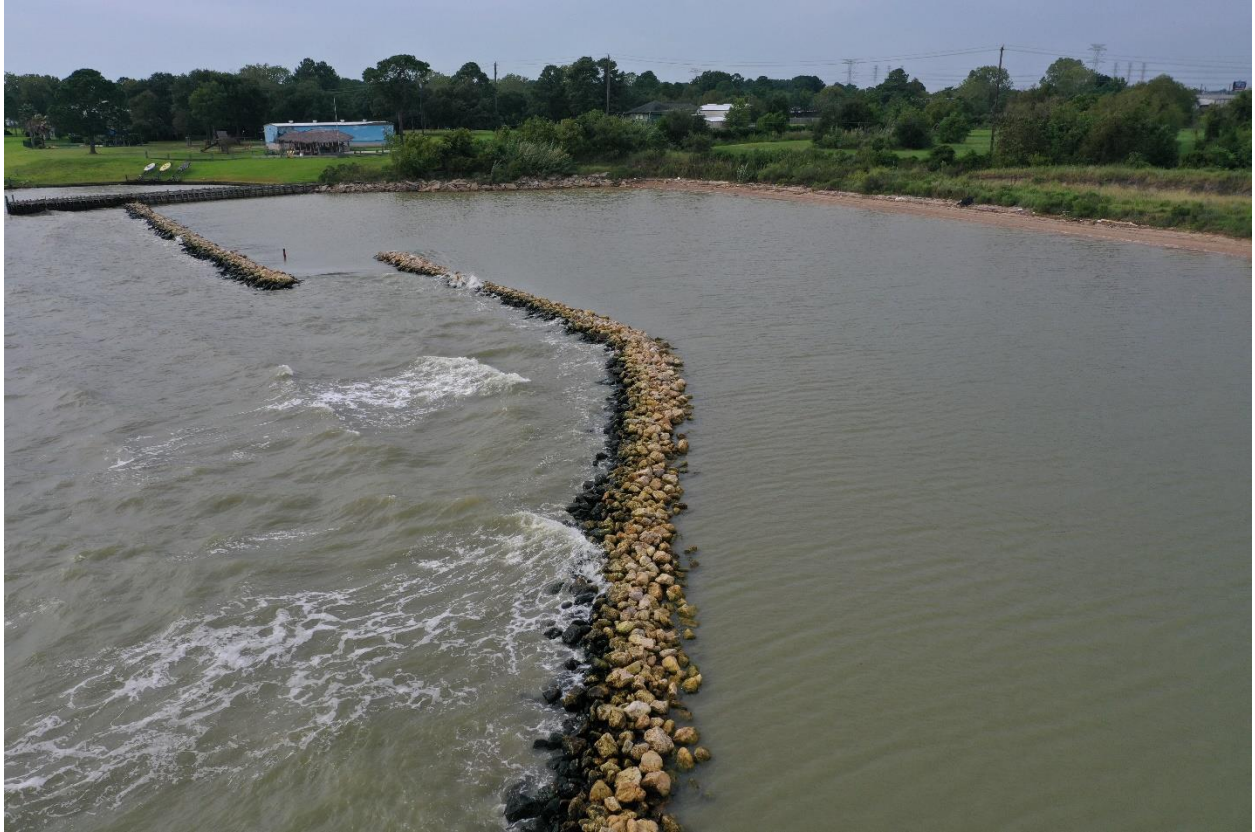
Figure 11: Rough water bayward of breakwater and calm water shoreward of breakwater.

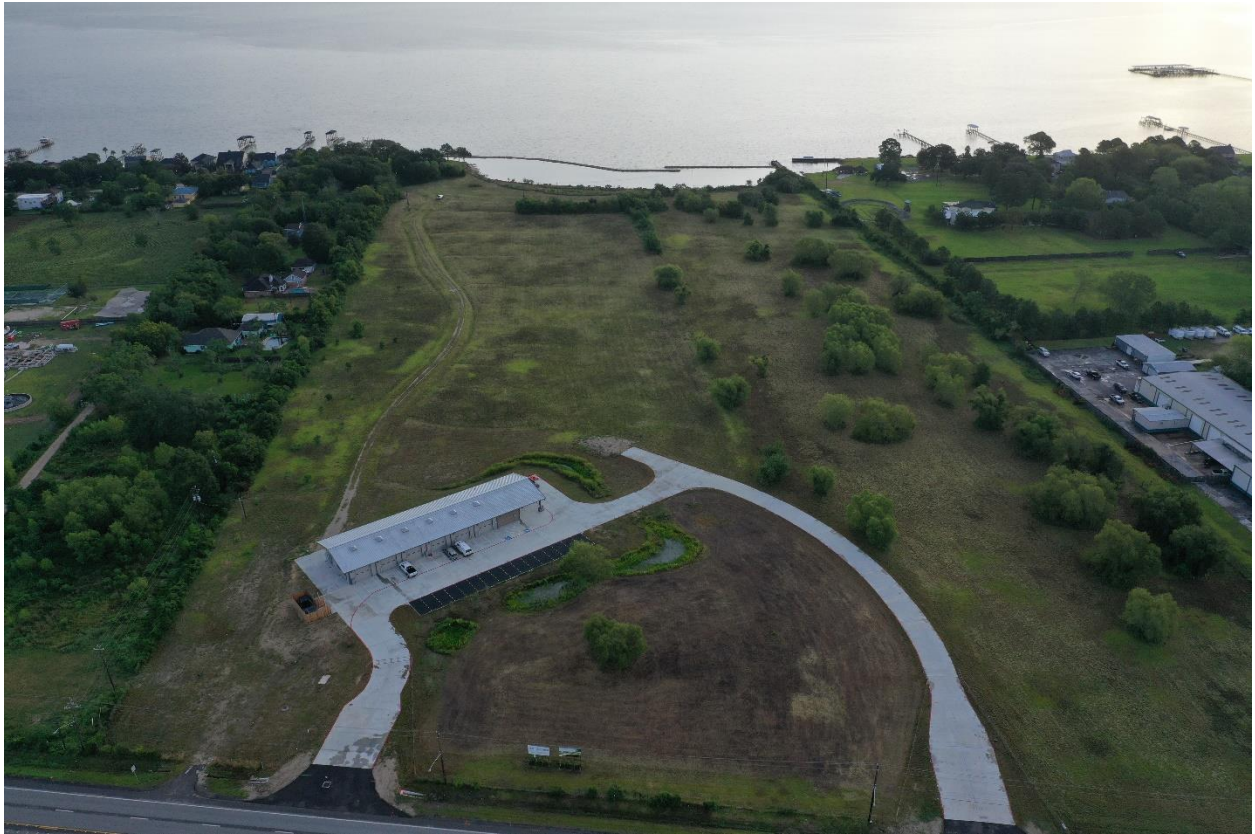
Figure 12: View of completed structure and GBF headquarters property

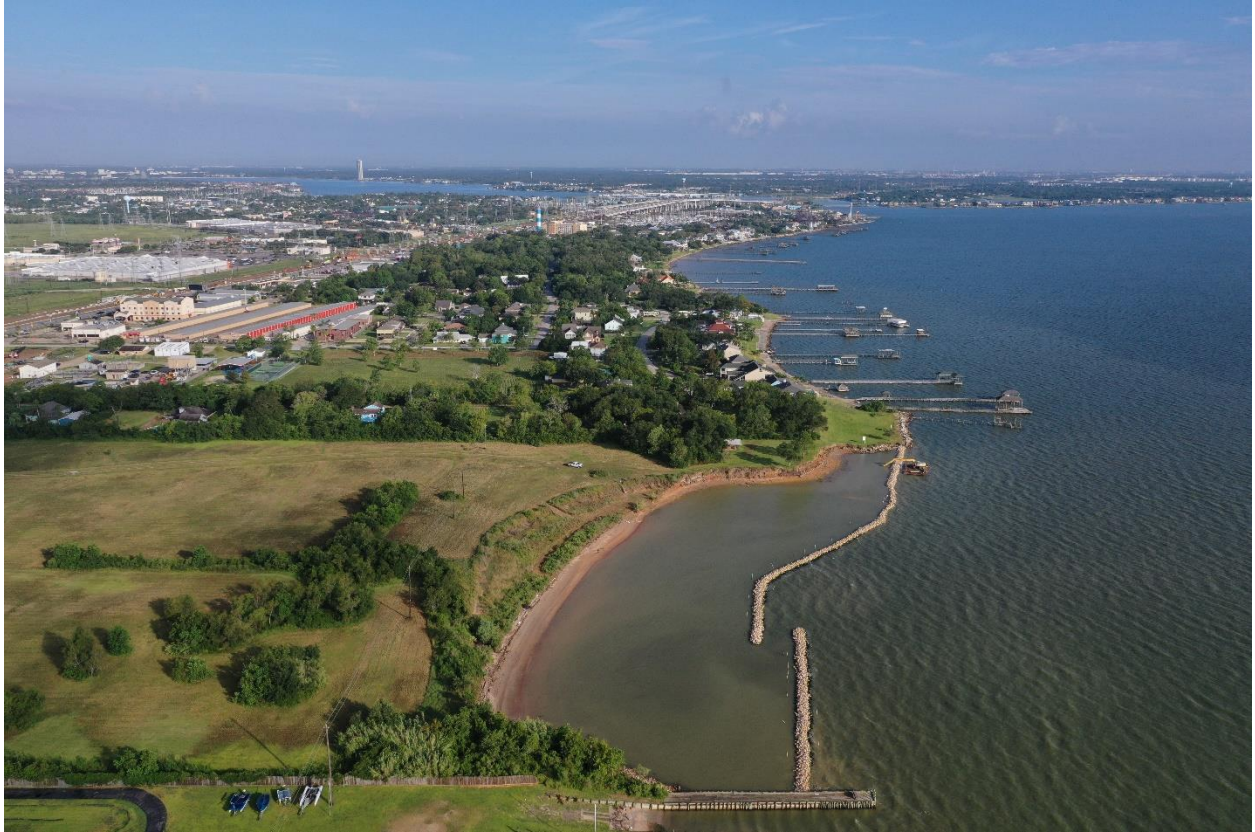
Figure 13: View looking toward City of Kemah

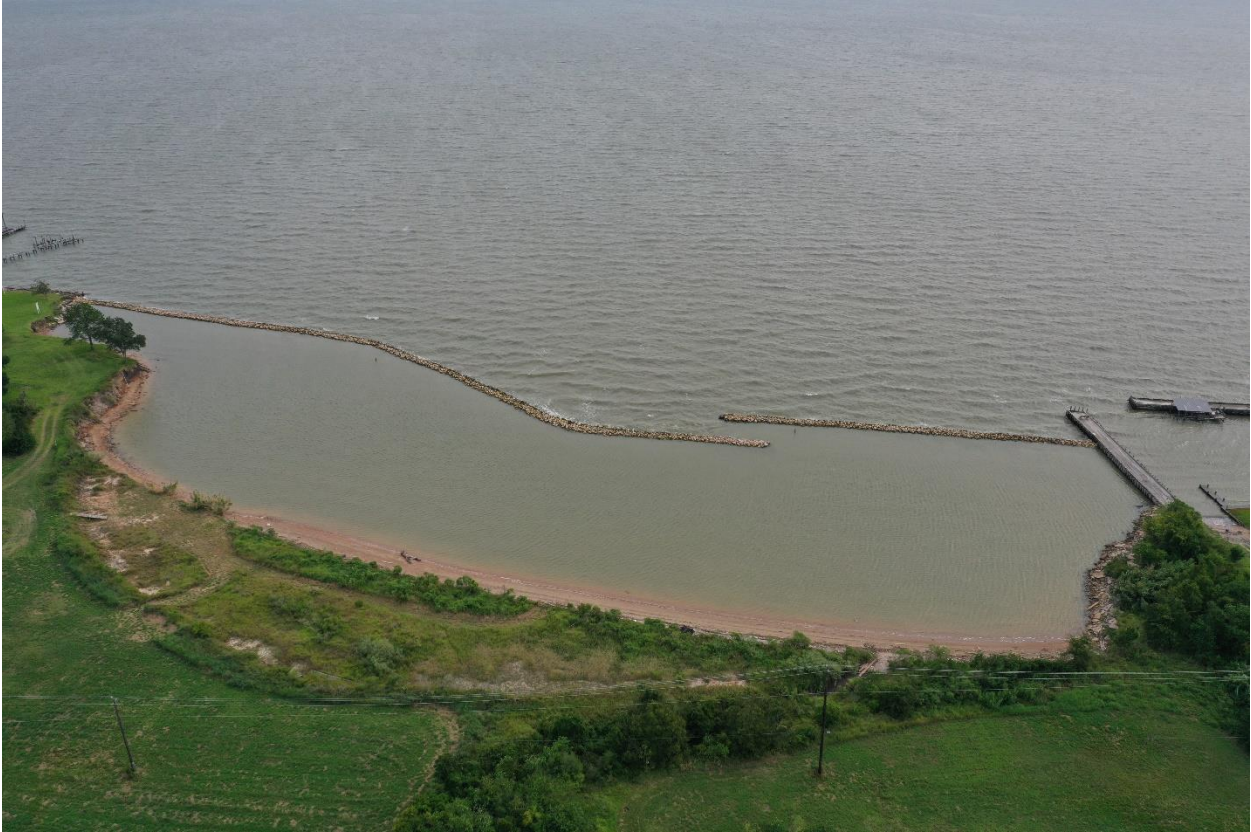
Figure 14: Fully completed breakwater

The project resulted in the construction of 905* linear foot of breakwater structures being constructed to a minimal elevation of +3.0 NAVD88. The final breakwater layout has resulted in 2.8 acres available for intertidal wetland complex to be restored. In
