High Island Rookery Expansion and Resiliency Project Update

Wulfert Bayous Bird Nesting Habitat Design

State of the Bay Symposium (Galveston TX)

J.N. "Ding" Darling National Wildlife Refuge

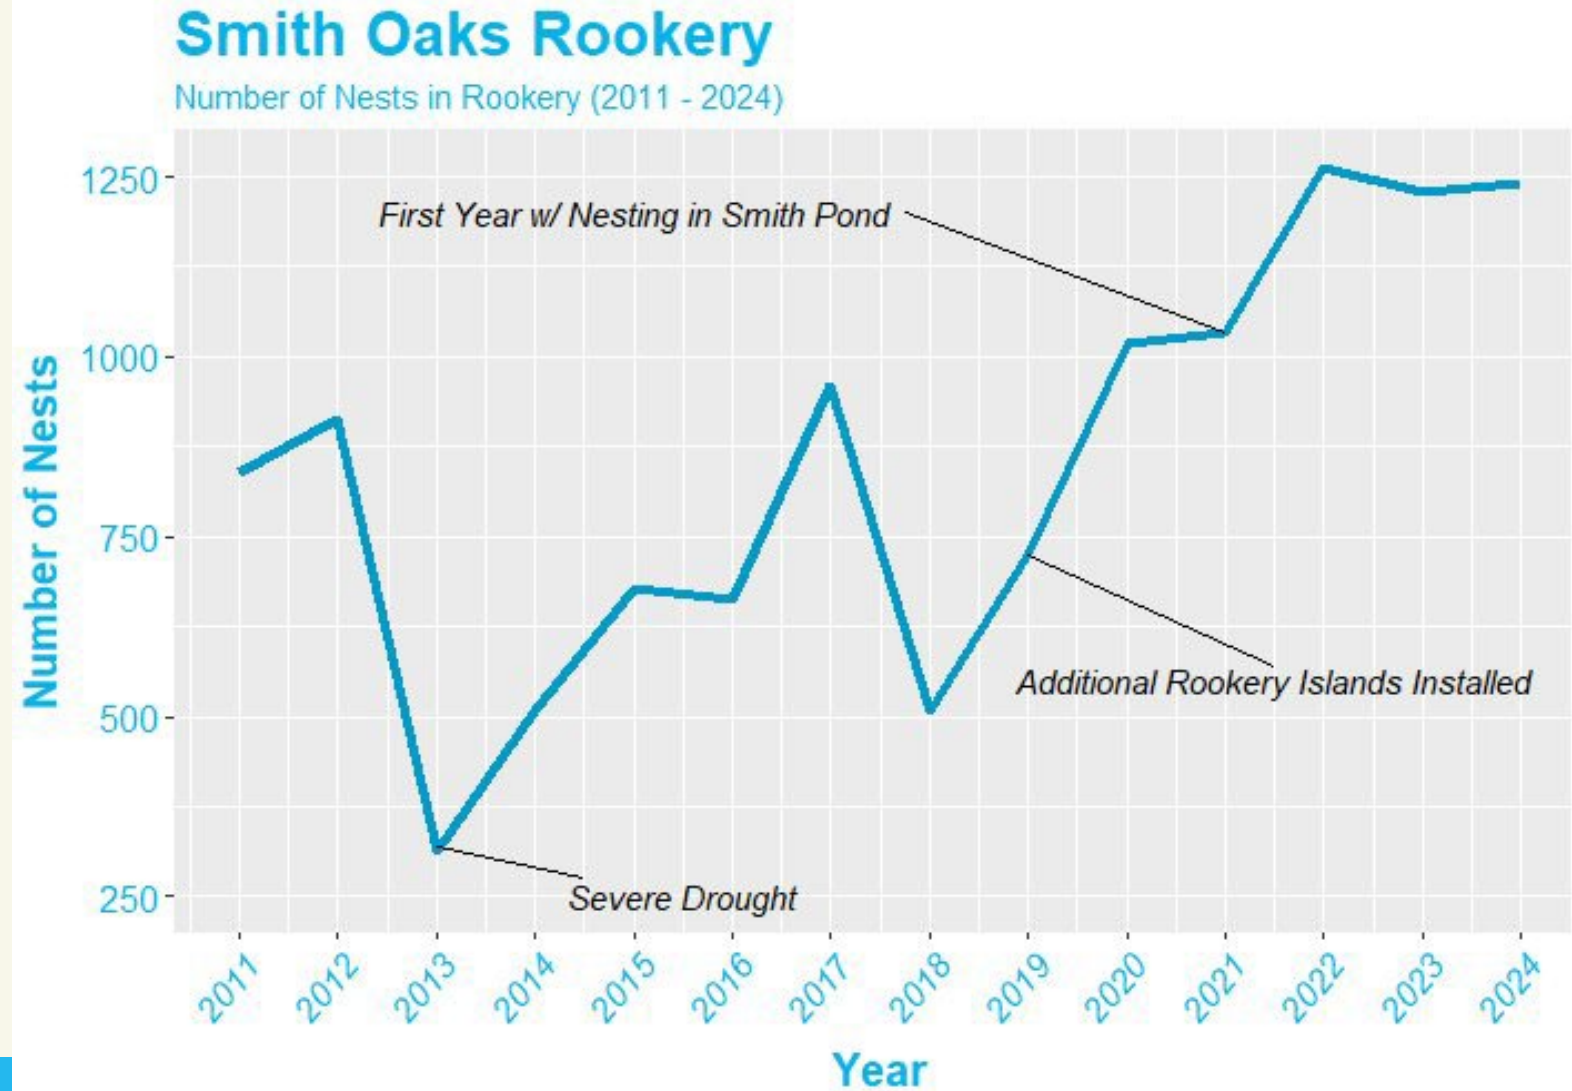
Habitat Expansion and Resiliency with DU

- General upward trend of bird nests between 2012 and 2022.
- Disruptions from Drought, Hurricanes
- Temporal Lag

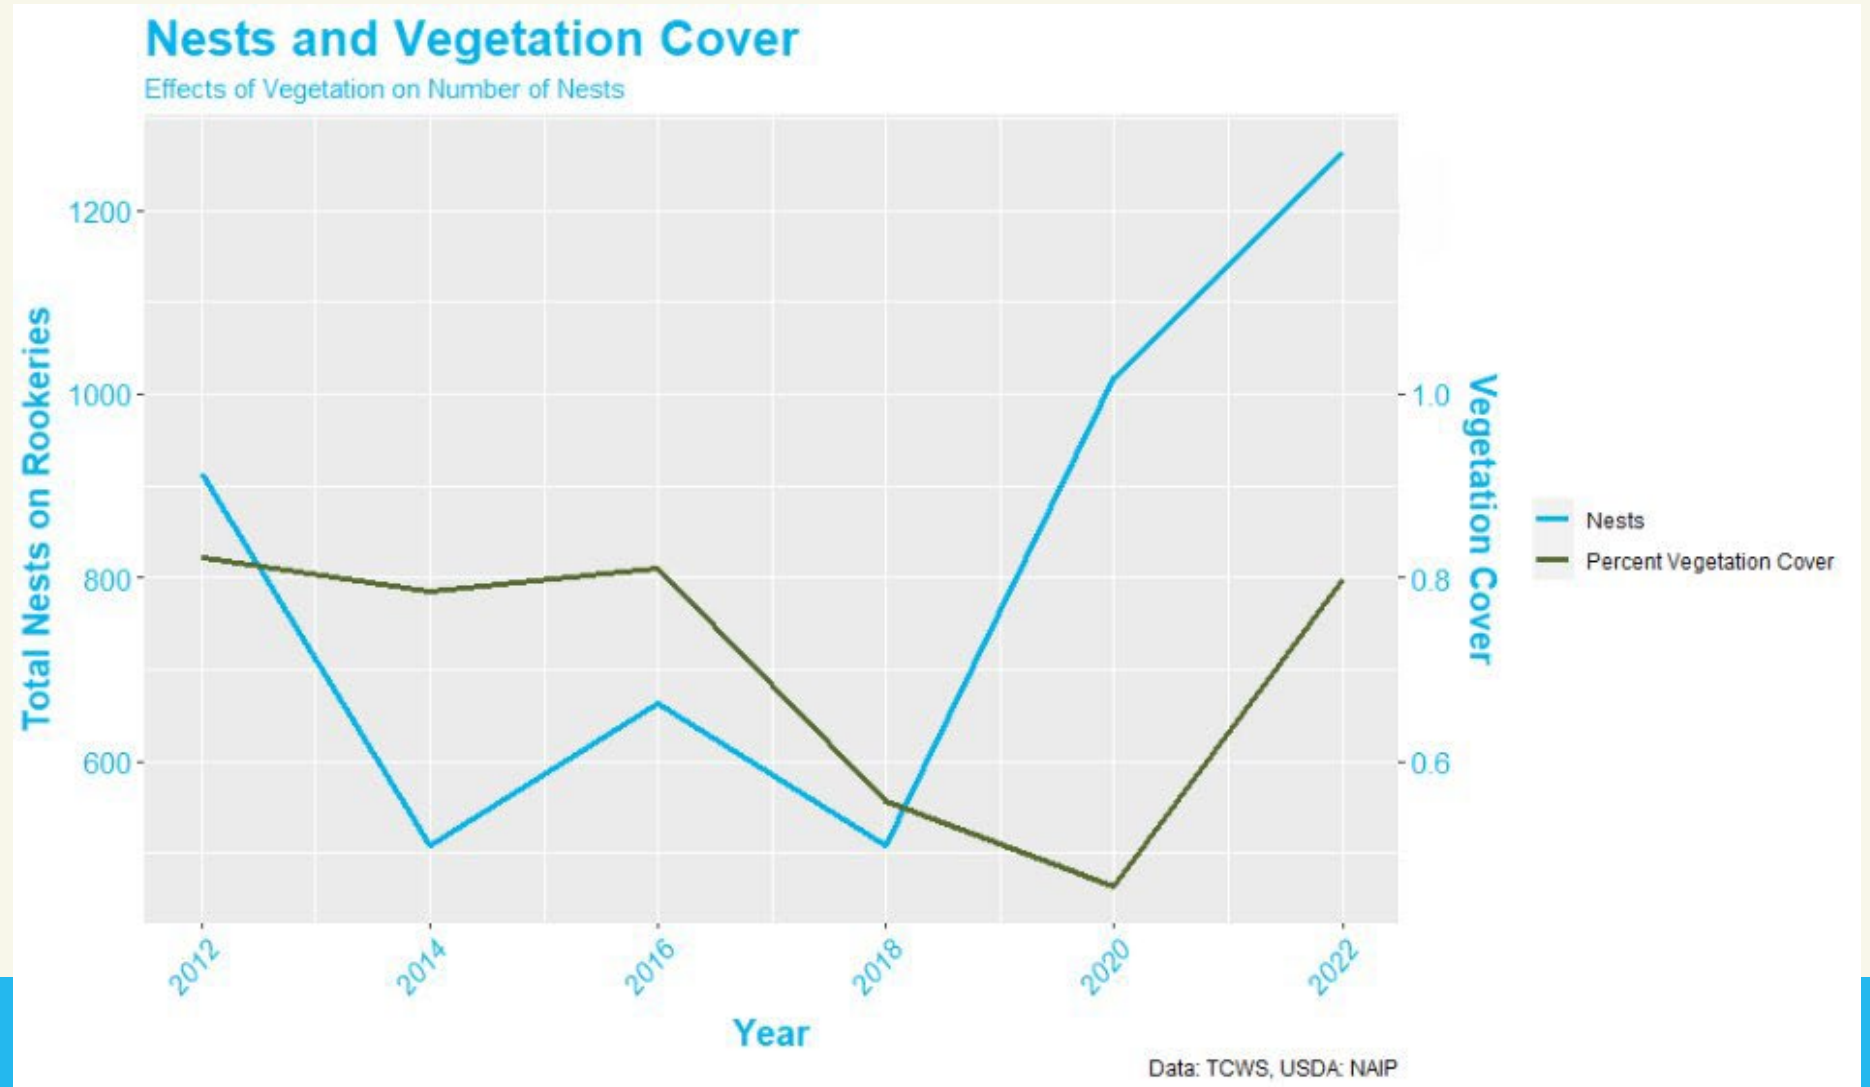
Habitat Expansion and Resiliency with DU

- When vegetation drops, bird nests drop as well.

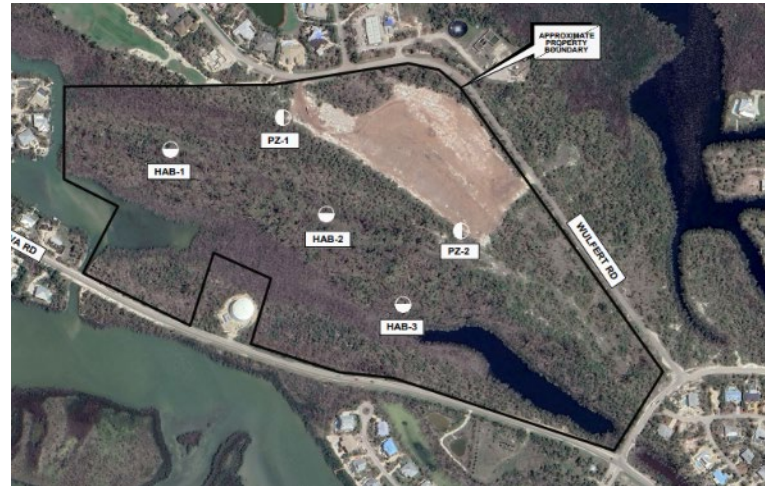
Subsurface Exploration

- Two 2-inch diameter piezometers, each screened at ~5 to 15 feet below ground surface.
- Outfitted to support long-term monitoring of the water table.
- Five auger borings to 5 to 15 feet below the existing ground surface.
- Soil samples were visually classified in the field and representative portions of the samples were sent to a lab.
- Groundwater levels measured during boring activities ranged from 2-1/2 to 4-1/3 feet below existing ground surface.
