Dickinson Bay Island 2 | *Monitoring: 2024 Bird Surveys*

Beneficial Use of Dredge Material for Restoration of Pierce Marsh

Sally Clark; Director of Habitat Restoration

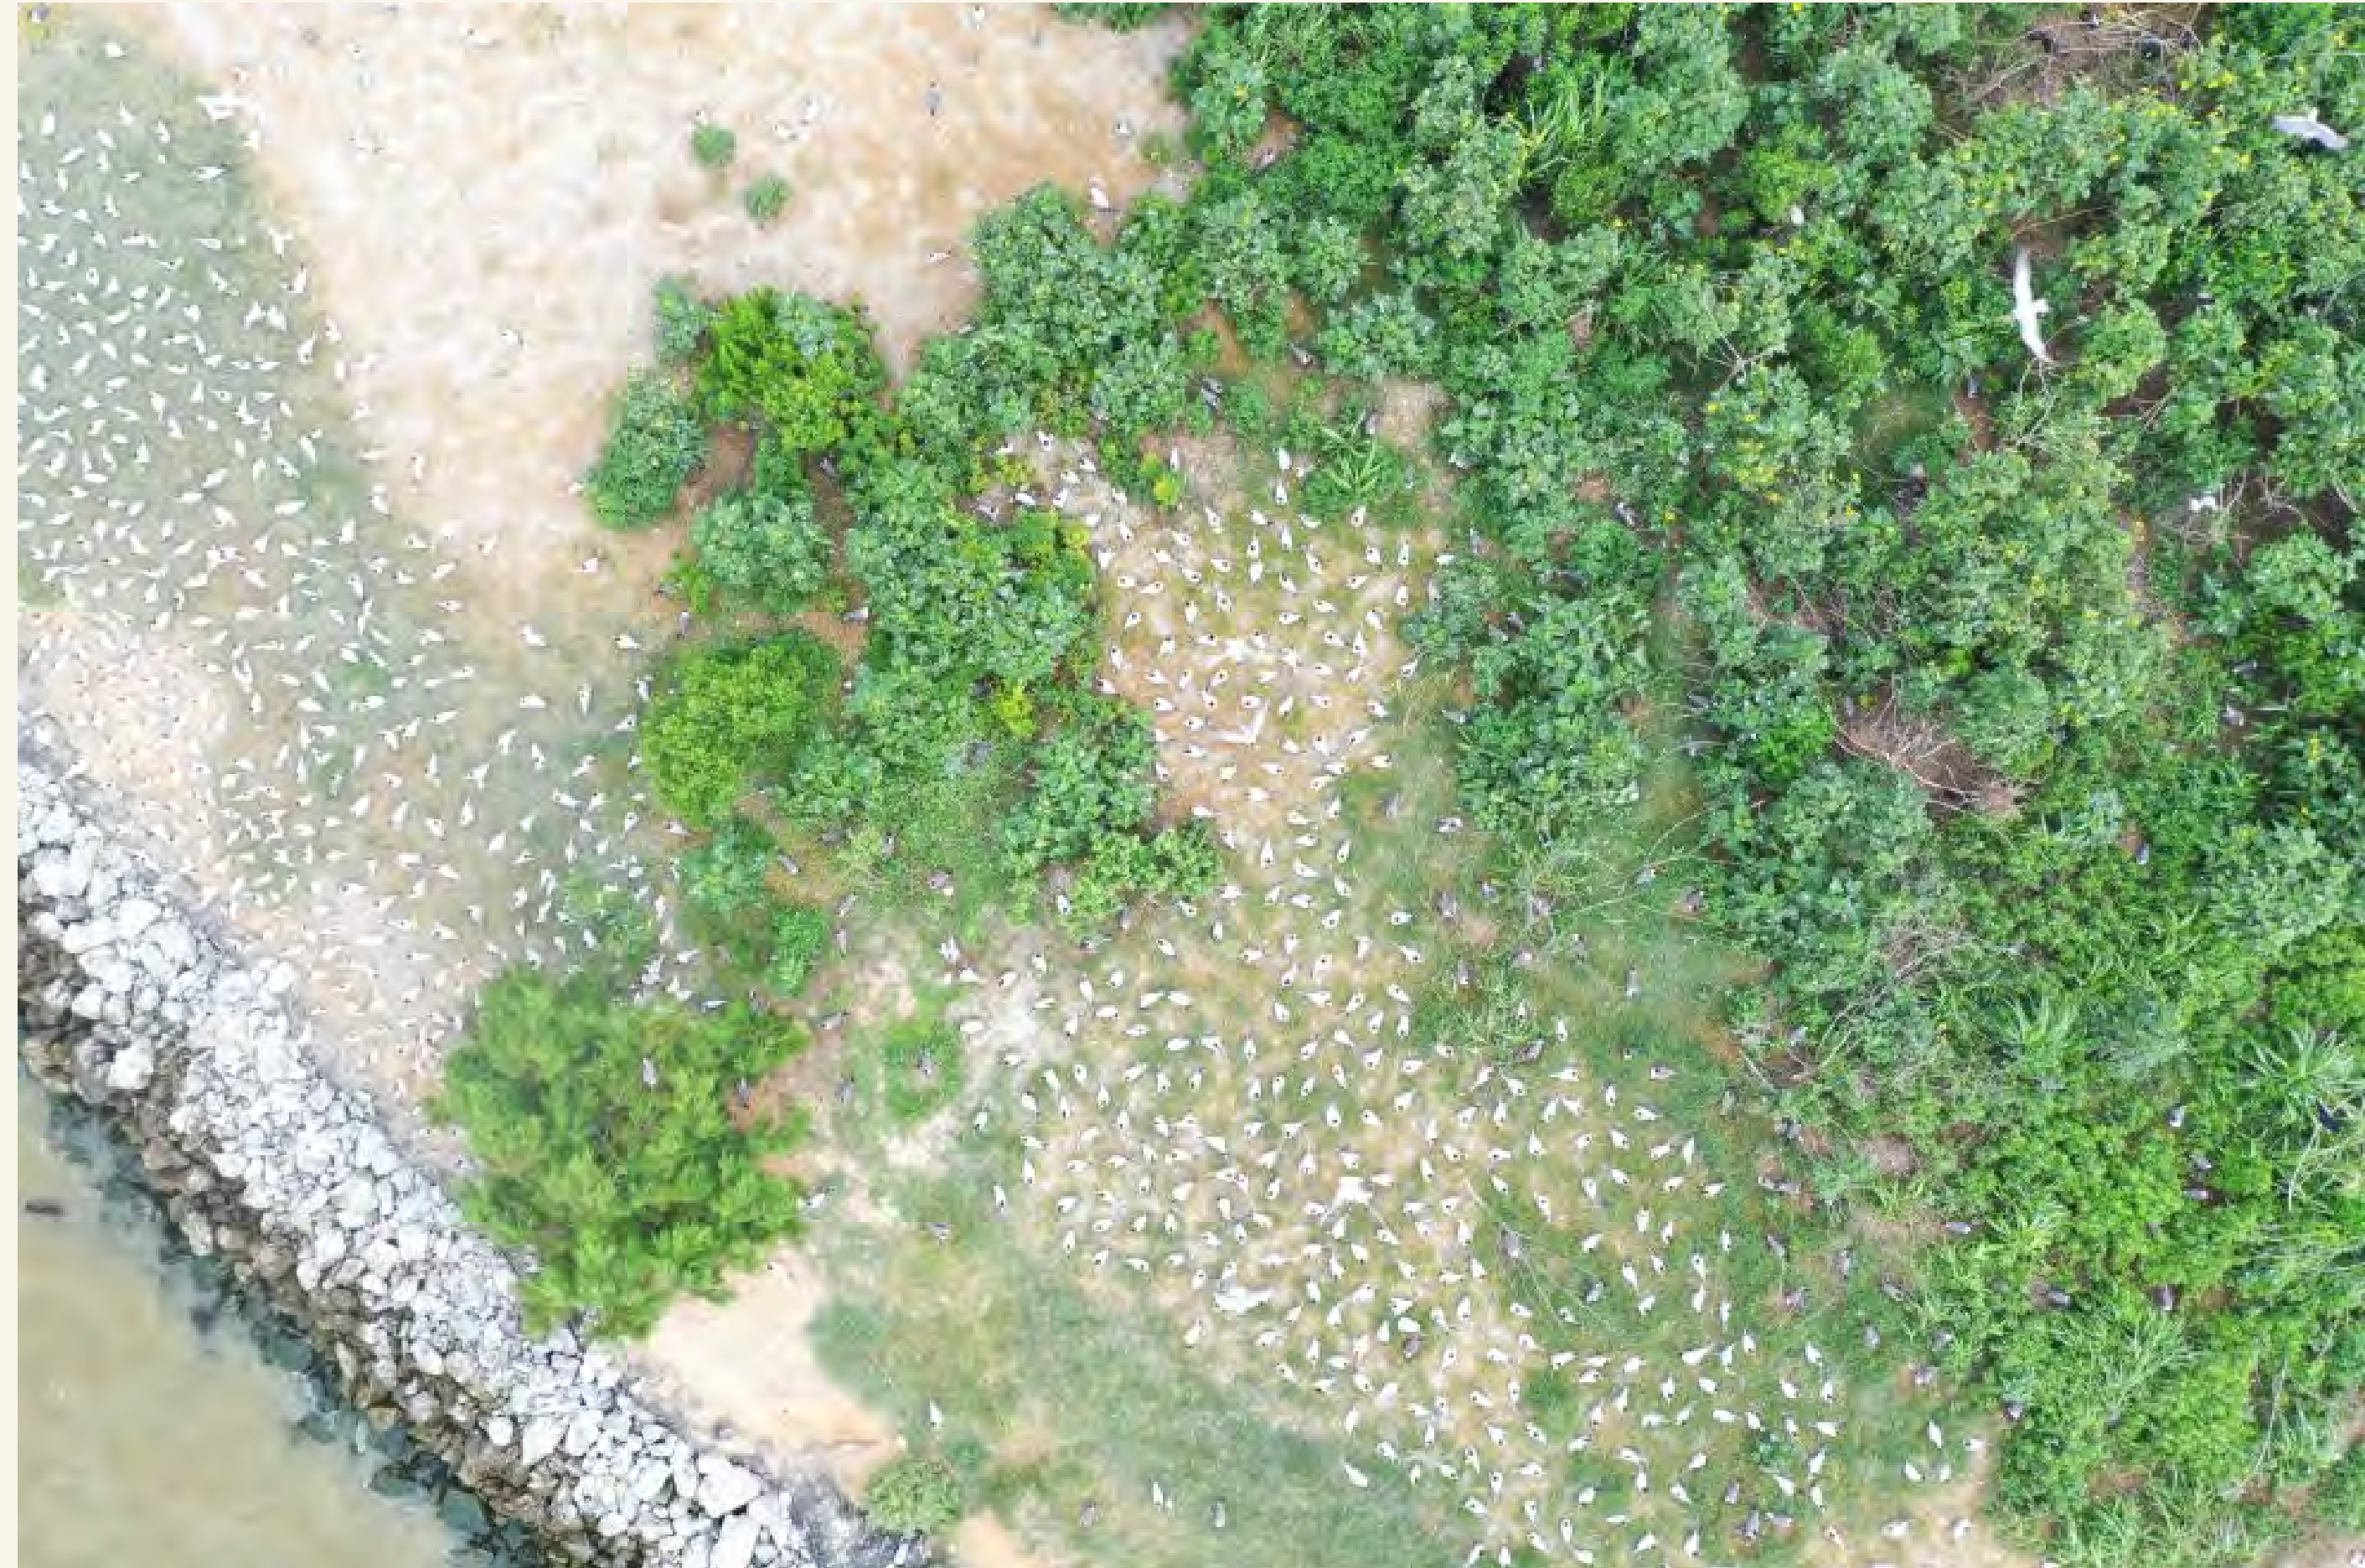
Terns nesting on the edge of the island, May 2024

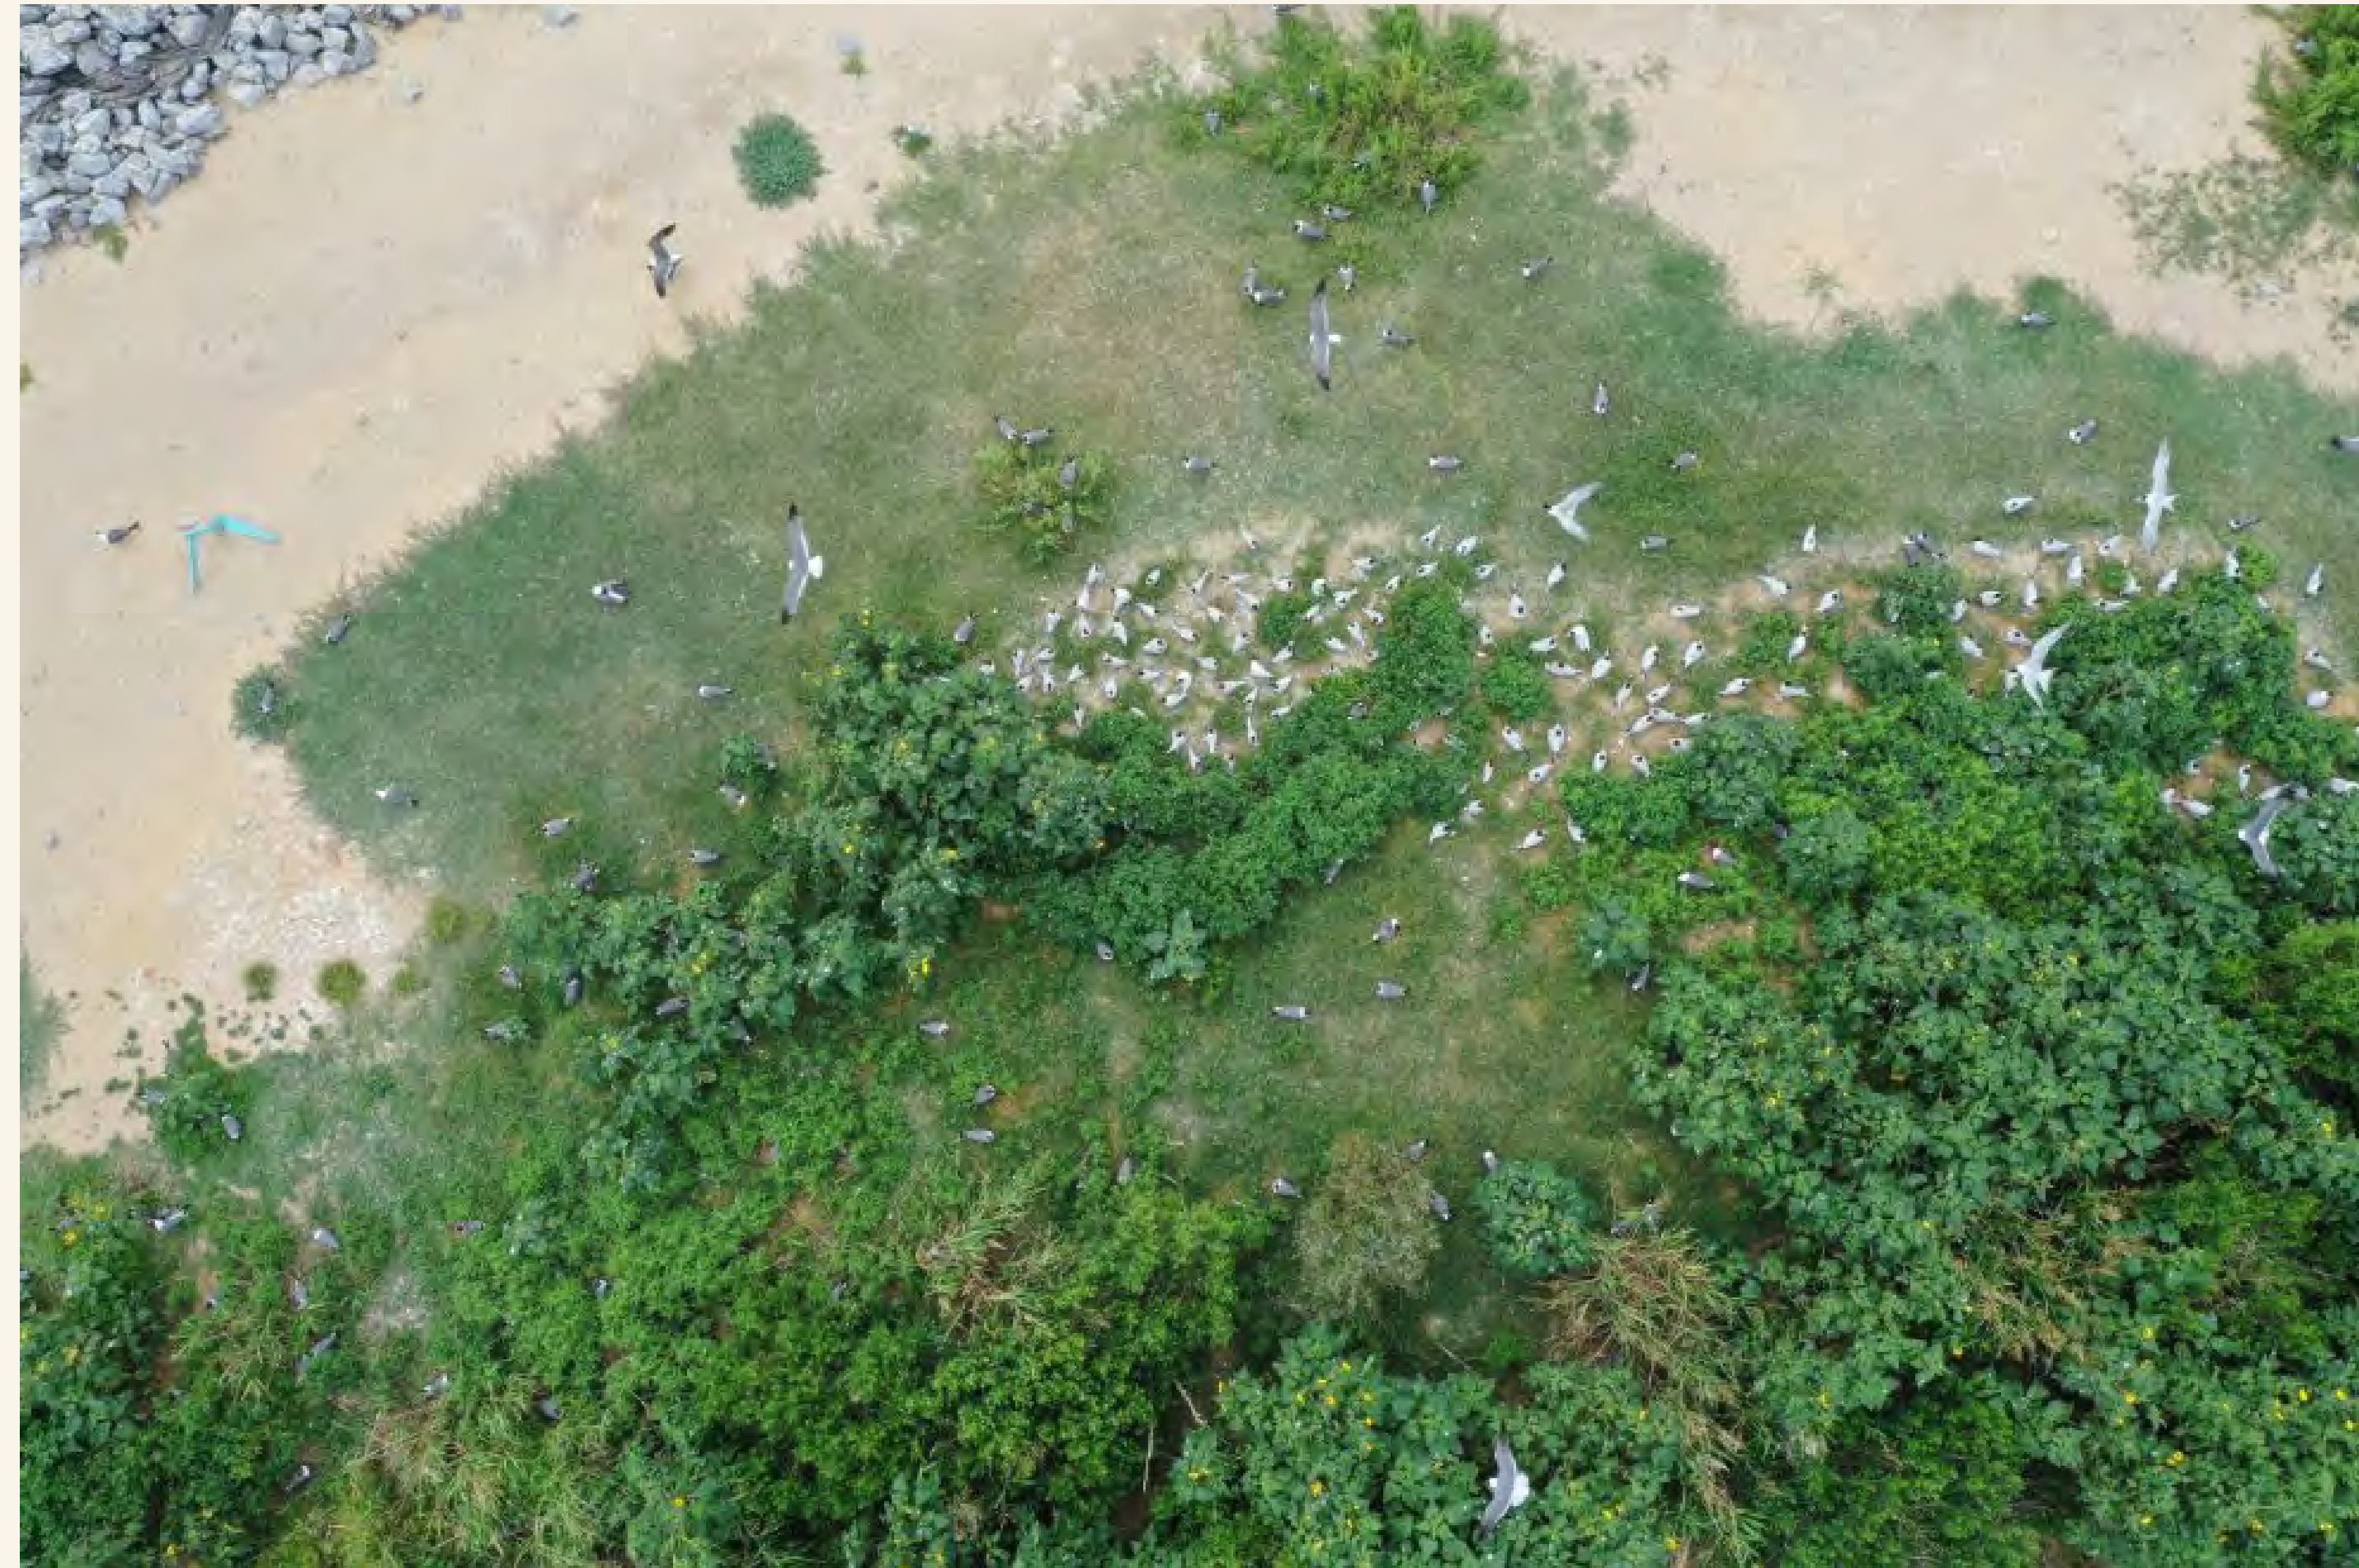
Terns nesting on the edge of the island, May 2025

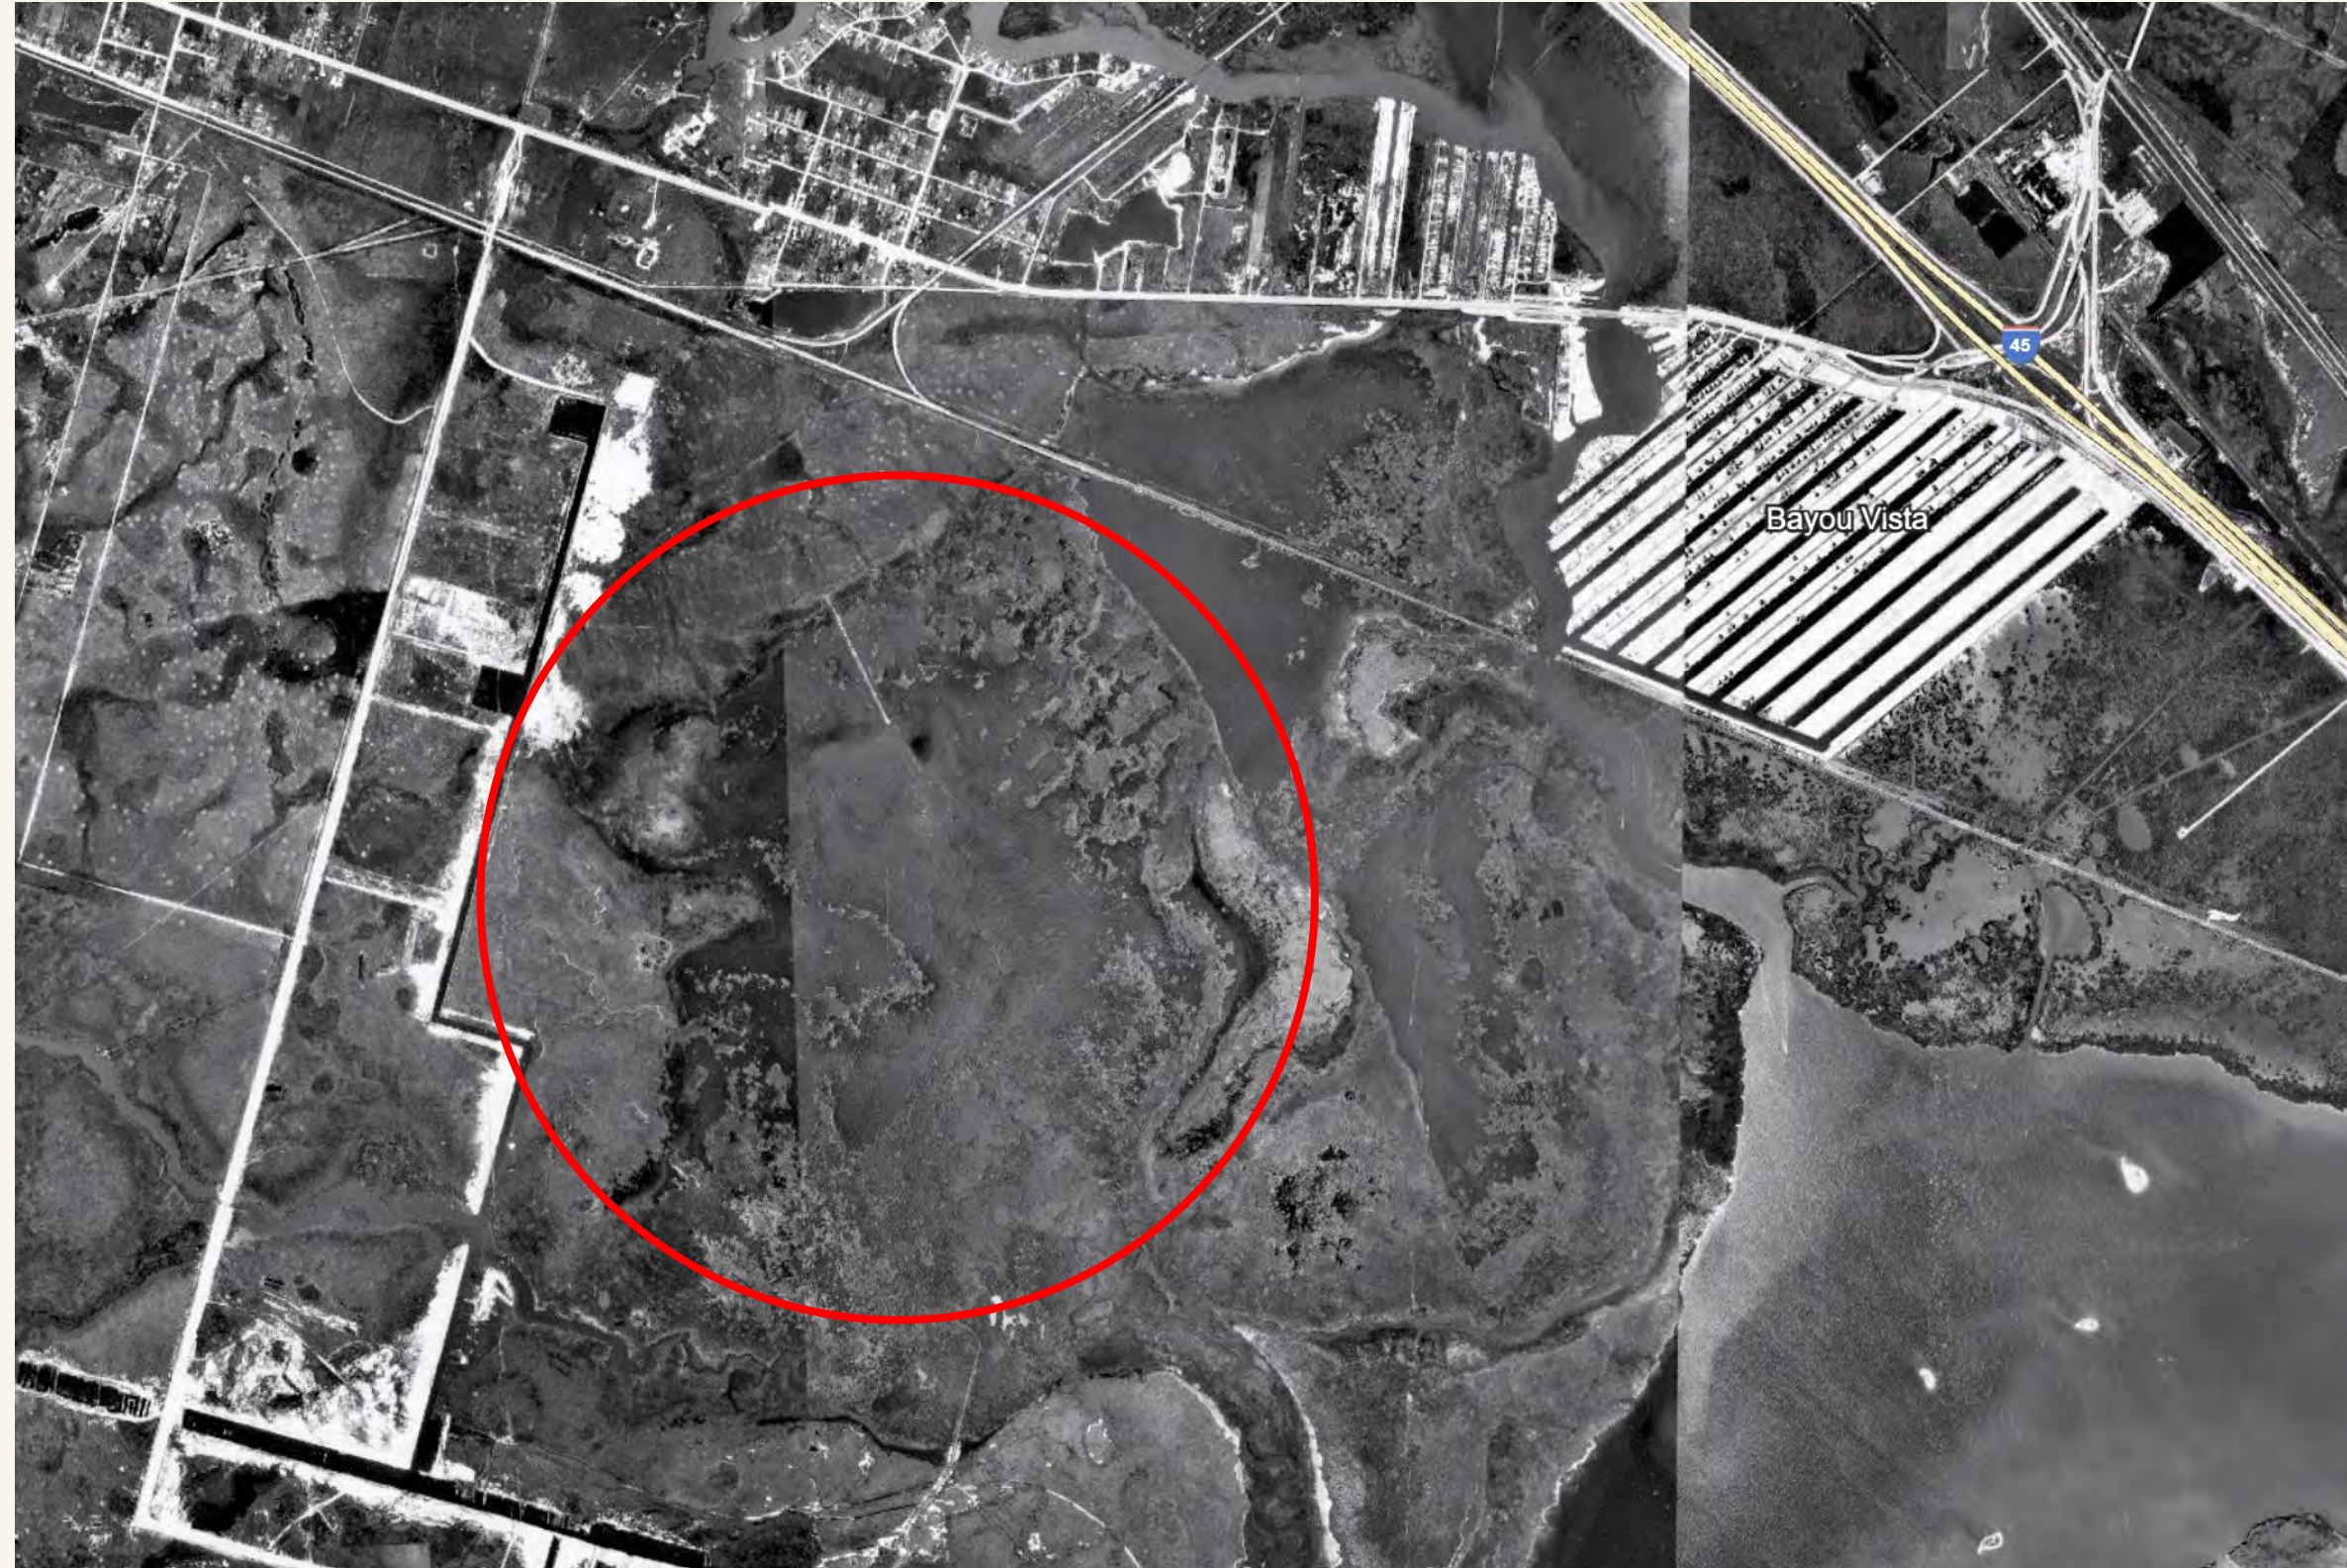
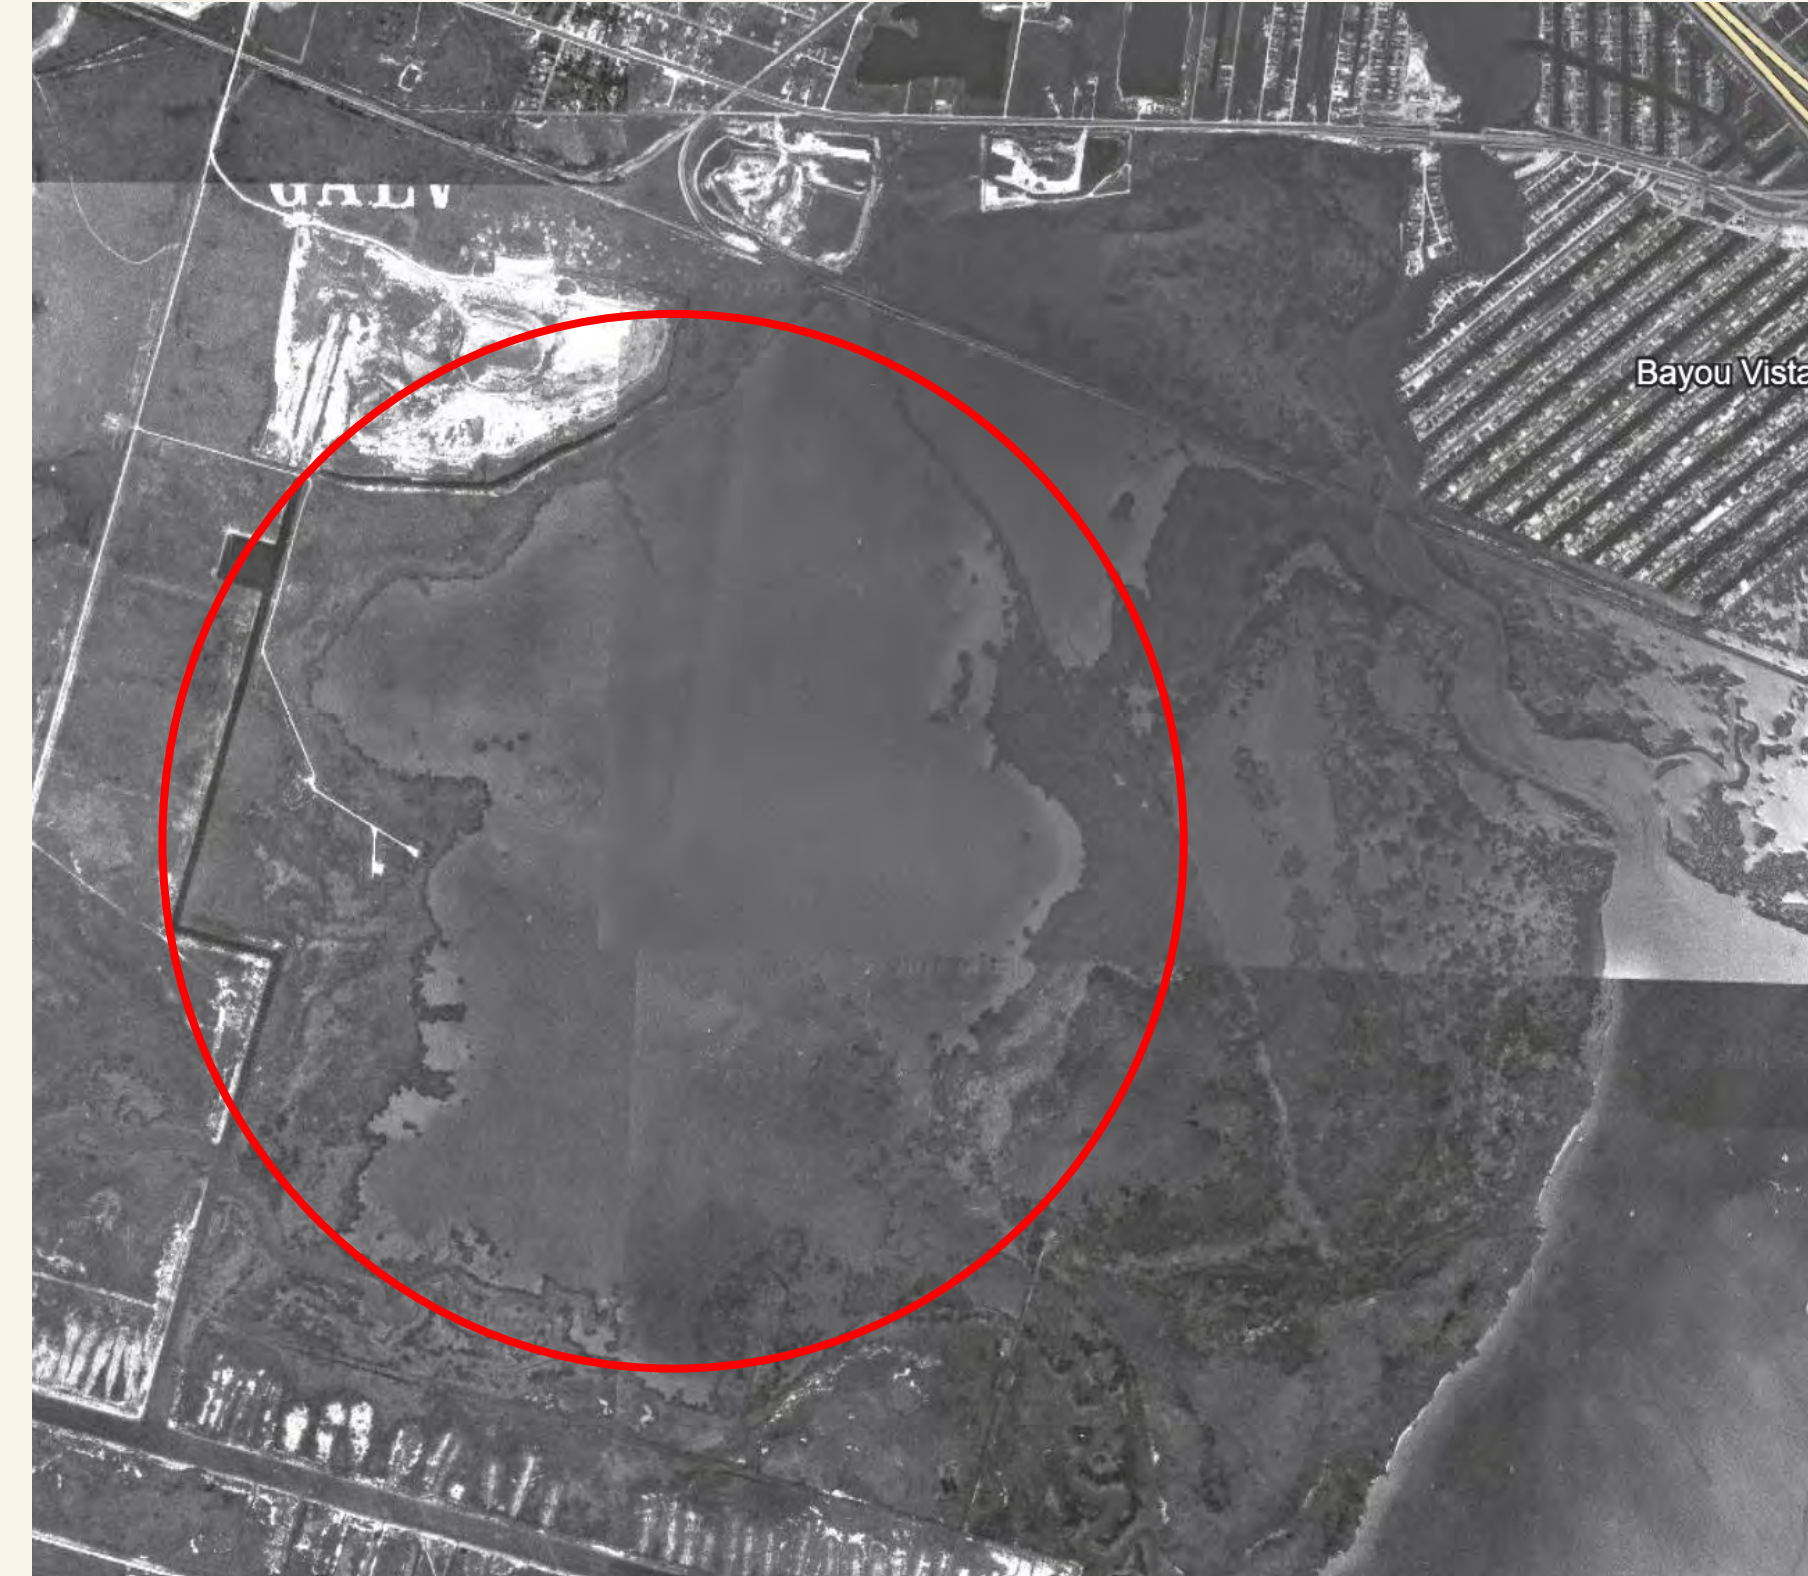
Pierce Marsh – 1967 – 1989

Causes for Pierce Marsh degradation:

- Oil and Gas subsidence
- Hurricanes and erosion
- Sea Level Rise

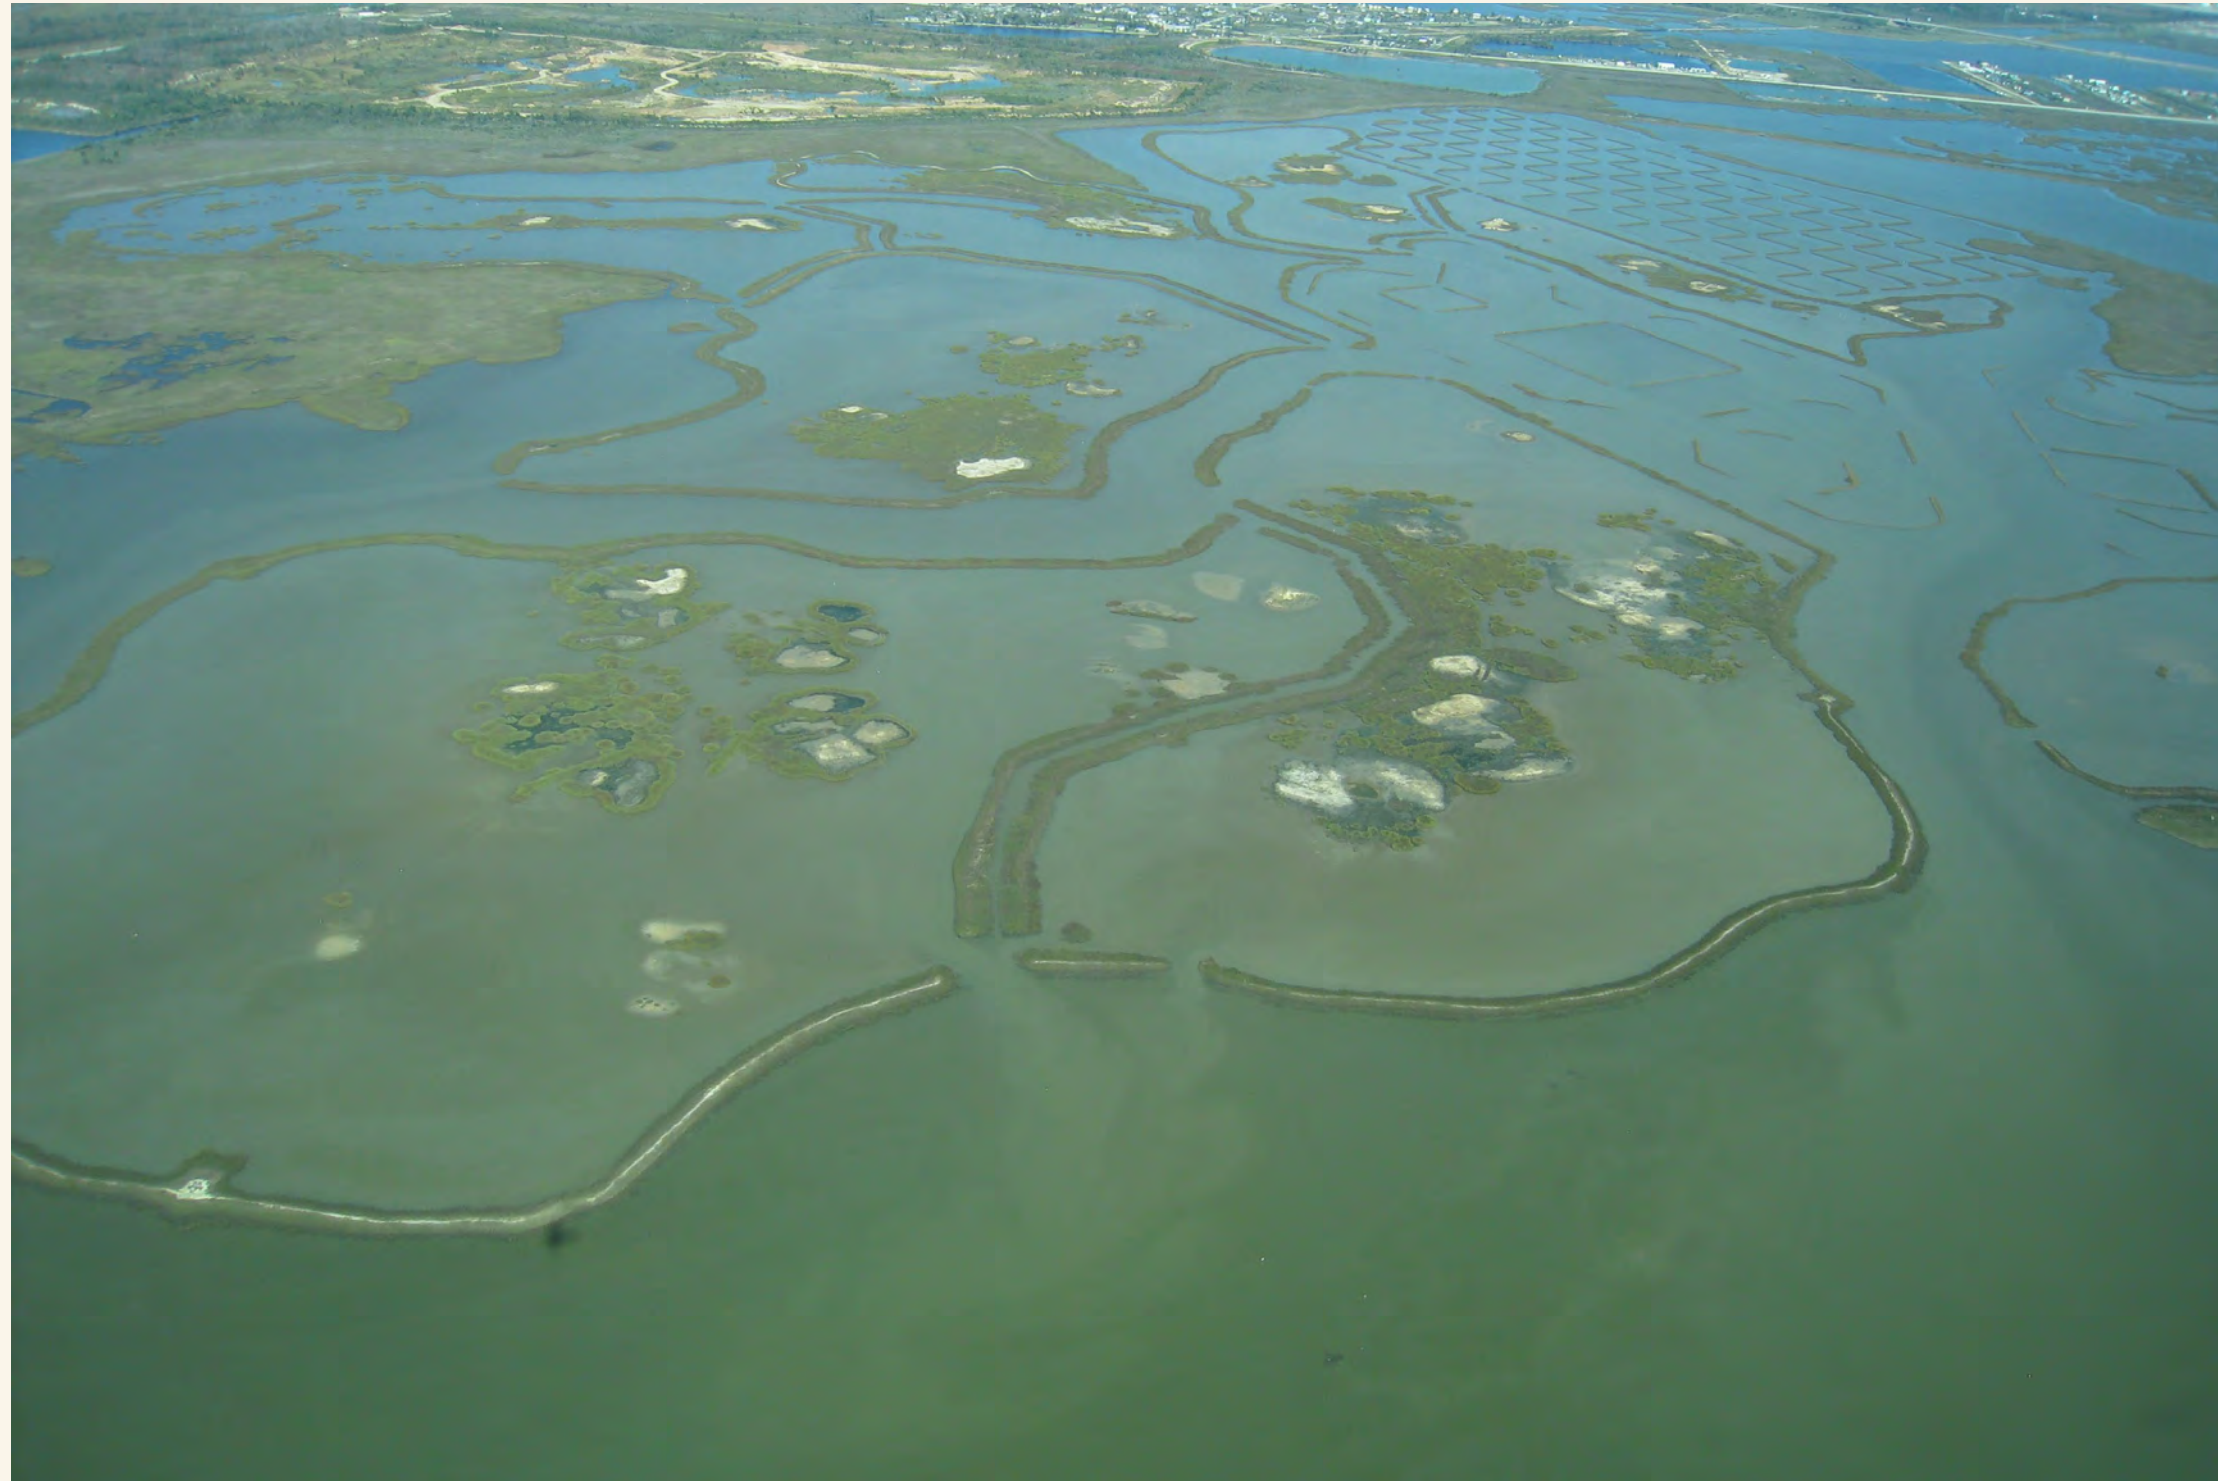
Pierce Marsh - 2005

Levees were constructed in 2005

Utilized dredge material from the development of Harborwalk community

Designed to beneficially utilize dredge material from USACE Gulf Intracoastal Waterway (GIWW) maintenance dredging activities

Purpose is to restore an estuarine marsh complex

Includes intertidal fringe marsh, salt marsh, sand flat and protected shallow water
