BACTERIA IMPLEMENTATION GROUP'S TOP FIVE MOST AND TOP FIVE LEAST IMPAIRED WATER BODIES

PRELIMINARY ACTION REPORT

August 4, 2016

Prepared by
Paniz Miesen
Houston-Galveston Area Council
P.O Box 22777
Houston, Texas 77227
(832) 681-2523
paniz.miesen@h-gac.com

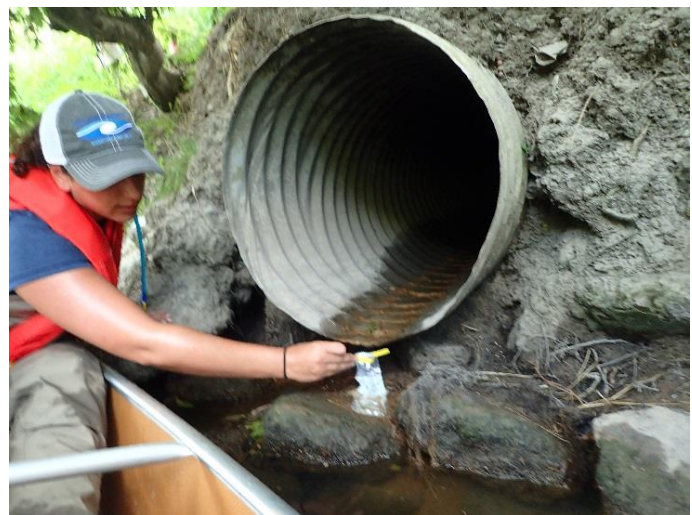
Figure 7. Collecting sample from discharging outfall

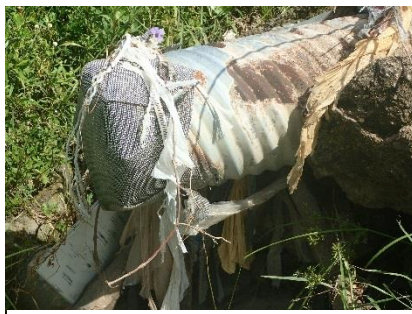
Figure 16. Outfall Tier II ID 035

- 1) Three suspicious outfall pipes adjacent to the Moody Park area had metal screened covers attached to the ends. One of the three pipes had a small amount of discharge dripping from the outfall, but not enough for sample collection and bacteria screening. Locations for the screened outfalls can be found in Table 3 (Tier II ID 033, 035, and 040). Refer to Figures 15-17 for images of the three suspicious outfall pipes.

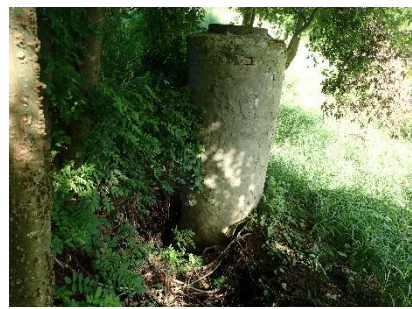
Figure 19. Outfall Tier II ID 052

- 2) Two sewer manholes require follow-up investigation. One manhole (Tier II ID 047) was found along the Bayou with an open lid likely from a recent sewer overflow. The smell of sewage inside the manhole could be detected from the bank. A second damaged manhole was found along the Bayou (Tier II ID 052). This manhole was about six feet tall with a large hole in the cement casing. Another hole was found in the ground by the sewer manhole. It was unclear if this was an active or abandoned manhole, but further investigation is recommended to ensure raw sewage does not discharge at the location. Refer to Table 3 for locations of each manhole, and to Figures 18-20 for images of each.

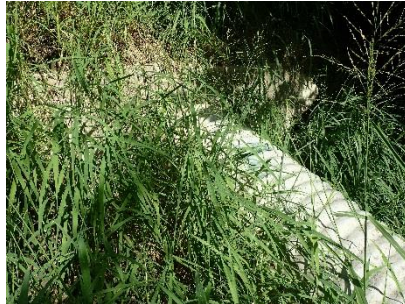
Figure 22. Outfall No. 31

- 3) A suspicious drain line from the Astro Inn's parking lot leads directly into Little White Oak Bayou on the right bank upstream of the West Cavalcade Street bridge. There was no discharge at the outfall at the time of sampling, but a surface water sample (019) was collected directly downstream of the pipe line resulting in an *E.coli* concentration of 7,300 cfu/100mL. Additional investigation is recommended to ensure this is not an illicit discharge. Refer to Table 3 (No. 31) for GPS coordinates and to Figure 21-23 for images of the drain line and parking lot.

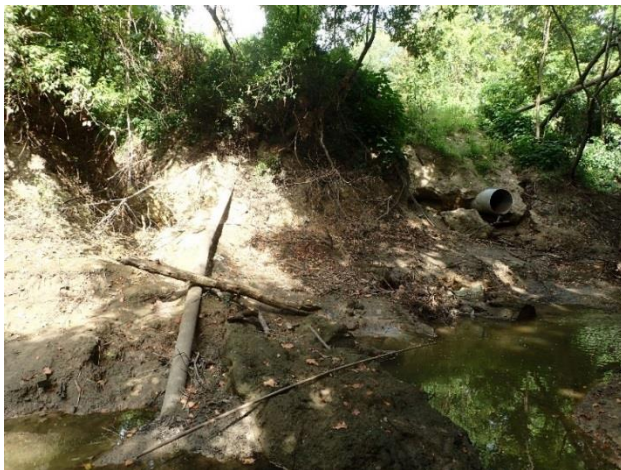
Noteworthy findings include sample 033 collected at a bend in the stream segment where trash accumulation was observed and apparent groundwater discharge was present. A slight sheen was visible on the water surface at the same location disturbed by the groundwater movement in the otherwise stagnant water (Figure 31). Two dilapidated pipes were observed at sample location 034 where high bacteria levels were detected. One pipe was bored under the waterway (Figure 32) while the other crossed above the water at street level. A concrete slab was found on the floor of Rummel Creek just downstream of the Rummel Creek Road bridge (Figure 33). The concrete was impeding water flow and creating high algae accumulation

Figure 32. Pipe and outfall near sample 034

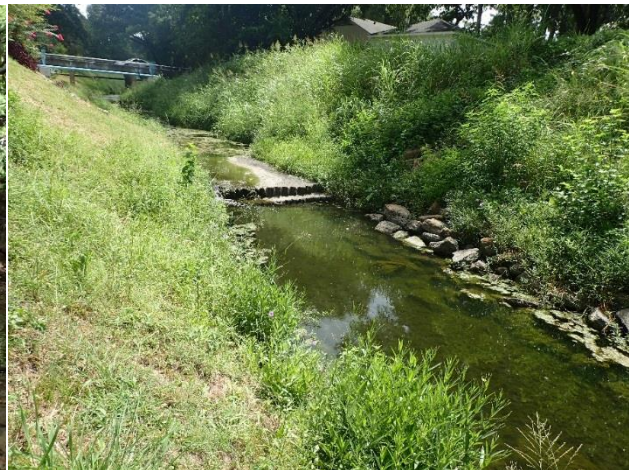
on the upstream side of the slab. Samples were taken upstream and downstream of the concrete slab, and bacteria levels were higher upstream where water flow was slower (sample 039). Algae was common throughout the waterway but appeared particularly dense north of Memorial Drive near Rummel Creek Elementary School (Figures 34-35). The sample collected at this location (sample 036) had the highest bacteria concentration collected during the Rummel Creek survey.

Figure 33. Concrete slab downstream of Rummel Creek Road

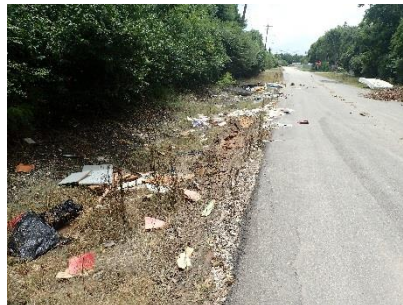
The windshield survey for Canal C-147 was conducted on June 22, 2016. The waterway was investigated by vehicle, and points of access and potential pollution sources were noted. Primary land use is residential throughout the catchment area, with light commercial land uses present along the primary thoroughfares of West Fuqua Street and the Beltway 8 corridor. Illegal dumping of trash was common in the neighborhood at the downstream end of the canal adjacent to the CRP monitoring station. A significant amount of household trash, including mattresses, fencing, and furniture, was found in alleyways and ditches near the stream (Figures 40-42). Refer to Figure E1 in Appendix E for a map of the windshield survey route.

Figure 41. Illegal dumping

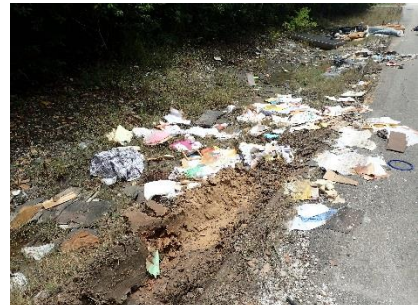
Figure 42. Illegal dumping

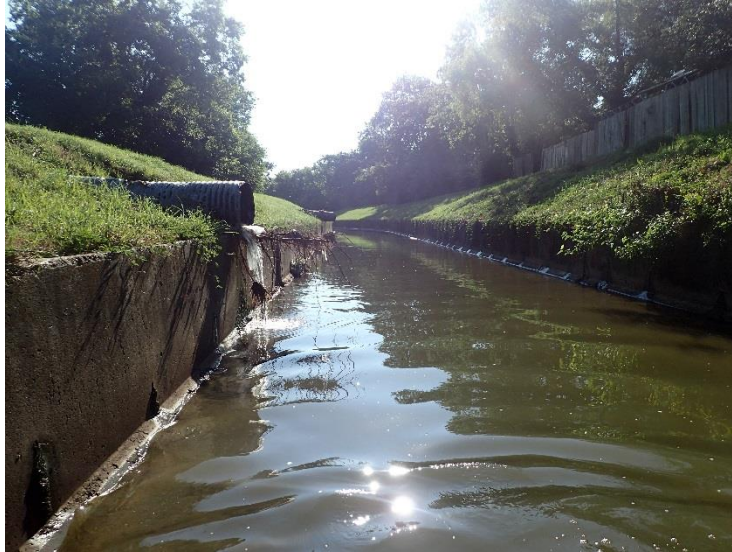
Noteworthy findings include the high bacteria loading from an outfall (sample 008) directly downstream of the CRP monitoring station off Tiffany Drive (Figure 46). Discharges from this outfall would not be captured in routine CRP monitoring due to its location. Two large concrete storm drains directly downstream of the South Post Oak Road bridge (Figure 47-48) had high *E.coli* concentrations (samples 013 and 014). Another high bacteria source discharging into the canal was a small tributary north of Beltway 8, sample 021 (Figure 49).

Figure 46. Outfall with dry weather discharge downstream of CRP monitoring station (sample 008)

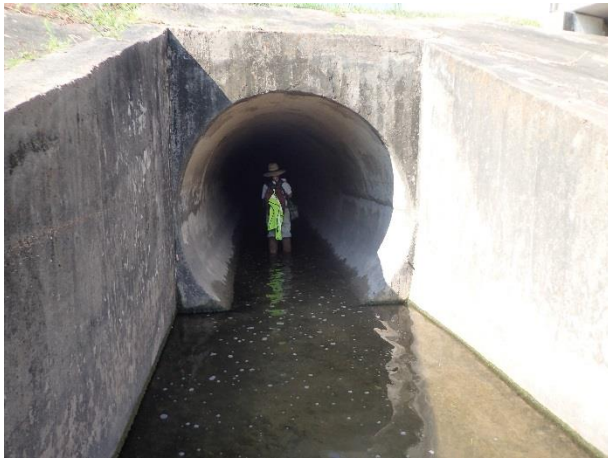
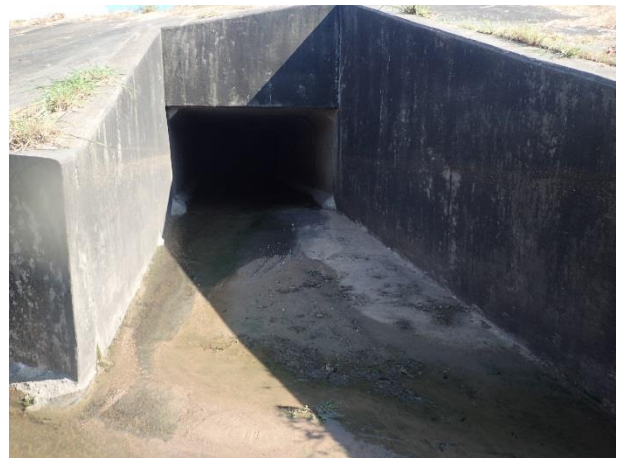
Figures 45 and 46. Storm drains downstream of the S. Post Oak Road bridge (samples 013 and 014)

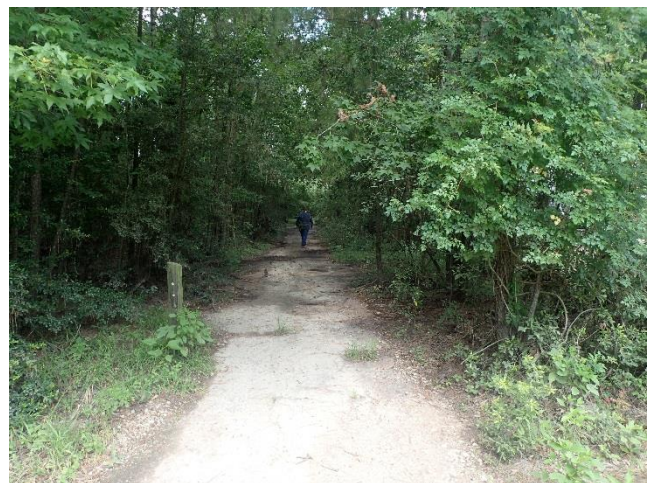
Figure 52. Hiking trail leading to Upper Panther Branch

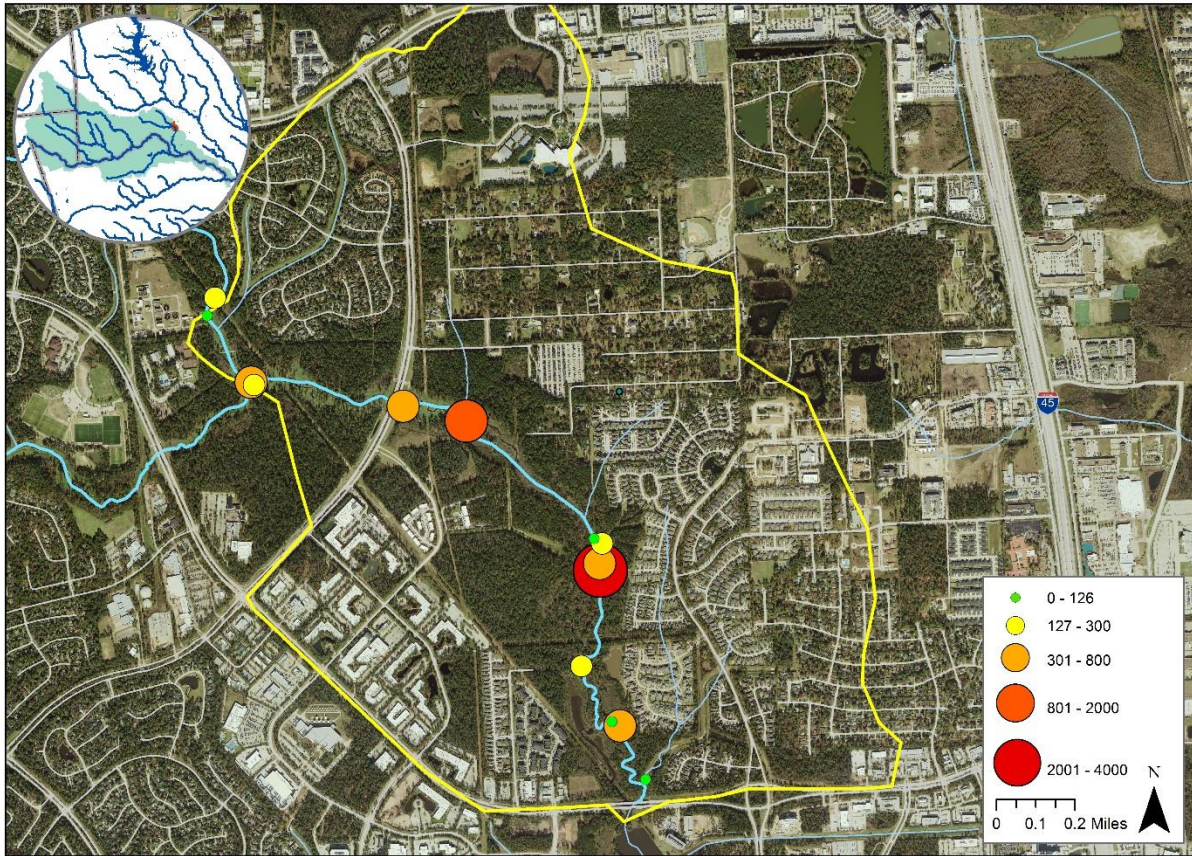
Figure 54. Bacteria screening results for Upper Panther Branch surveys

Table 6 lists all significant findings that require further investigation and follow-up sampling. The average *E.coli* count for Upper Panther Branch bacteria screening was approximately 496 cfu/100mL. Samples collected with *E.coli* counts greater than 500 cfu/100mL were flagged as problem areas where further investigation is recommended.

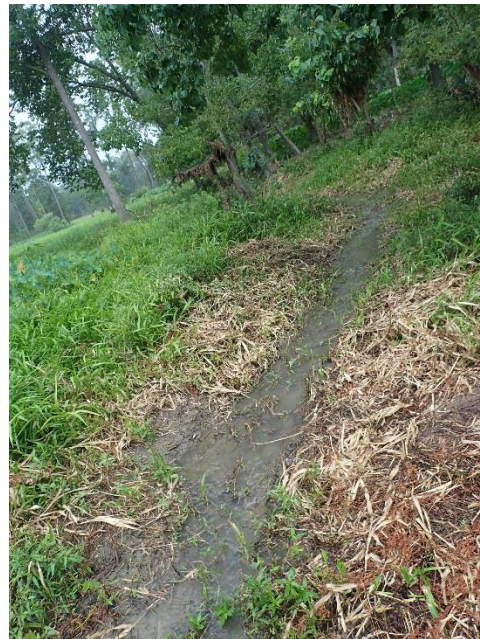
Figure 57. Stormwater drainage tributary with high bacteria concentration (Tier II ID 072, sample 009)

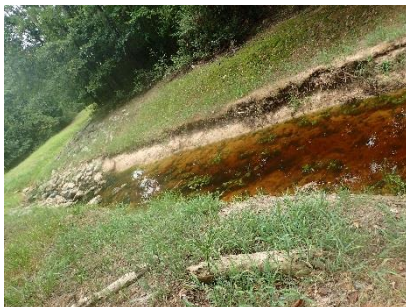
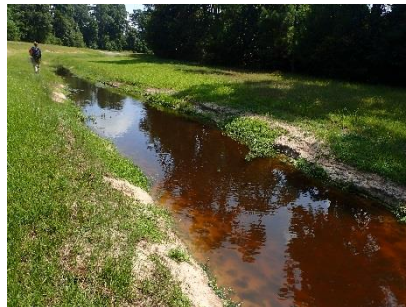
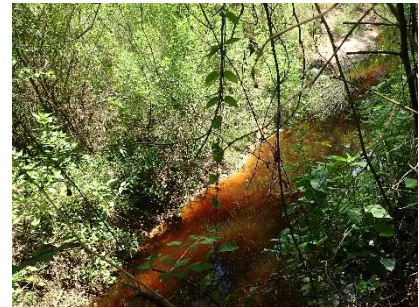
Noteworthy findings include the high bacteria loading from a stormwater drainage tributary (Tier II ID 065) originating from the subdivision off Grogans Mill Road (Figure 56). Homeowners were seen walking their dogs along the drainage tributaries in this area, making pet waste a potential contributor of bacteria at this location. Another stormwater drainage tributary (Tier II ID 072, sample 009) coming from the sporting facility on Marisco Place had high *E.coli* concentrations, 1 with the water sample having a strong petrochemical smell likely from surface runoff from the adjacent parking lot (Figure 57). Several of the tributaries feeding into Upper Panther Branch had a very distinct reddish tint (Figures 58-60). It was unclear if this was a result of impacts from different soil types or if there were other factors. However, there did not seem to be a correlation between bacteria concentration and red water at these sample locations.

Figures 58-60. Red tinted waters in the tributaries of Upper Panther Branch
