Bacteria Source Identification Report

BIG's Top Five Most and Top Five Least Impaired Water Bodies Project

Galveston Bay Estuary Program
Texas Commission on Environmental Quality
Local Jurisdictions

Prepared by:

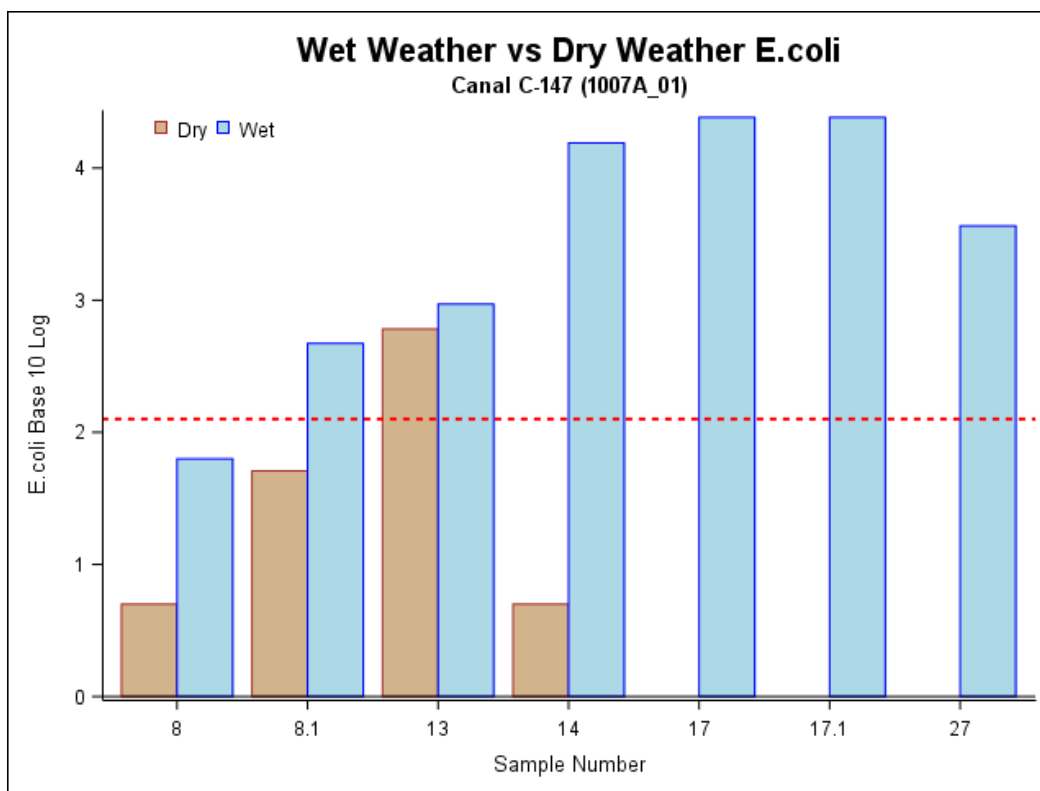
Figure 10. Wet weather and dry weather e.coli concentrations from Phase II Canal C-147 surveys. Red dotted line represents the state water quality standard for bacteria.

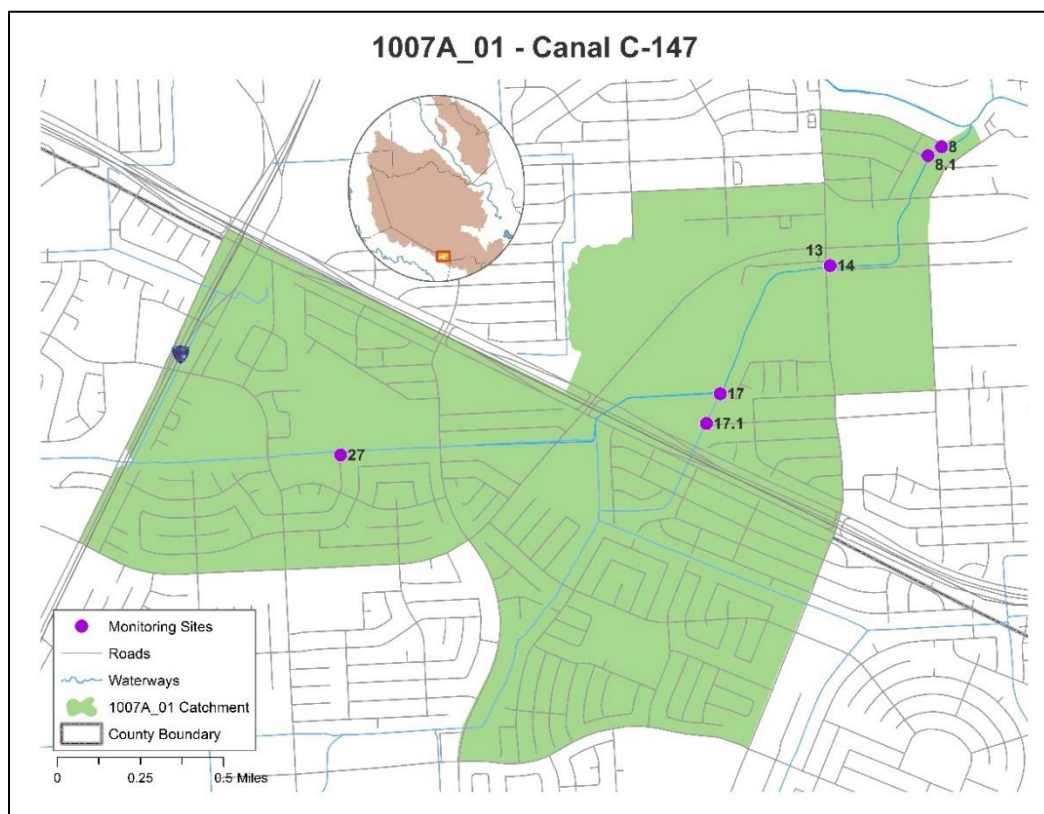
Figure 11. Phase II Canal C-147 monitoring stations

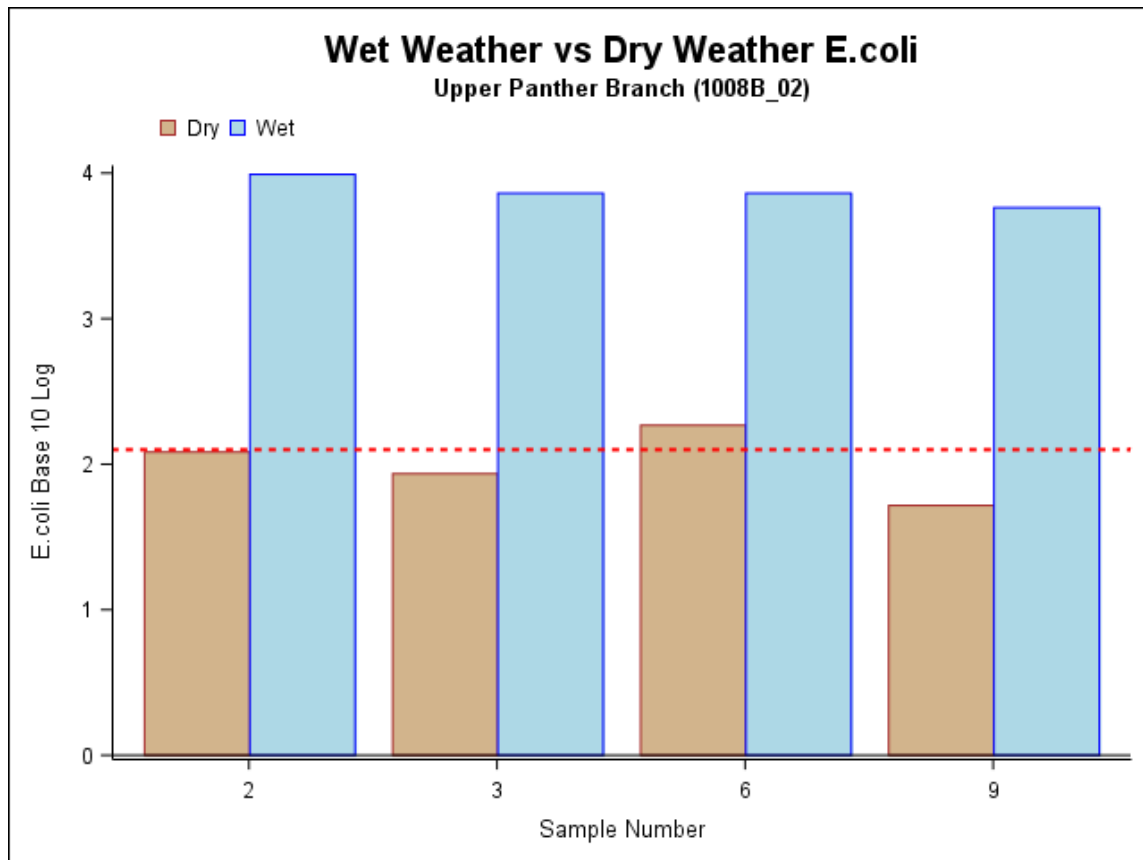
FIGURE 26. WET WEATHER AND DRY WEATHER *E.coli* CONCENTRATIONS FROM PHASE II UPPER PANTHER BRANCH SURVEYS. RED DOTTED LINE REPRESENTS THE STATE WATER QUALITY STANDARD FOR BACTERIA.

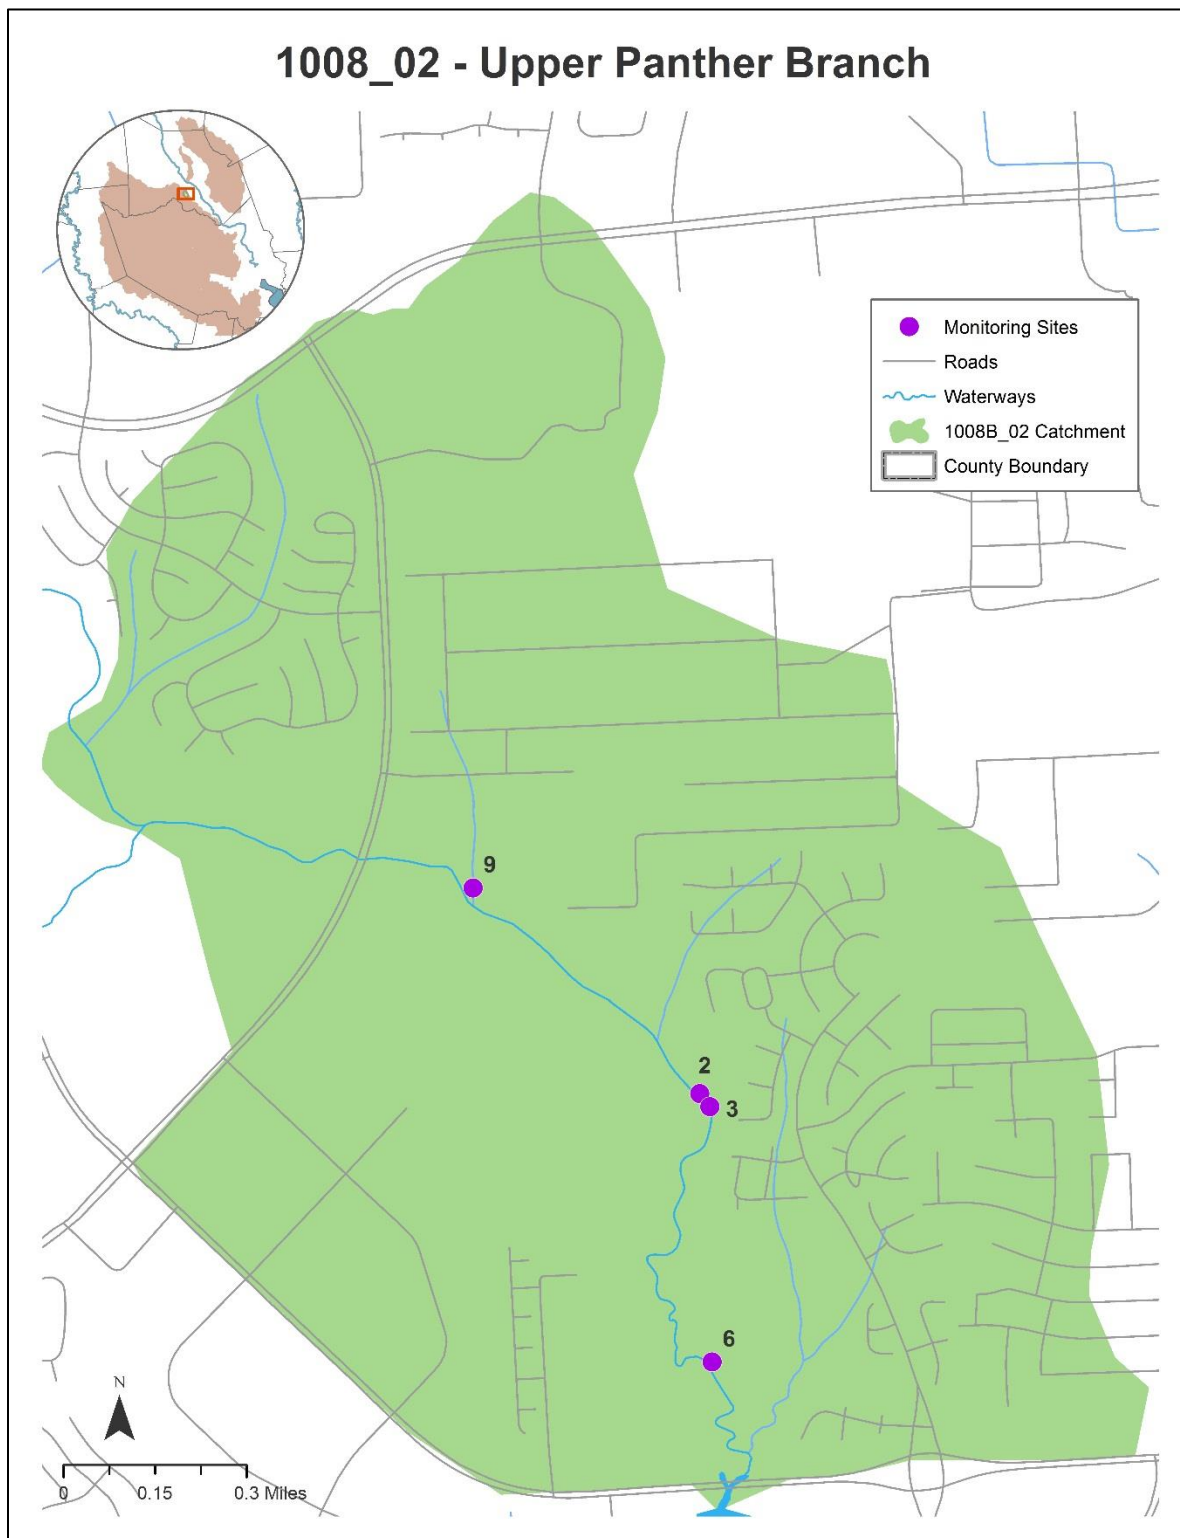
Figure 27. Phase II Upper Panther Branch monitoring stations

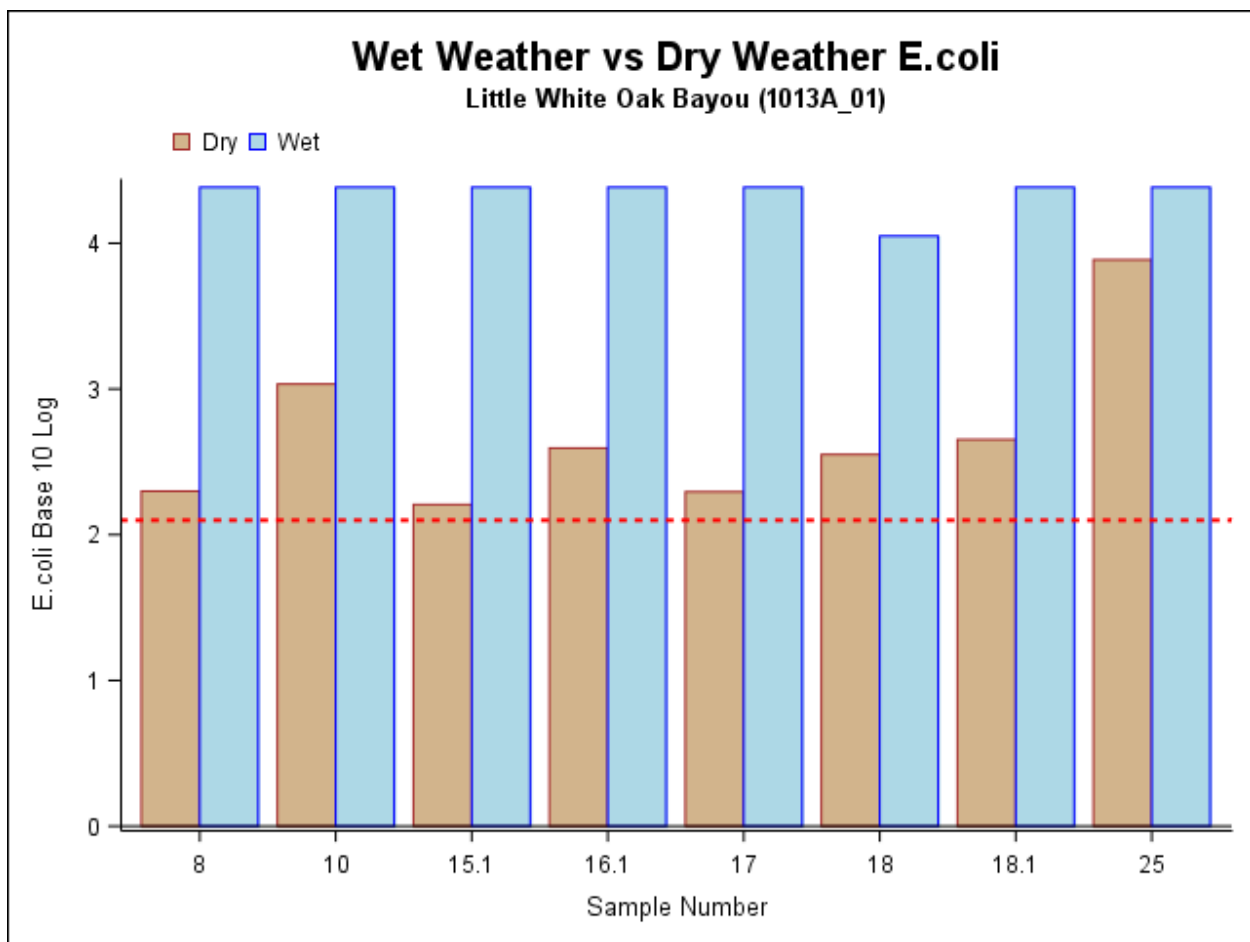
FIGURE 36. WET WEATHER AND DRY WEATHER *E.coli* CONCENTRATIONS FROM PHASE II LITTLE WHITE OAK BAYOU SURVEYS. RED DOTTED LINE REPRESENTS THE STATE WATER QUALITY STANDARD FOR BACTERIA.

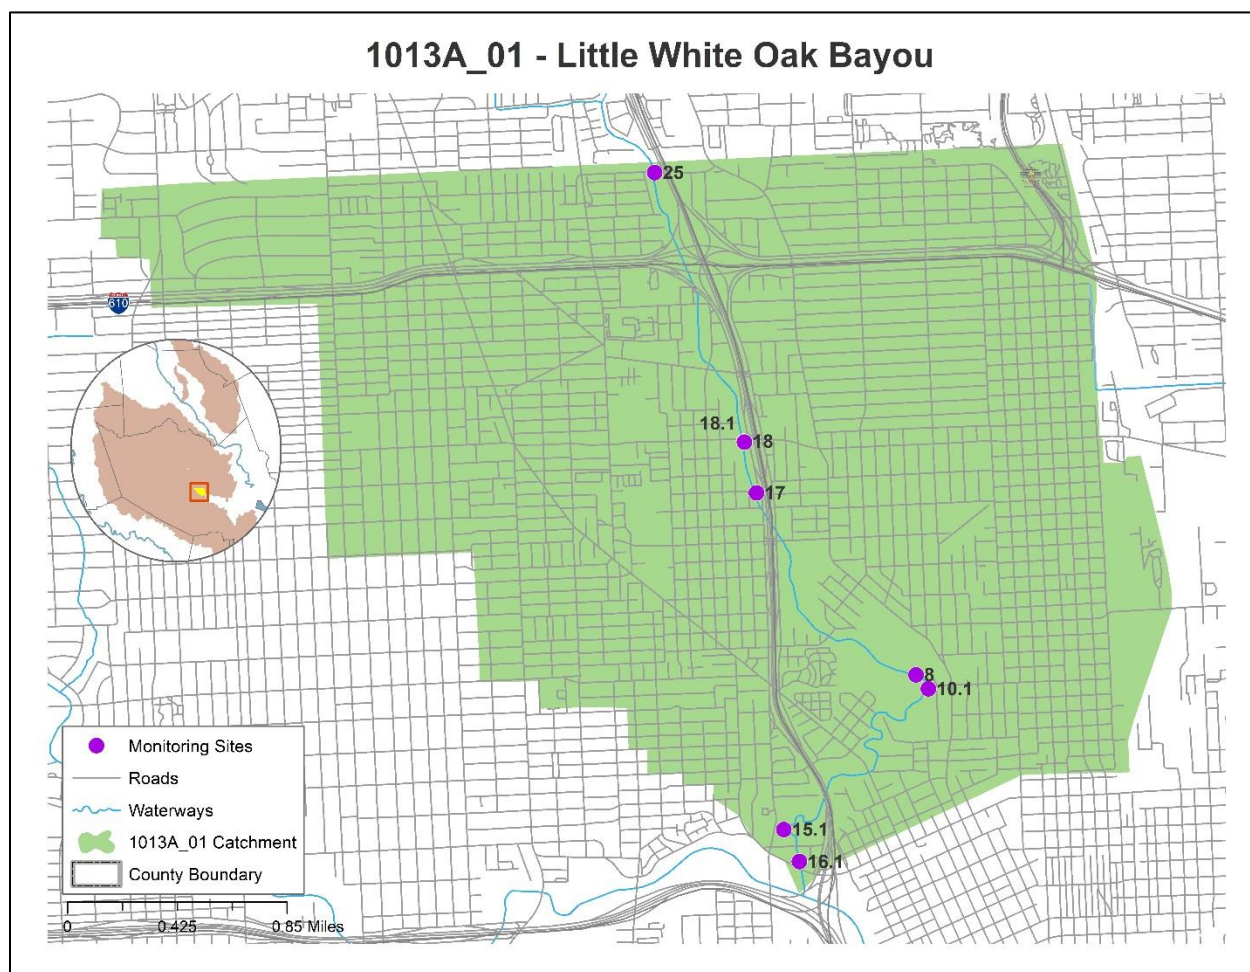
FIGURE 37. PHASE II LITTLE WHITE OAK BAYOU MONITORING STATIONS

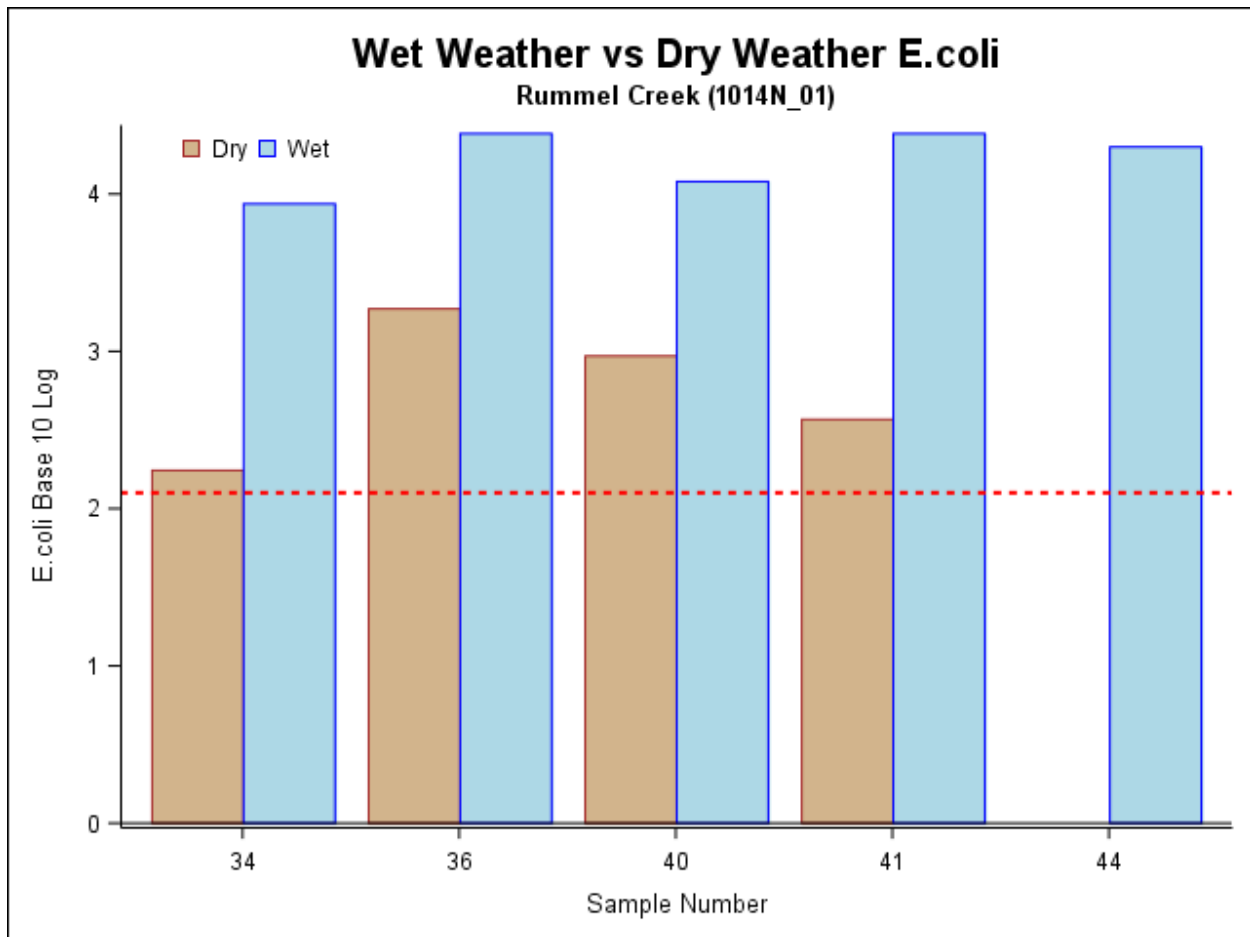
FIGURE 57. WET WEATHER AND DRY WEATHER *E.coli* CONCENTRATIONS FROM PHASE II RUMMEL CREEK SURVEYS. RED DOTTED LINE REPRESENTS THE STATE WATER QUALITY STANDARD FOR BACTERIA.

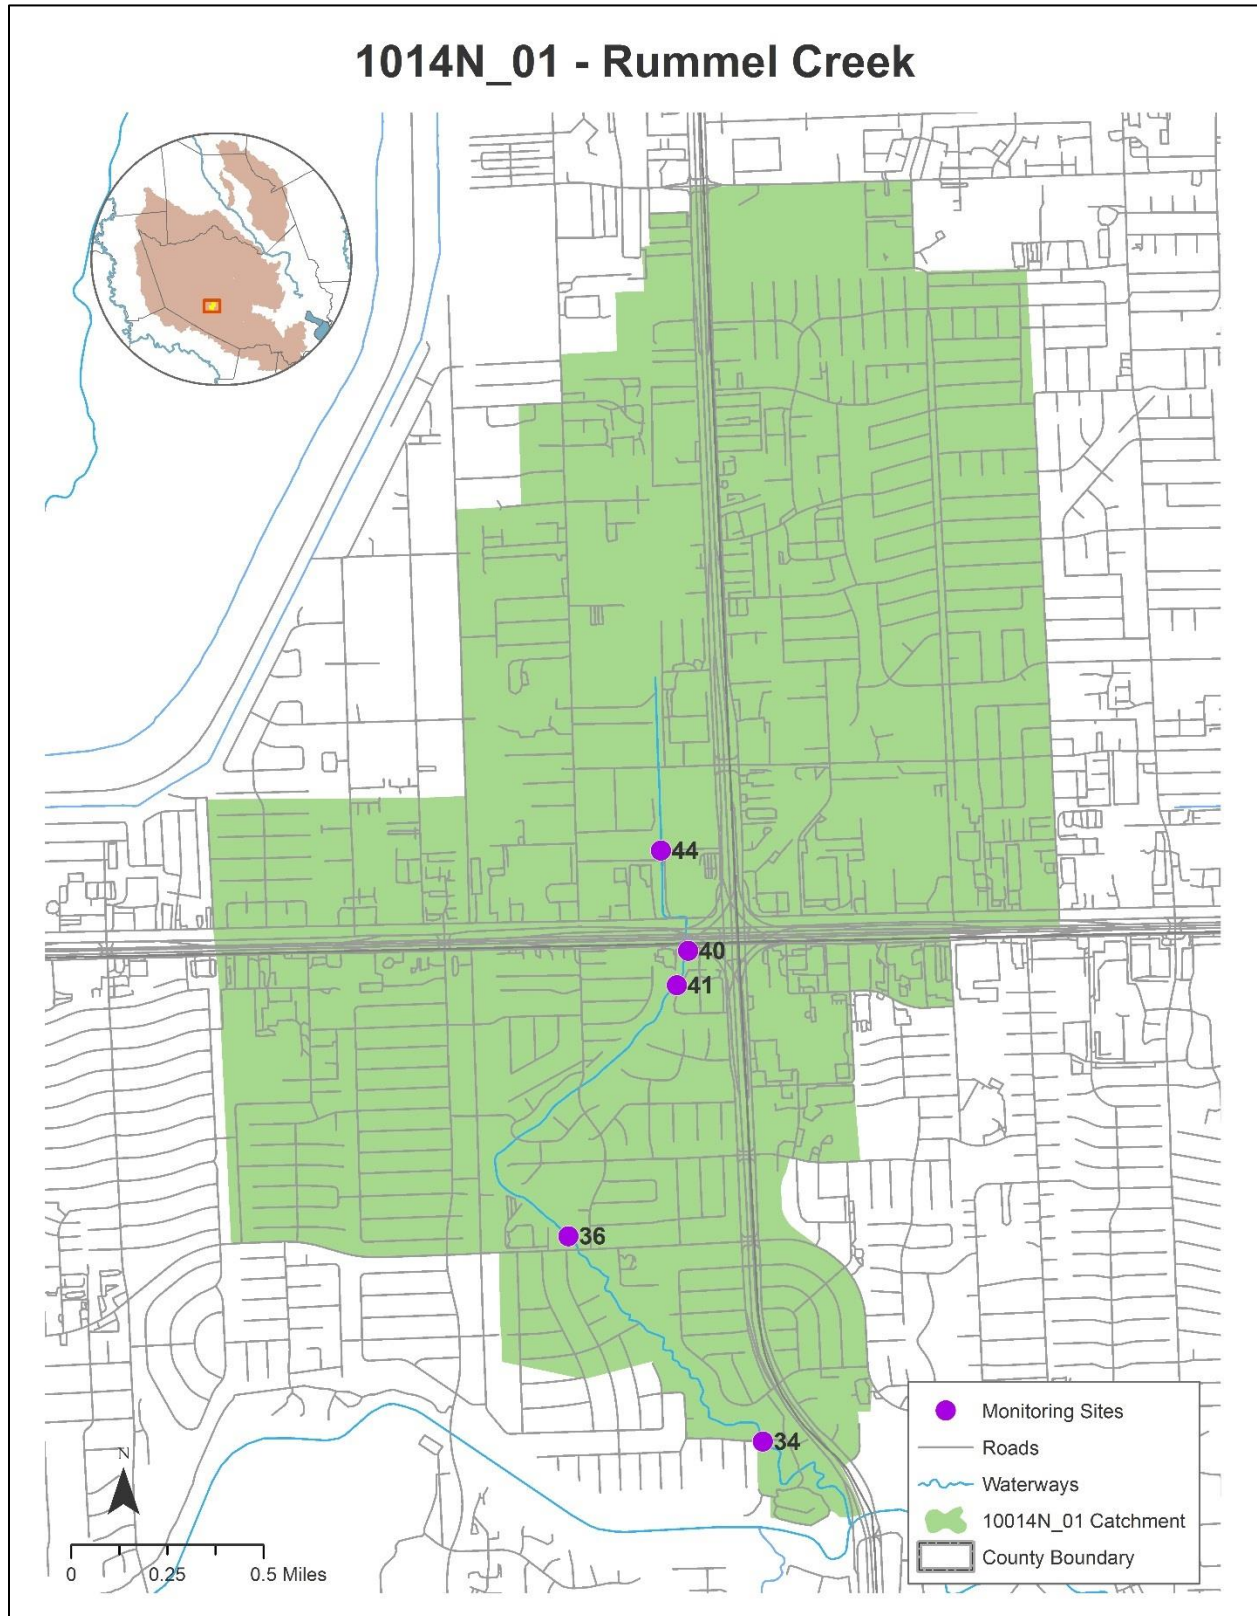
FIGURE 58. PHASE II RUMMEL CREEK MONITORING STATIONS
