North Trinity Bay

Well Plugging, Pipeline Abandonment & Structure Removal Project

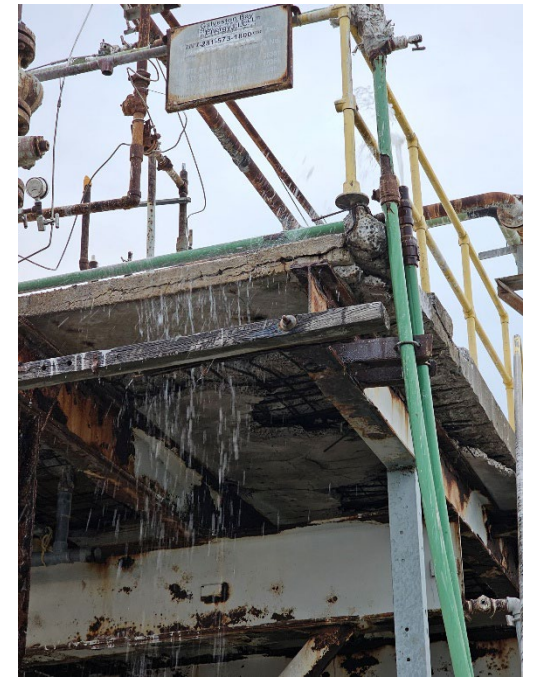
Flushing Flow Lines
