Stormwater Best Management Practice (BMP)
Testing at the
Ghirardi Family WaterSmart Park

FINAL REPORT
582-16-60055
August 2018

**Compiled by the
Texas Community Watershed Partners
A program of the Texas A&M AgriLife Extension Service**

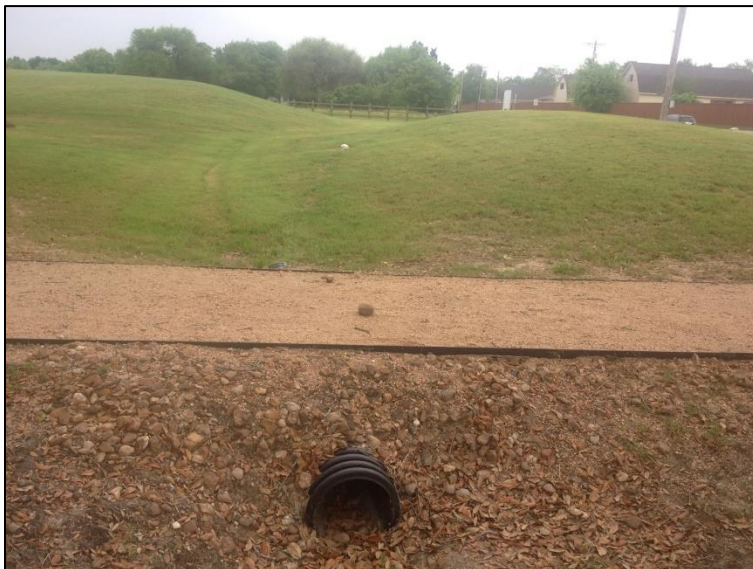
Figure 10. Bioswale vegetated with turf grass. Sampling point for this BMP is the pipe pictured.

The bioswale (Figure 3) is completely vegetated with Bermuda grass, and collects overland flow from within the park, only grassed areas contribute runoff, there are no impervious surfaces in this watershed.

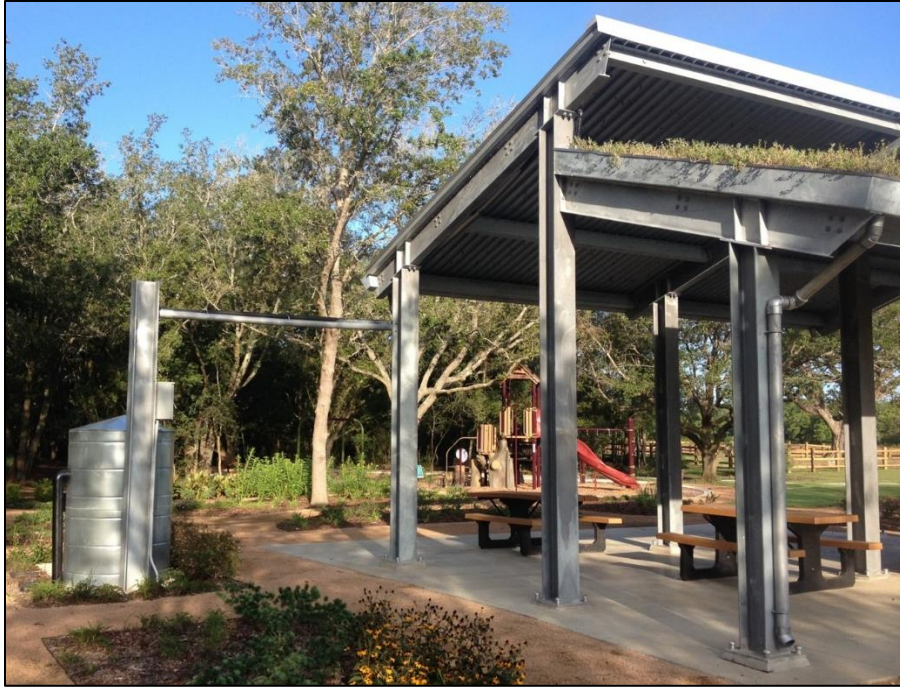
Figure 11. Pavilion at GBEP, the roof is split into two sections, allowing for both a green roof and rainwater harvesting practices on the same structure.

The green roof and rainwater harvesting cistern are situated to collect runoff from the roof of the park pavilion (Figure 4). The pavilion has a split roof design so each practice has a discrete watershed contributing to the BMP. The green roof is a system of interlocking tray filled with engineered soil due to the pitch of the roof.
