North Trinity Bay

Well Plugging, Pipeline Abandonment & Structure Removal Project

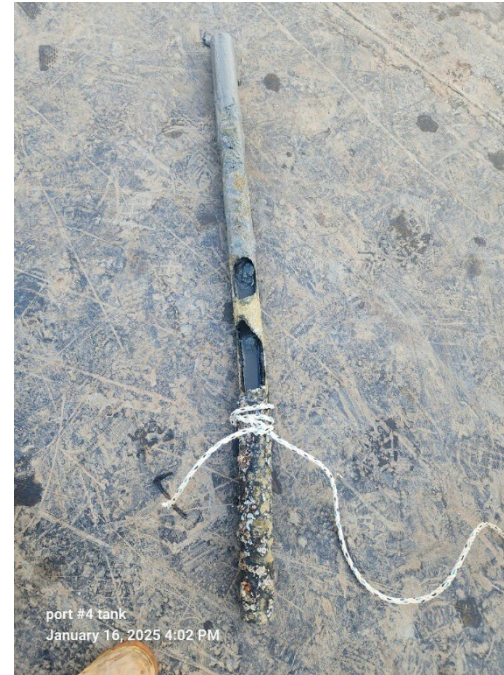
Broken Flow Line Recovery

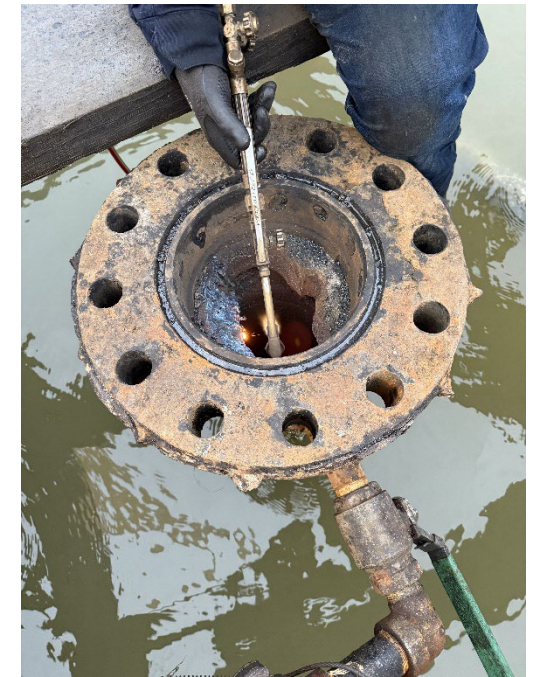
Cutting Dual Tbg Hanger

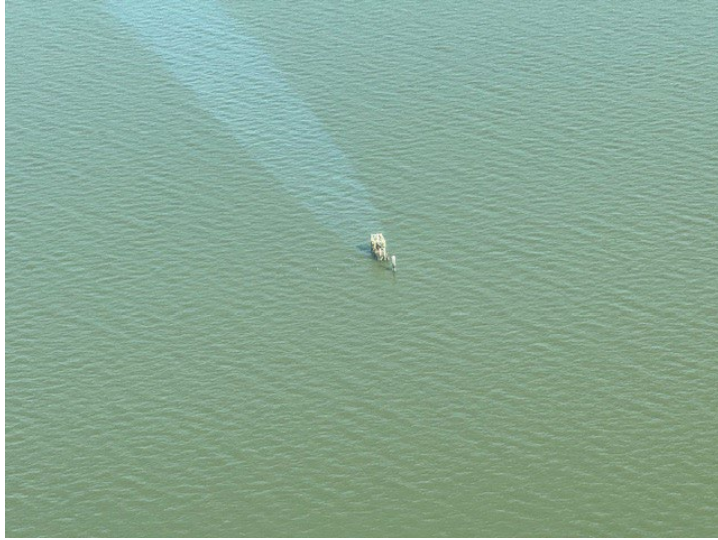
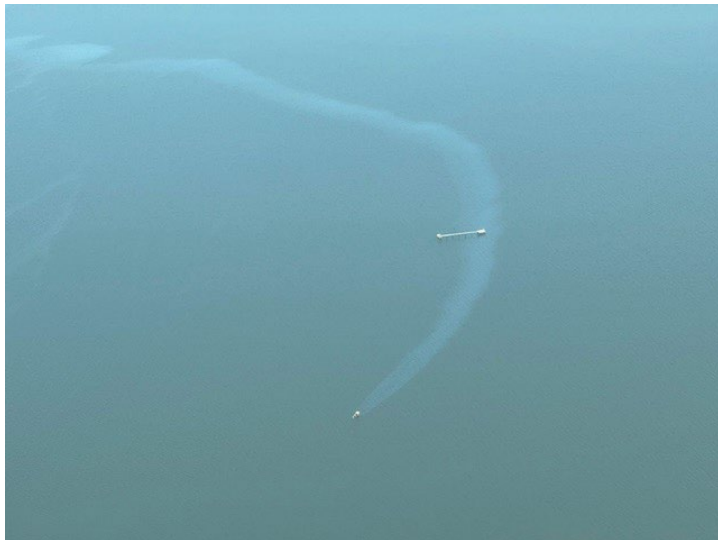
Fishers Reef Leaking Well

Corroded Needle Valve

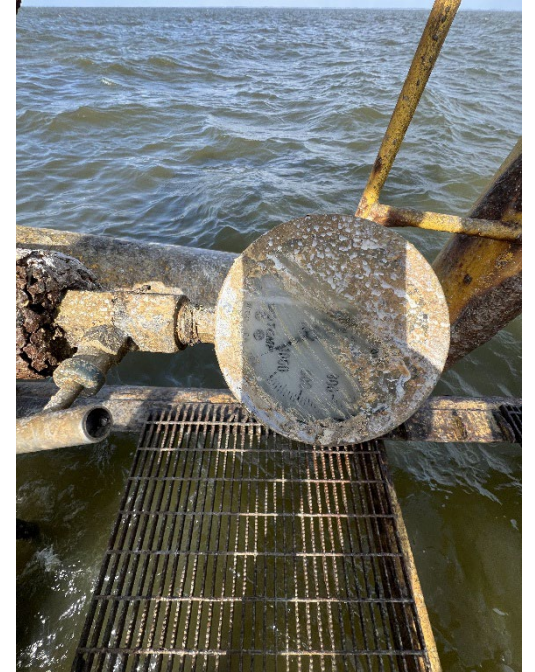
>1,000 psig still on the well

Needle Valve & New Gauge Installed
